NOTES FROM CONVERSATION WITH SCOTT KAPCSOS, AUTHORITY MANAGER FOR MOUNT JOY WATER AND SEWER AUTHORITY

885 SOUTH CHIQUES ROAD
RAPHO TOWNSHIP

RE: Preliminary Septic Testing for OAL

SITE: 855 S Chiques Road, Manheim, PA 17545
Rapho Township, Lancaster County

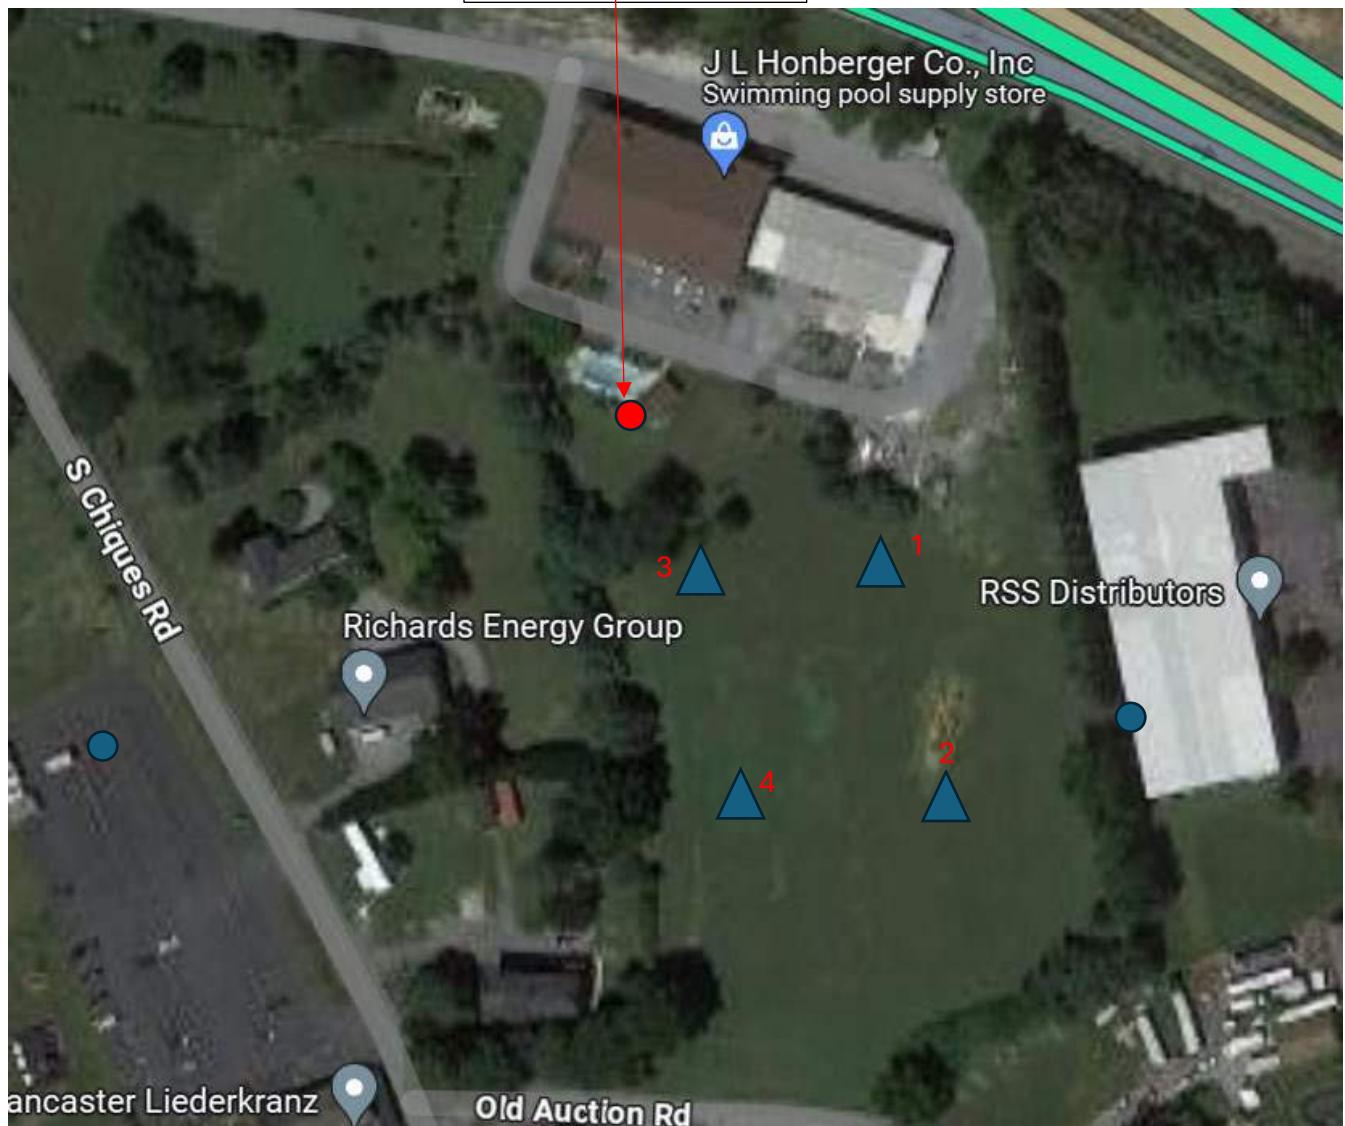
Existing septic tank
and in-ground system
