INSPECTION REPORT

2088-2090 New Danville Pike
Lancaster, Pennsylvania 17603

John Hemperly &
12/21/2023

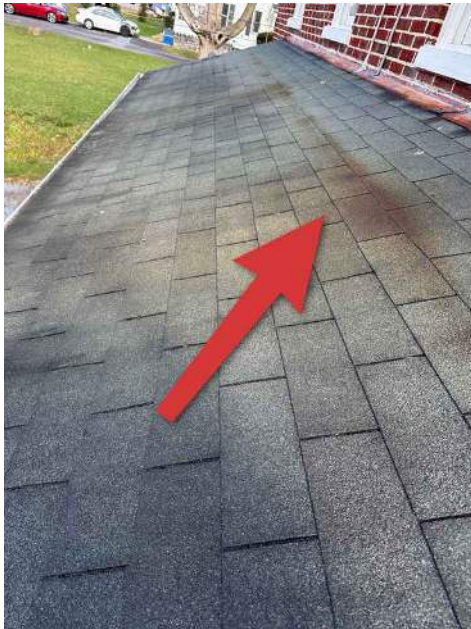
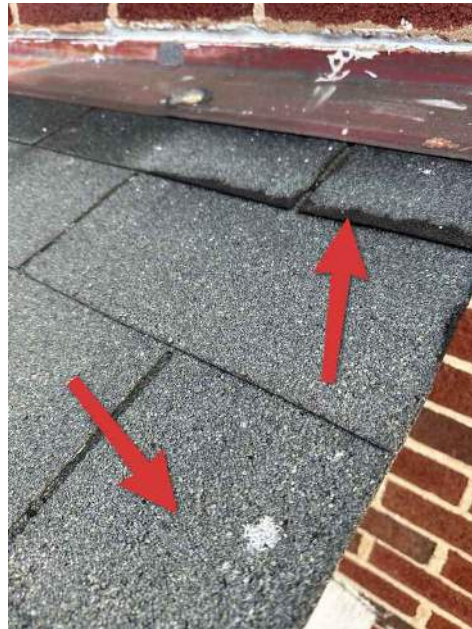
2.1.1 Coverings

The roof shingles showed signs of wear consistent with a roof nearing the end of its useful life. Surface wear, damaged shingles, loose granules and other defects were visible. I recommend making plans to budget for a new roof in the near future based on the **recommendation and evaluation of the roof by a qualified professional.**

Rear Porch Roof shingles wearing thin

Close up of shingle wear

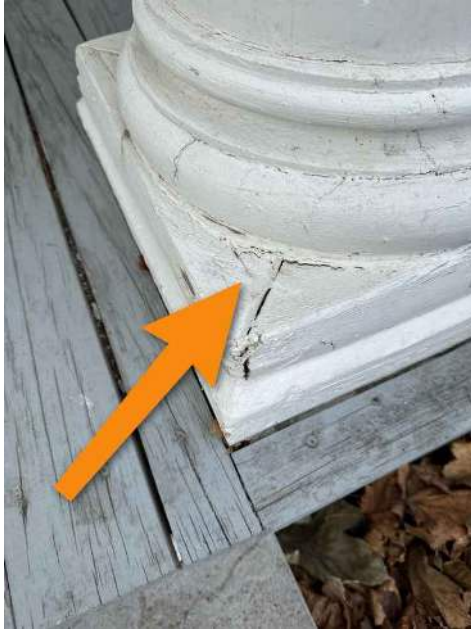
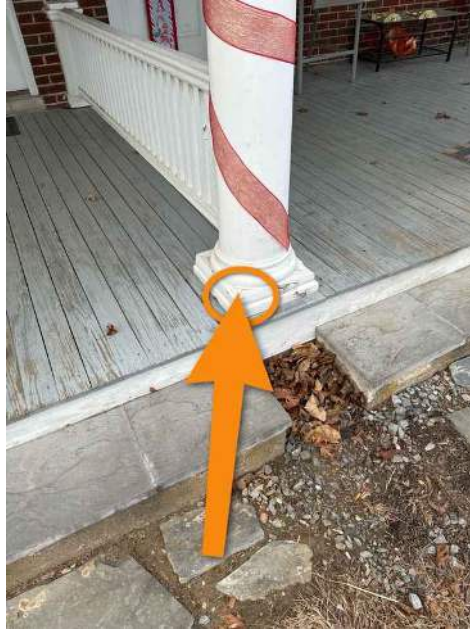
At the time of the inspection I observed parts of the porch that were rotten or missing. See photo descriptions. If left unaddressed this wood is vulnerable to continued damage. I recommend a licensed carpenter to fully evaluate the porch structure and reinforce or replace as necessary.

Wood, softening under paint

Rot beginning to develop at base of post

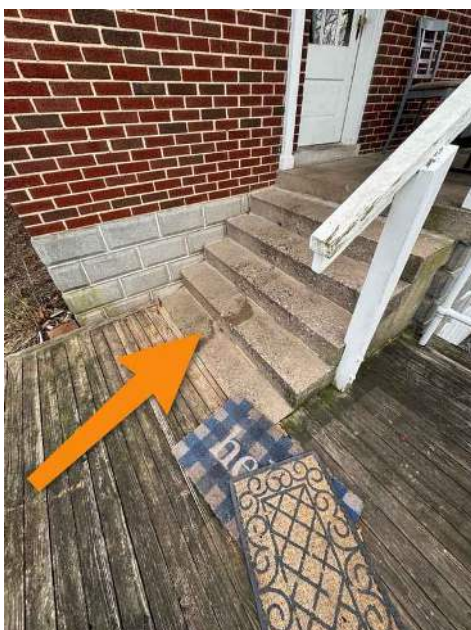
3.3.4 Porches, Balconies, Steps and Railings

At the time of the inspection I observed that the steps pictured here were settling. This condition may worsen if not repaired. I recommend a qualified professional to evaluate and repair as necessary.

Steps appeared to have settled

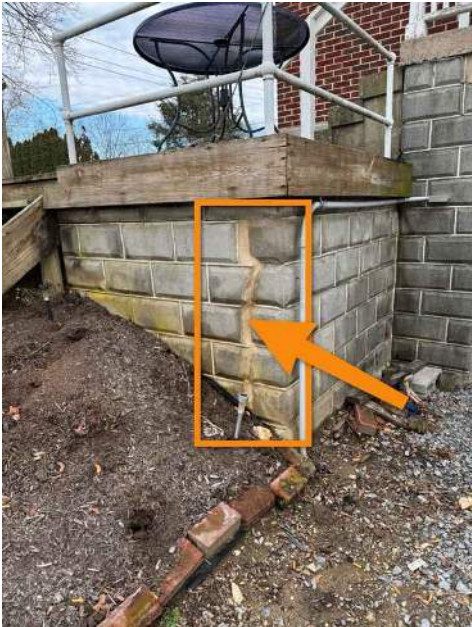
Gap separation at top of steps

Past repair made to wall that pushed out

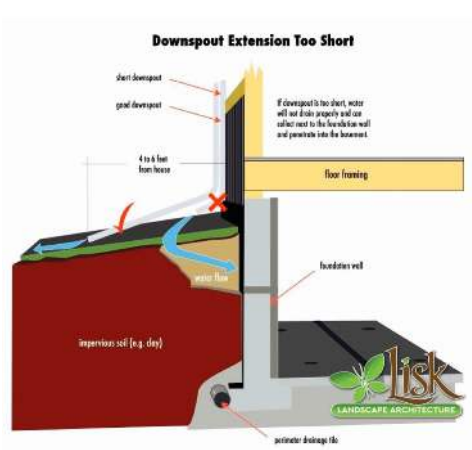
3.4.1 Grading and Drainage

At the time of the inspection one or more downspouts were discharging close to the structure. This can result in erosion and damage to the foundation structure because the soil remains constantly wet. The recommended distance for a surface extension of a downspout is 4 feet or more from the structure. I recommend these downspouts be extended.

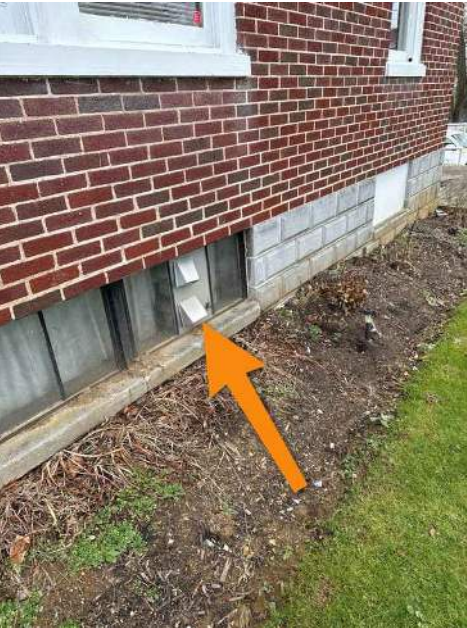
2088 dryer vent needs cleaned out

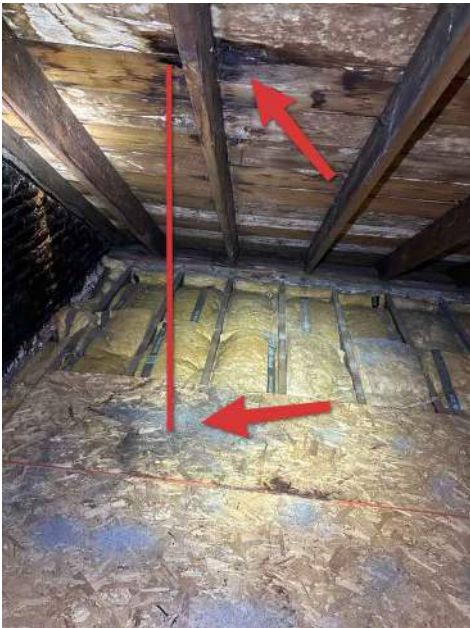
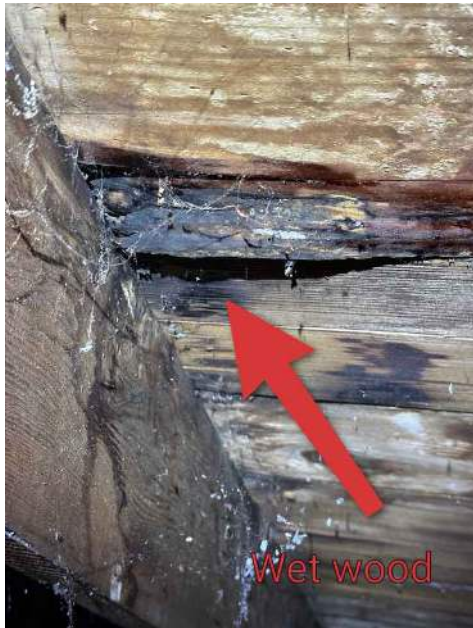
Leak at sheathing/deposit on floor

Close up - wet sheathing

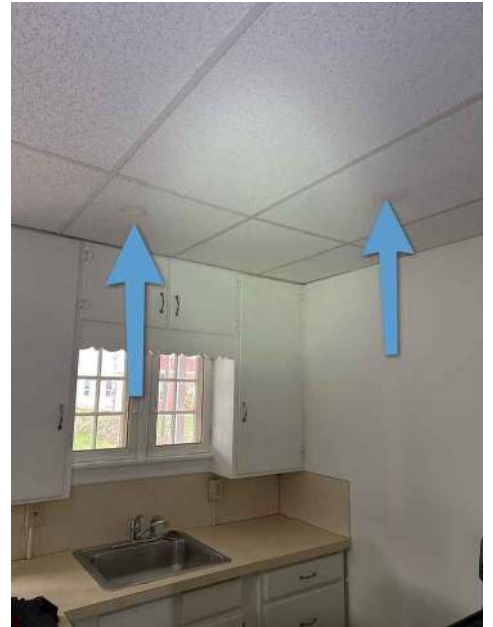
At the time of the inspection, I observed one or more stains in the ceiling. I was not able to determine the cause but do recommend a qualified professional to investigate the area to determine what might be causing the stain.

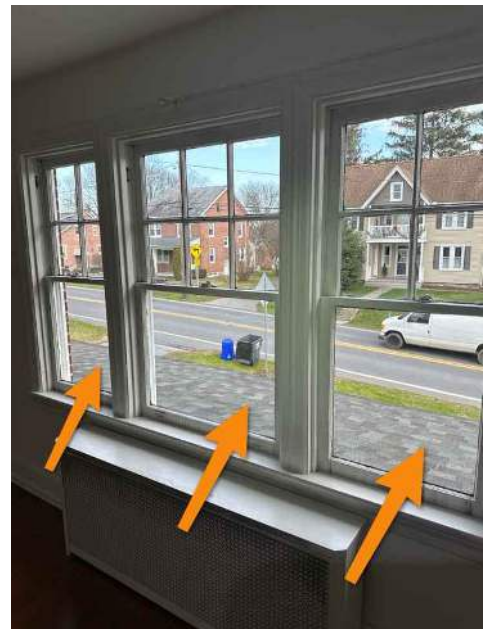
5.5.1 Windows

At the time of the inspection, the home had one or more older wooden windows. These windows can last 50 years or more. They may even outlast vinyl windows but they are less efficient and require more maintenance. For example, periodic painting, re-glazing and sash chord replacement are necessary. They can also become difficult to open and close. I recommend a qualified professional to evaluate all the wooden windows to assure that they are operational. In addition, ask the professional to offer cost comparisons on replacement vs. repair.

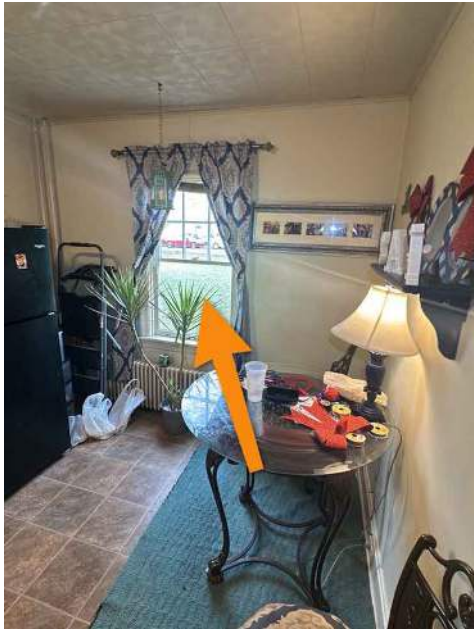
5.5.2 Windows

At the time of the inspection, the home had one or more older wooden windows. These windows can last 50 years or more. They may even outlast vinyl windows but they are less efficient and require more maintenance. For example, periodic painting, re-glazing and sash chord replacement are necessary. They can also become difficult to open and close. I recommend a qualified professional to evaluate all the wooden windows to assure that they are operational. In addition, ask the professional to offer cost comparisons on replacement vs. repair.

Representative

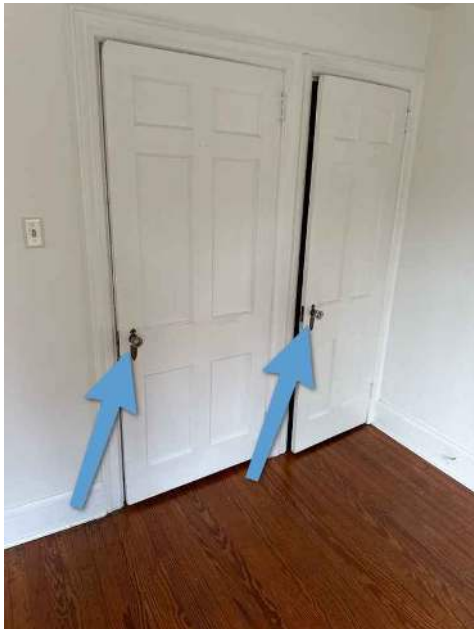
5.7.1 Doors

At the time of the inspection one (or more) interior door was not latching properly. It appears to be a hardware or fitting defect. I recommend this be adjusted.

Master Bedroom Front

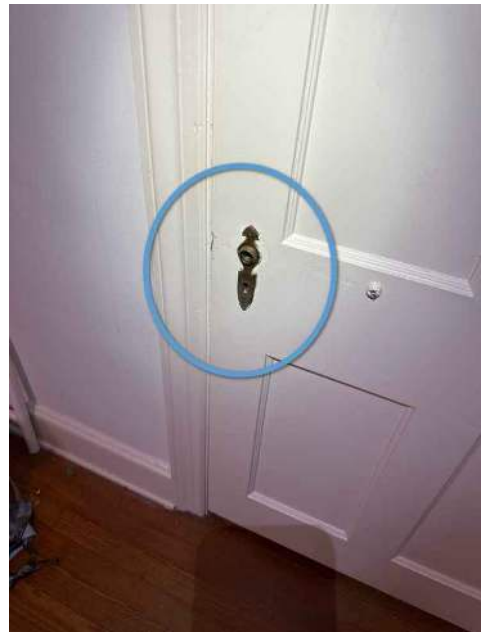
At the time of the inspection I observed one or more doors that were missing hardware. I recommend new hardware be installed.

Missing knob

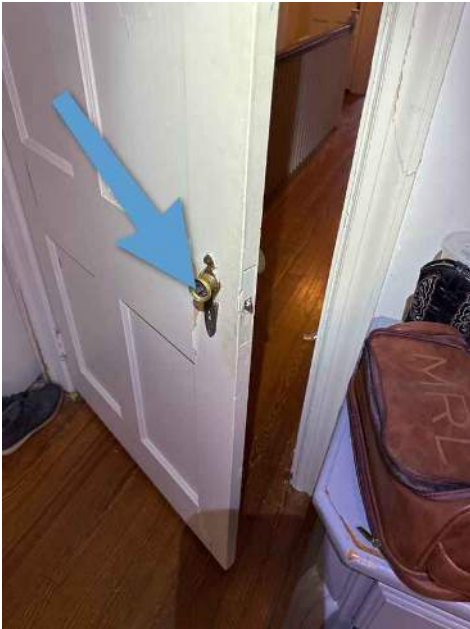
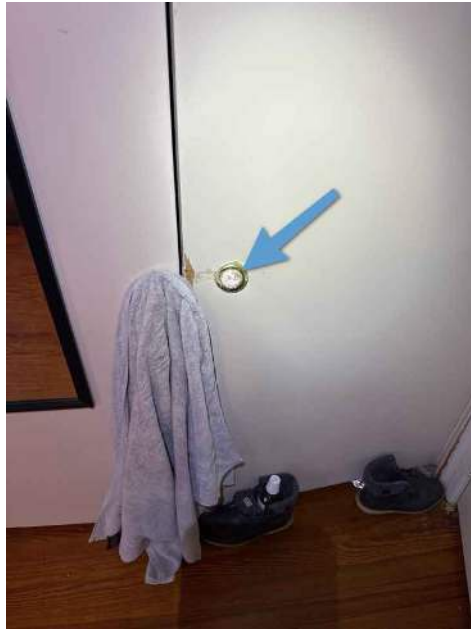
5.7.3 Doors

I observed one or more doors where the operating hardware was damaged. This makes it difficult to close and/or open the door. I recommend that a handyman or DIY repair so that the door operates properly.

Broken knob

Broken knob closet

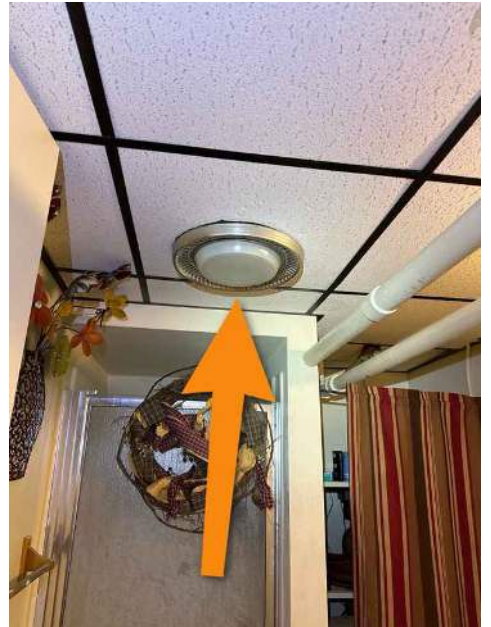
At the time of the inspection the bath exhaust fan was not working. This may indicate that the motor has reached the end of its serviceable life or that there is an electrical problem. I recommend a professional evaluate and repair or replace.

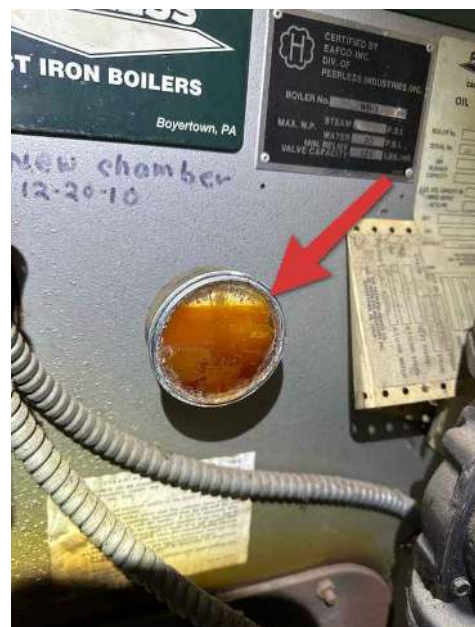
The pressure gauge on the furnace was not functioning properly or broken. I recommend replacement.

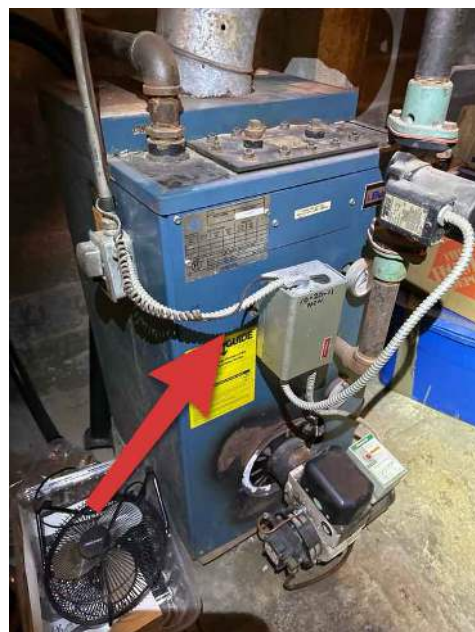
7.3.1 Heating Equipment 2088

OIL BOILER NEEDS ROUTINE MAINTANENCE

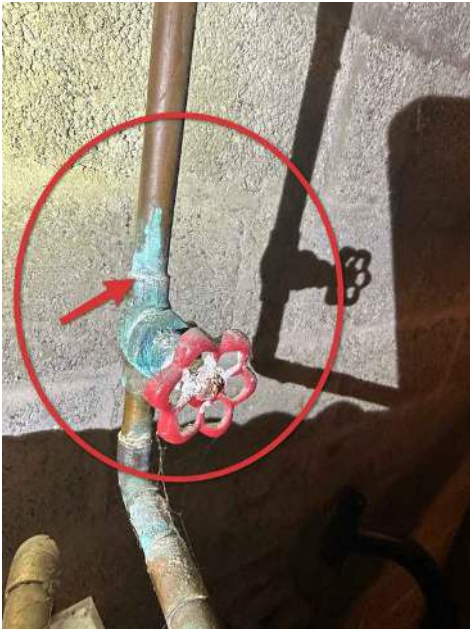
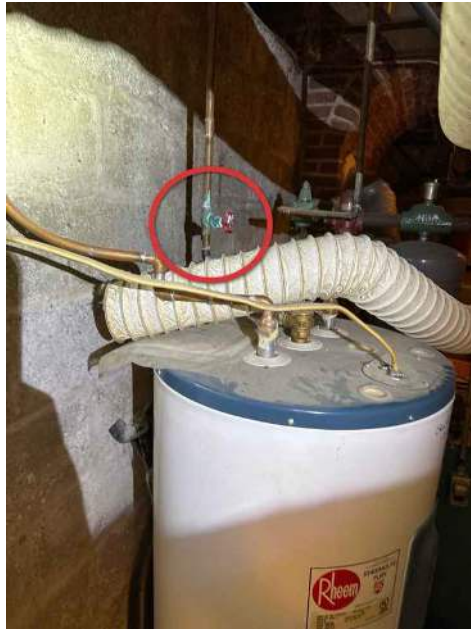
8.7.1 Water Heater 2088

ACTIVE LEAK

Supply line

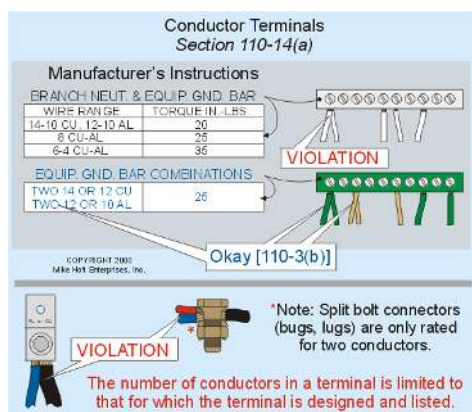
Shared neutral and ground wires

Code specifications

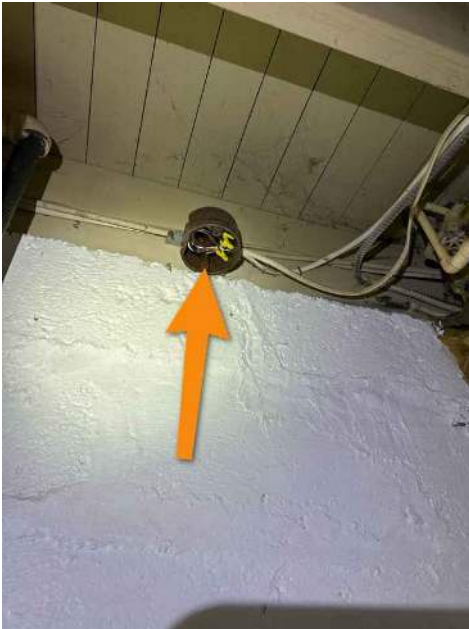
9.4.1 Branch Wiring

JUNCTION BOX COVER(S) MISSING

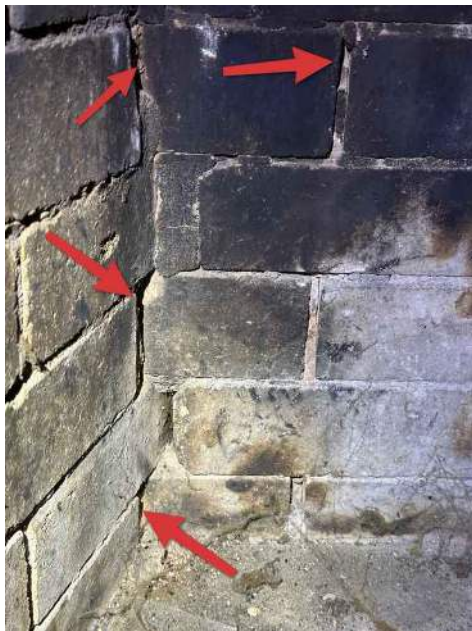
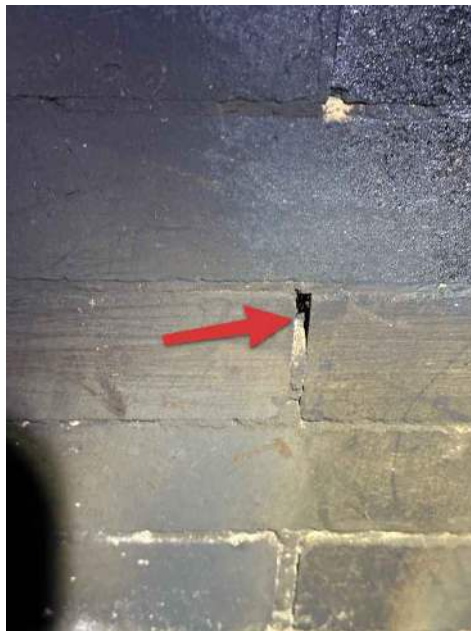
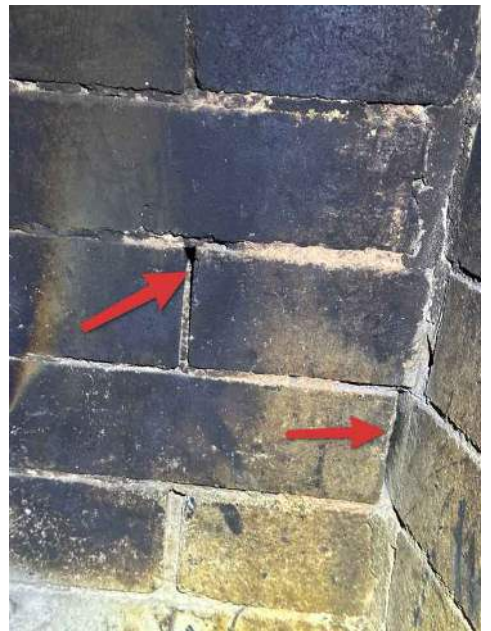
At the time of the inspection the masonry joint in the hearth needed pointing in one or more areas. This condition will only deteriorate if not addressed. I recommend a qualified professional to evaluate and make repairs.
