INSPECTION REPORT
1303 Central Manor Rd
Washington Boro, PA 17582
Nancy Jenkins
04/08/2024

Inspector
Matthew Haughery
Matthew Haughery
ASHI, #267507
717-808-5997
Bill@PreciseInspecting.com

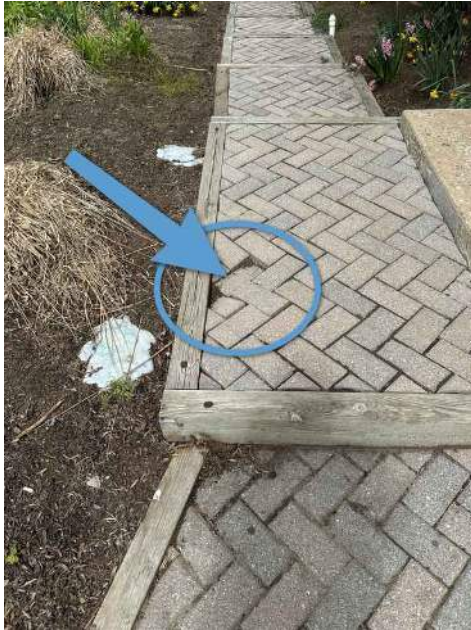
Walkway

****Safety Hazard**** At the time of the inspection I observed a portion of the exterior walkway that was settling. This creates an uneven surface that is not safe to walk over. If not repaired further settlement and cracking will occur. I recommend a qualified professional to repair.

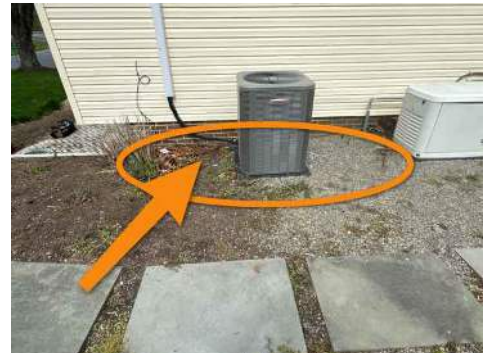
Right Side

At the time of the inspection there was a potential low spot(s) around the foundation wall. The depressed area(s) creates a pathway for water to enter the home causing water damage. I recommend this area(s) be evaluated and re-graded to avoid this potential entry point.

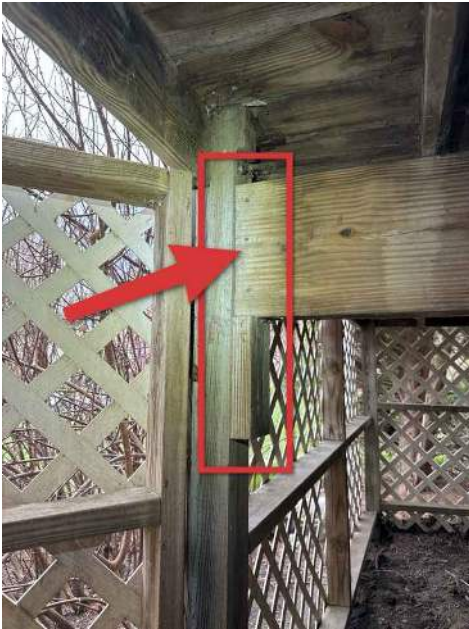
The deck was functional but had the following notable defects, missing lateral load connectors, missing joist hangers, insufficient lag fasteners, Lag bolts missing

Beam support not adequate

I recommend consulting a qualified deck contractor AND the national code standard [DAC6](#) so that a thorough evaluation of the deck can be made against current deck construction codes followed by professional recommendations.

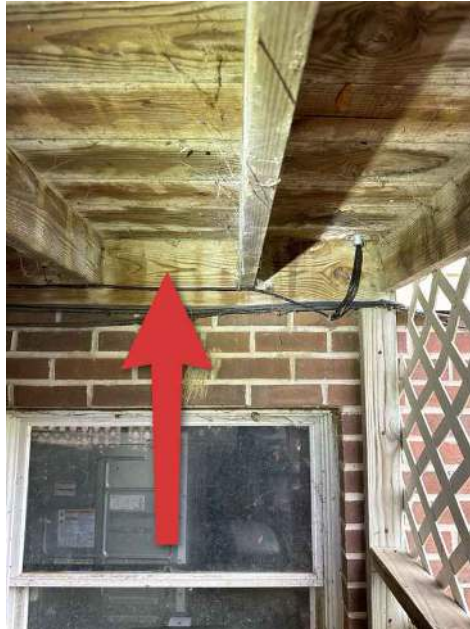
Lateral load connectors missing

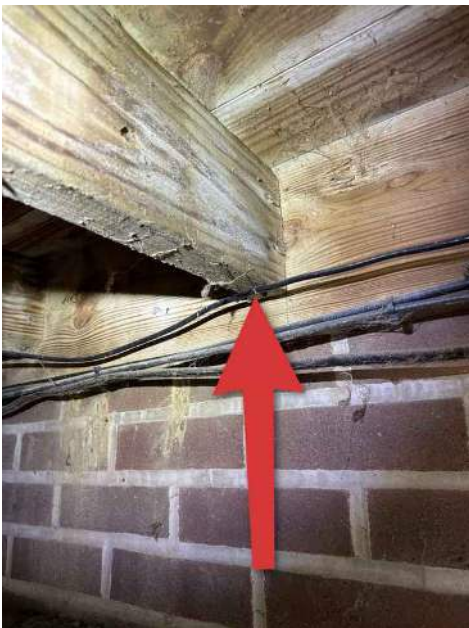
Joist hangers missing at house

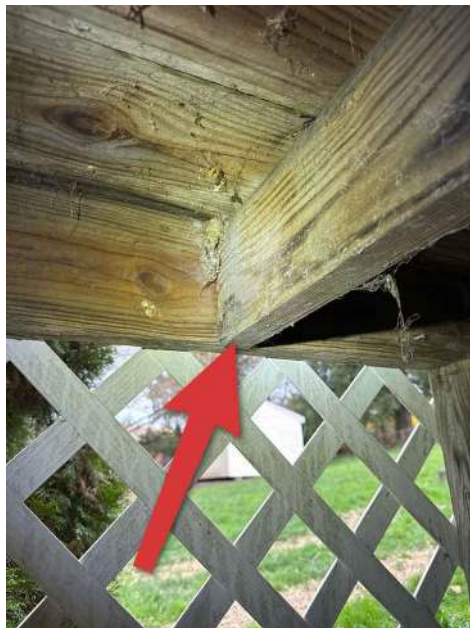
Joist hangers missing at rim joist

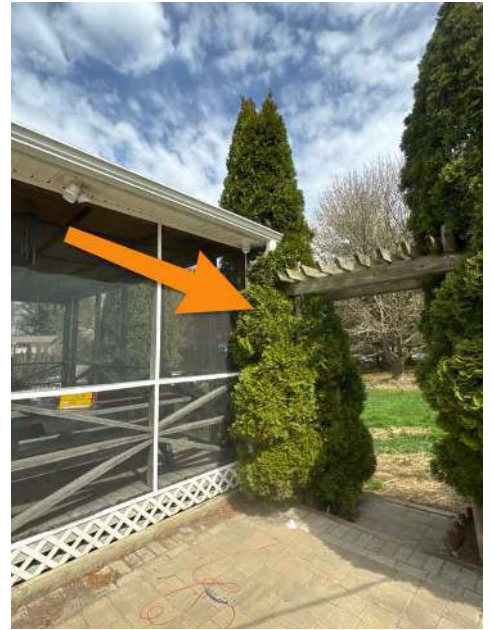
At the time of the inspection there was at least 1 tree(s) that was growing too close to the house. Potential damage to the structure may result, especially from high winds, if this tree is not removed. I recommend a qualified professional to make recommendations for trimming or removal.

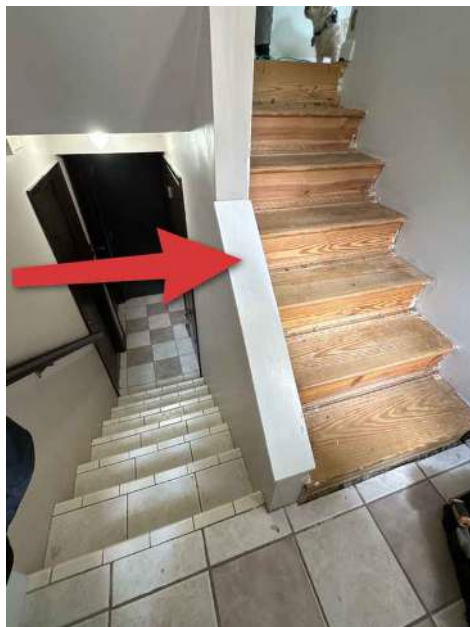
****Safety Issue**** - At the time of the inspection I found a stairway that had openings in the railing(s). Adequate spacing at railings protect against falls (think children and elderly). The spacing must be 4-3/8" between rails or balusters. Install necessary railings and/or balusters in order to make this stairway safe.

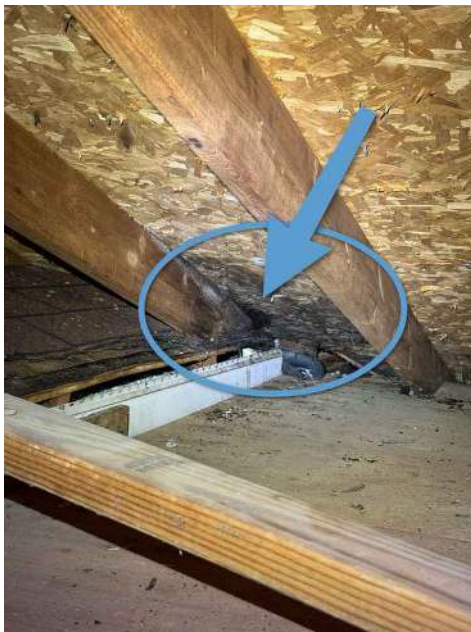
Close up

NOTE: This corner was difficult to get to and I was not able to confirm the moisture level of the wood.

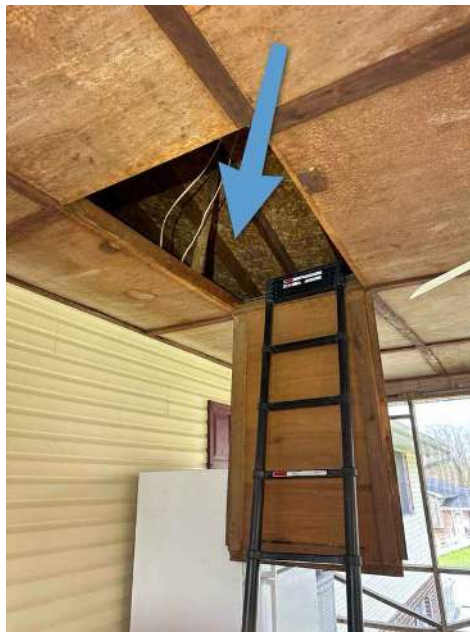
Moisture stain in corner of roof valley

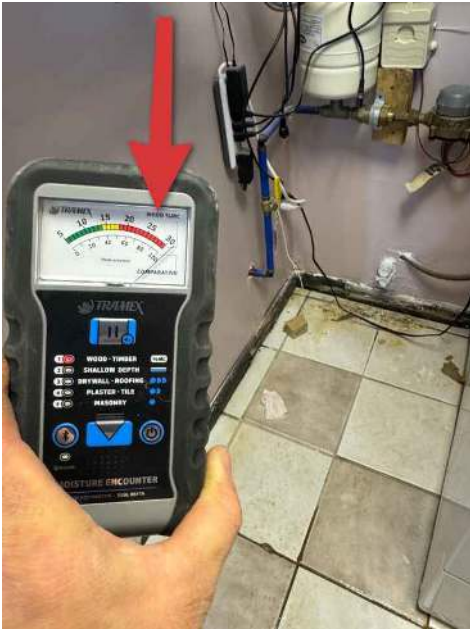
Moisture appeared to be entering the foundation. See photos. Most moisture problems originate on the exterior. If the source is not identified, this moisture can cause significant damage. I recommend the exterior be evaluated in order to determine where the water is coming from and so repairs can be made to stop future water penetration.

Wet reading on meter

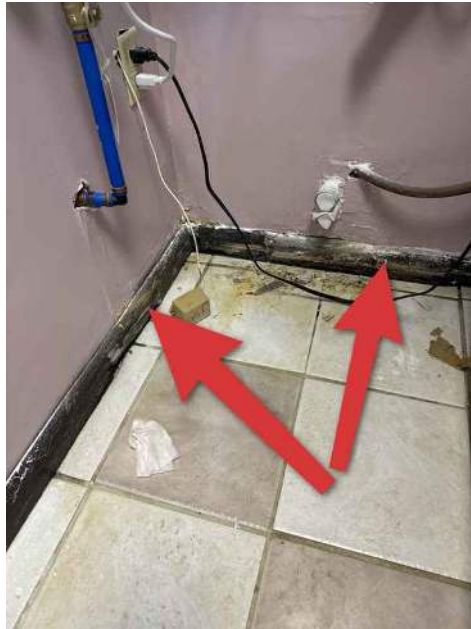
Moisture at base of wall

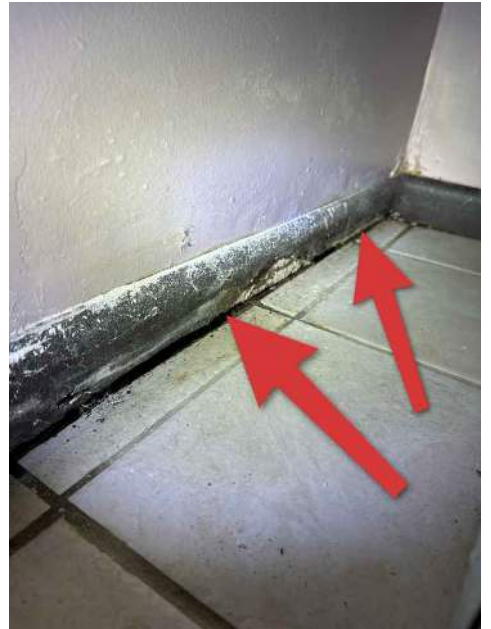
Moisture soaking through trim

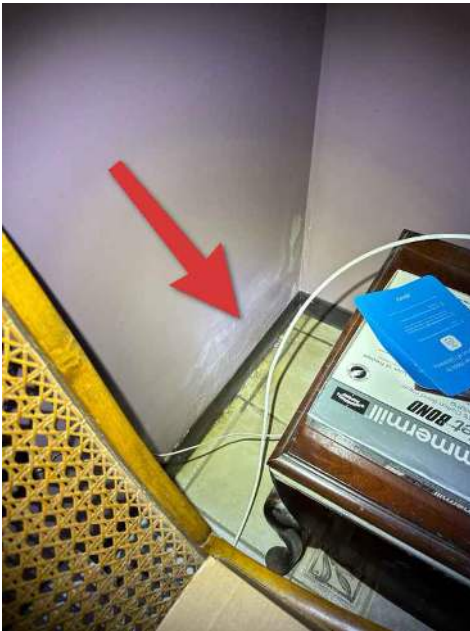
Moisture, extending into adjacent room

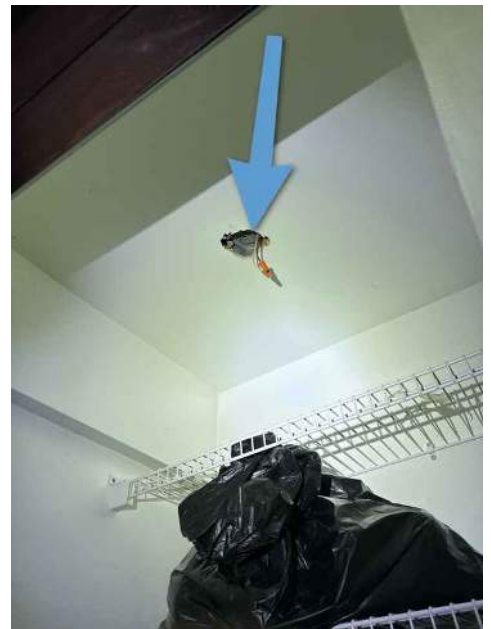
At the time of inspection, I observed one or more electric fixtures that were missing. I recommend a new fixture(s) be installed at this location.

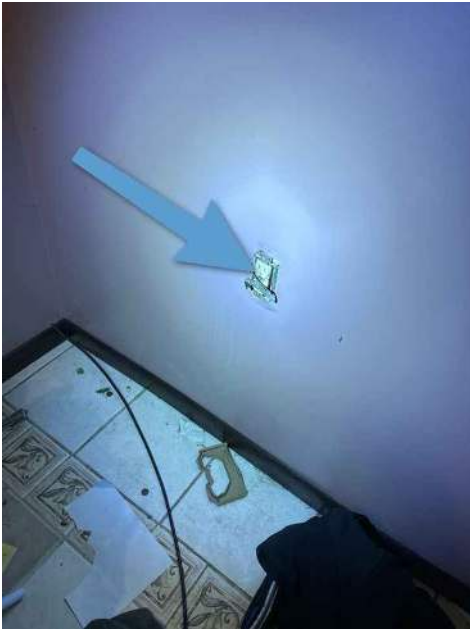
••**Safety issue**•• -- I observed an electrical box(es) that had missing cover plate(s). This presents a shock hazard. I recommend replacing all missing cover plates.

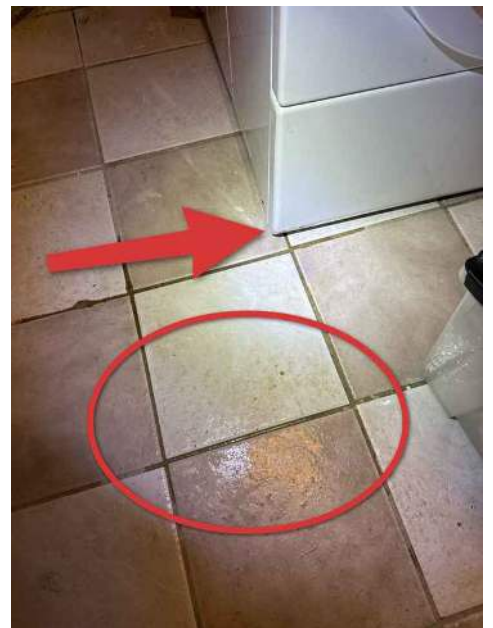
Washing machine may be leaking
