## INSPECTION REPORT

2083 Gamber Rd  
Washington Boro, PA 17582

Estate of William Hess

03/06/2024

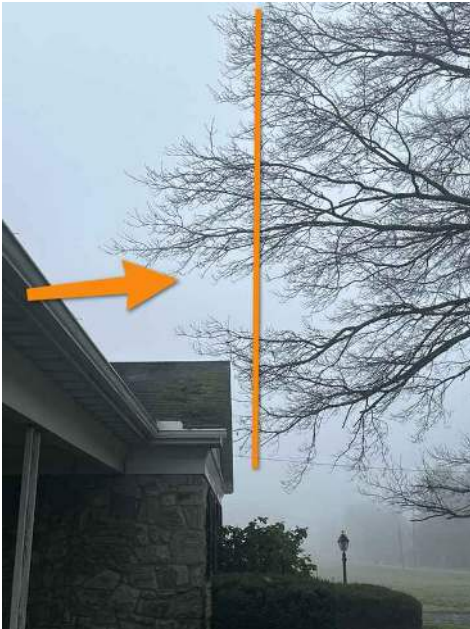
Front Roof

I observed a tree(s) whose branches were overhanging the roof. This condition is not healthy for roof life. Moisture, insects and biological growth are encouraged to remain on and around the roof surface. I recommend this growth be cut back.

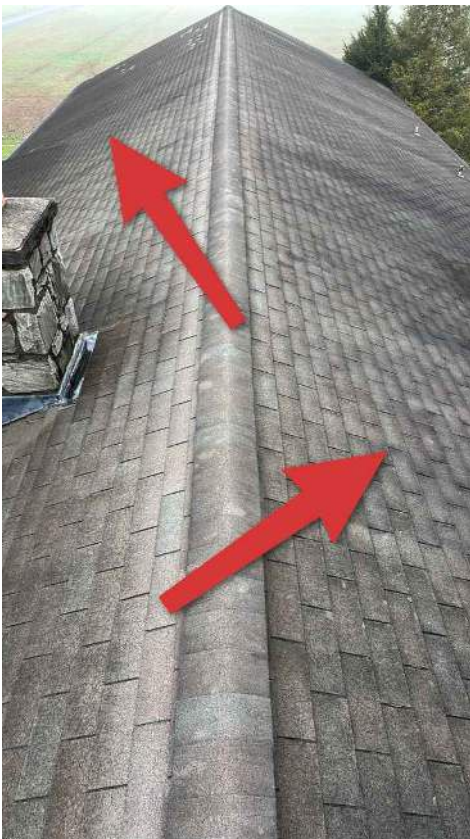
Overall Roof

At the time of the inspection I observed that the shingles appeared to be worn to the point where they are reaching the end of their serviceable life. I recommend this roof be evaluated by a licensed professional prior to settlement for a definitive opinion. In addition, consider budgeting for a new roof.

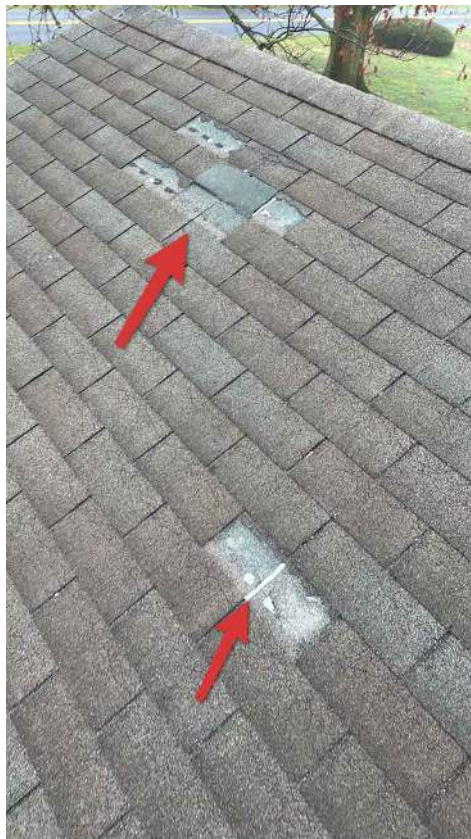
Shingles missing

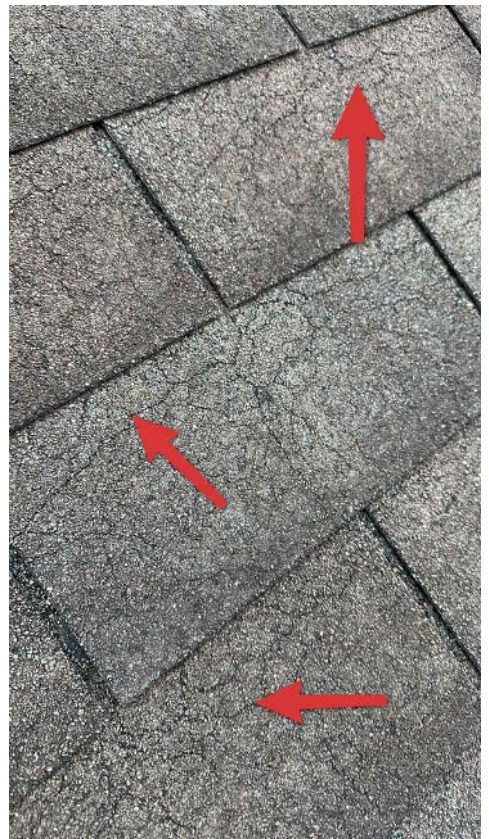
Extensive cracking

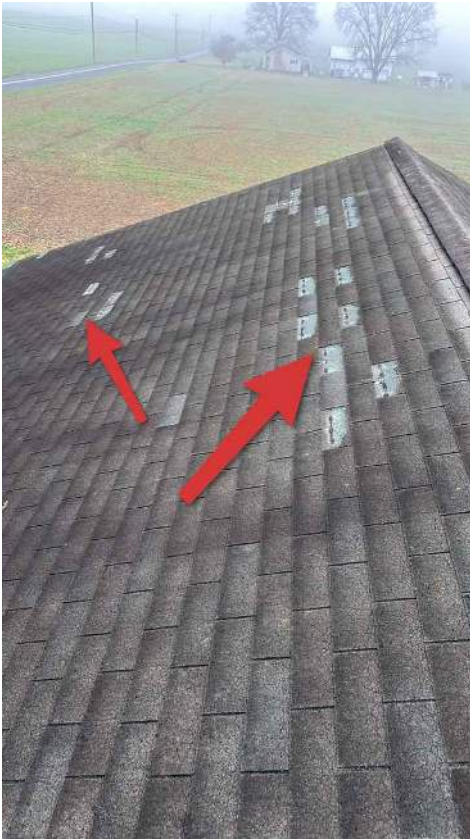
Missing shingles

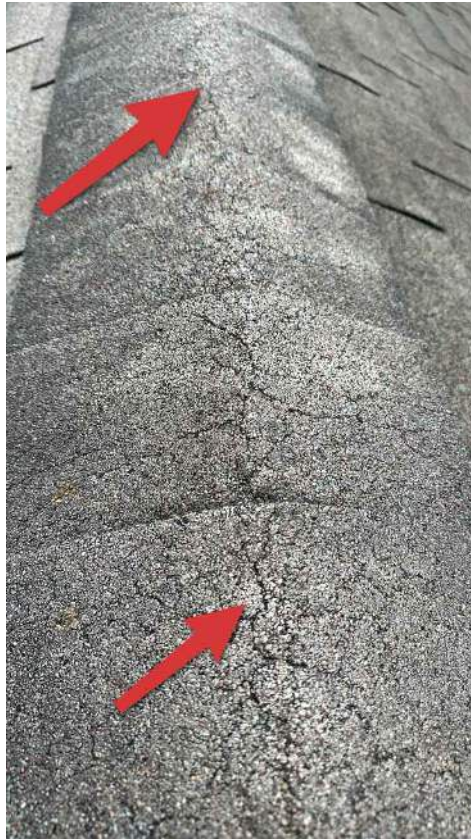
Ridge cracking

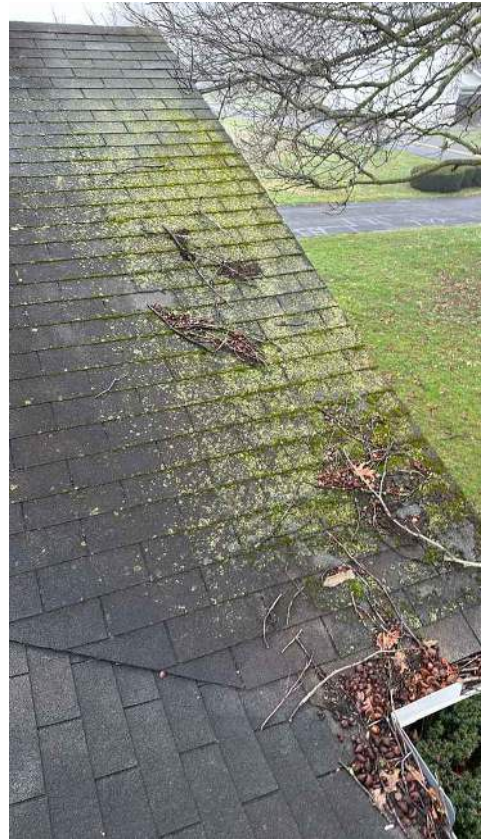
Excessive biological growth

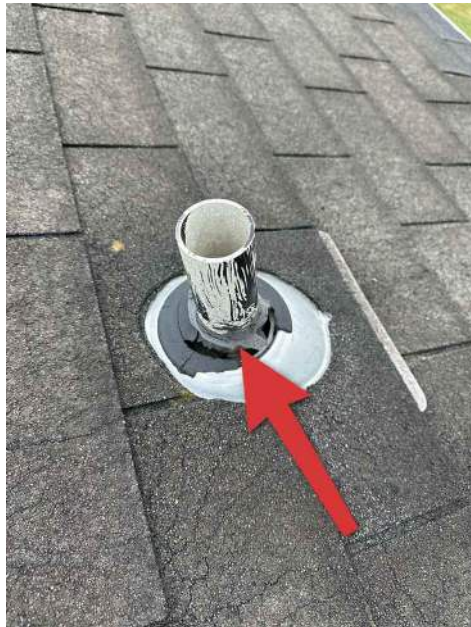
Rear Roof

**PLUMBING BOOT CRACKED**

The rubber/vinyl collar around the plumbing vent was deteriorating. This presents a clear path for water to penetrate the roof and cause damage to the interior structure. I recommend evaluation and replacement by a qualified professional.

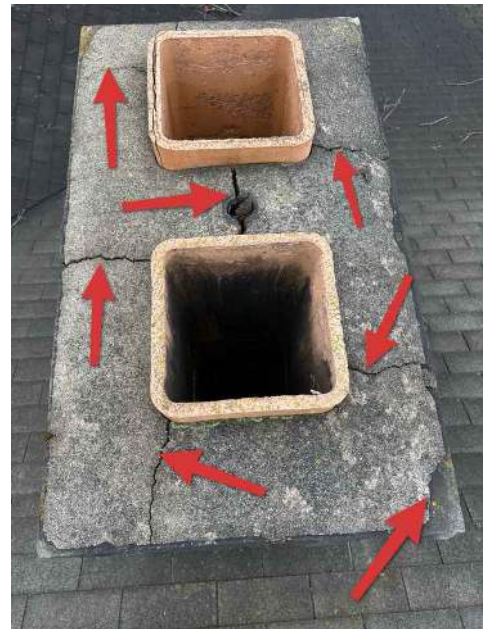
**CHIMNEY CROWN DETERIORATION**

I observed the chimney crown to be damaged. Cracking was visible in the chimney cap and/or masonry in close proximity. The damaged areas should be repaired immediately to prevent further moisture penetration. I recommend a qualified professional evaluate and repair.

Extensive cracking

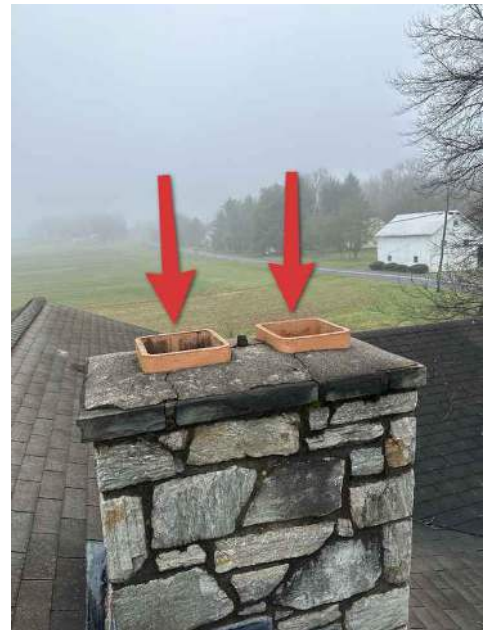
### MAIN CHIMNEY

## CHIMNEY CAP RECOMMENDED

The chimney(s) pictured here did not have a cap. This is an abandoned chimney. The absence of a chimney cap can lead to potential damage to the chimney from corrosive gases and allow moisture to penetrate into the home causing further damage to wood, ceilings and walls. I recommend installing a properly sized chimney cap.

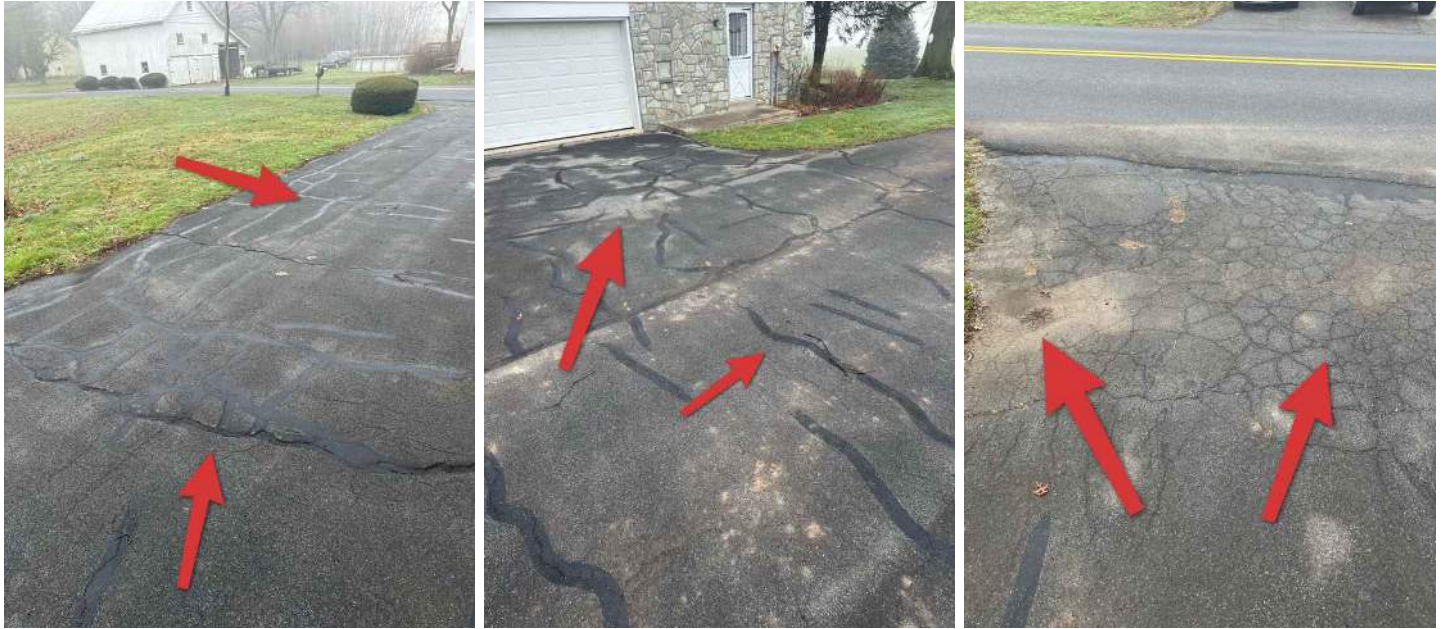
At the time of the inspection the driveway showed signs of significant cracking. In order to maintain a serviceable surface, the driveway should be free from cracking and maintained with top coating.

Because the photo is representative of more than one crack I recommend a qualified professional to evaluate the entire driveway and repair.

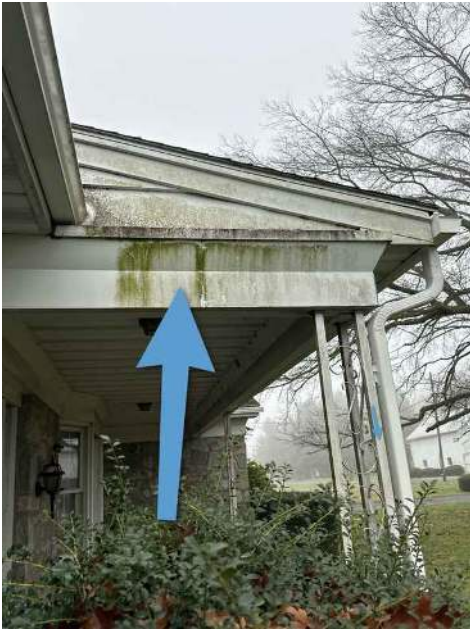
Front Porch gable

I observed mildew staining on the exterior in one or more places. This is primarily a cosmetic issue. I recommend power washing by a professional.

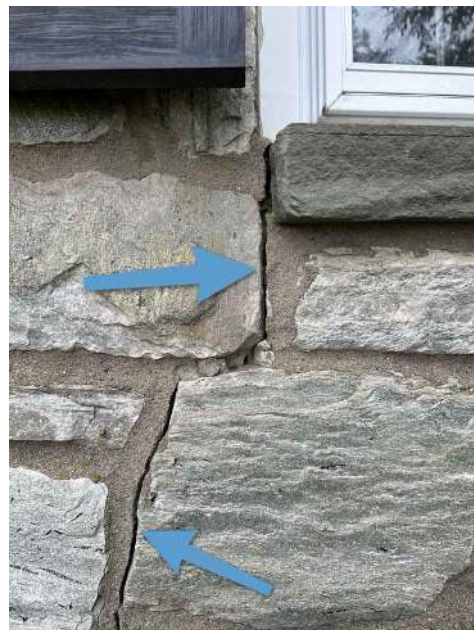
At the time of the inspection I observed one or more areas where the stone was cracking. Masonry undergoes irreversible expansion during its lifetime. This creates stress concentrations around door and window openings or at offsets in walls. These are common and usually do not reflect a structural problem or foundation issue. However, I recommend a qualified professional to discuss repair options.

Crack in stone veneer joint

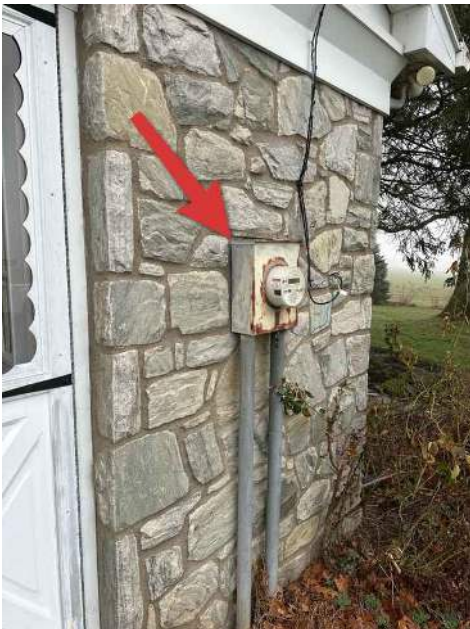
Pulling away from wall

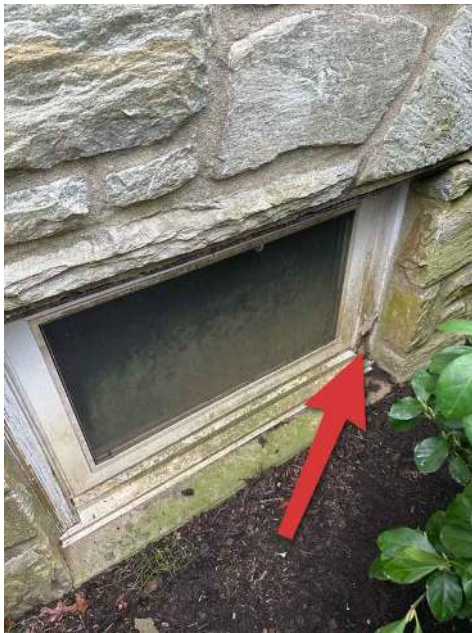
Left Side Basement Window trim

At the time of the inspection I found signs of rotten wood trim. Moisture has penetrated over time and rotted the wood. If not repaired, this condition will continue to deteriorate, leak and allow moisture to compromise the home. I recommend a qualified professional to evaluate and repair.

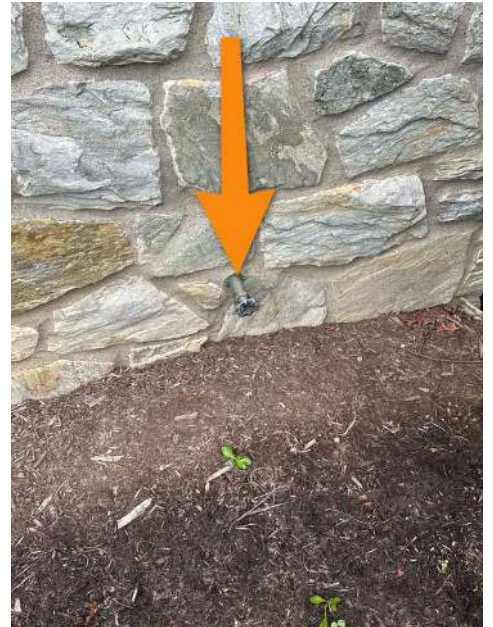
Front Exterior

At the time of inspection the spigot handle was tight. Because of this I was not able to turn the bib on to inspect the flow. I recommend this be examined and repaired.

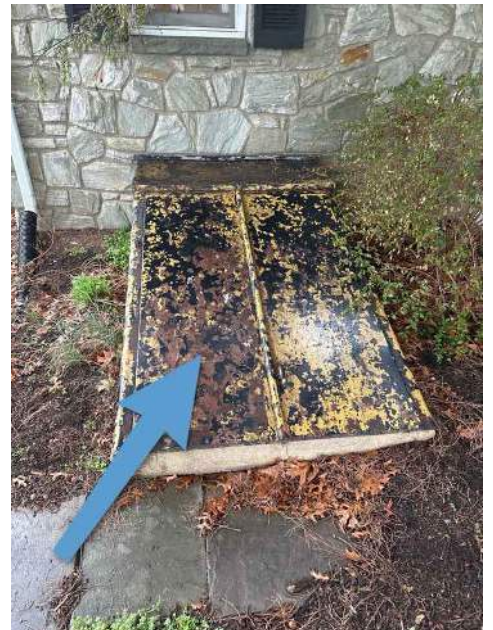
Rear Basement access

At the time of the inspection the painted exterior surfaces showed signs of peeling/blistering and exposure to weather in numerous locations. I recommend all the exposed surfaces be evaluated and maintained on a regular basis.

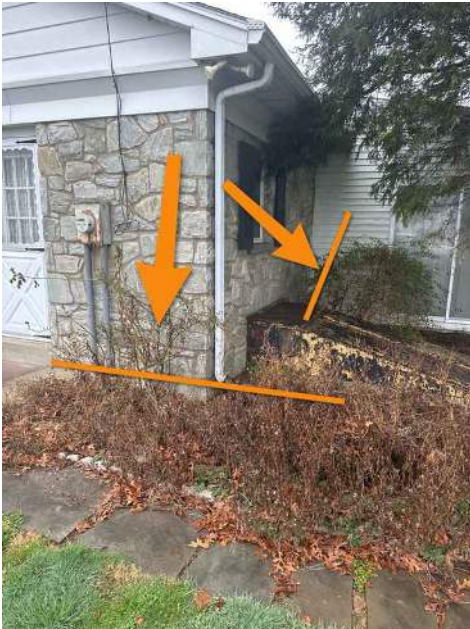
Rear Corner Right Side

Vegetation is overgrown in one or more places around the house. This creates a potential path for insects and moisture to enter the home and can damage the structure of the house. I recommend that all plants, shrubs and trees be trimmed back 12-18" from house.

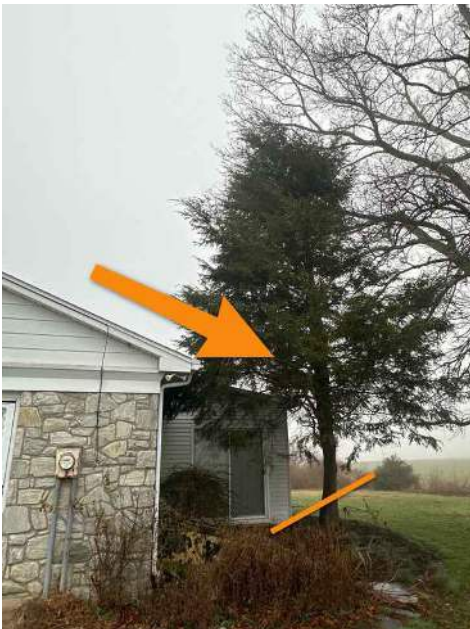
Rear Addition

At the time of the inspection there was at least 1 tree(s) that was growing too close to the house. Potential damage to the structure may result, especially from high winds, if this tree is not removed. I recommend a qualified professional to make recommendations for trimming or removal.

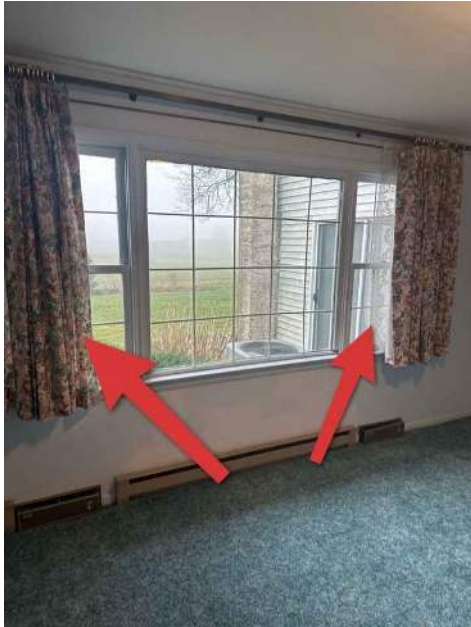
At the time of the inspection, the home had one or more older wooden windows. These windows can last 50 years or more. They may even outlast vinyl windows but they are less efficient and require more maintenance. For example, periodic painting, re-glazing and sash chord replacemnt are necessary. They can also become difficult to open and close. I recommend a qualified professional to evaluate all the wooden windows to assure that they are operational. In addition, ask the professional to offer cost comparisons on replacement vs. repair.

Very difficult to operate

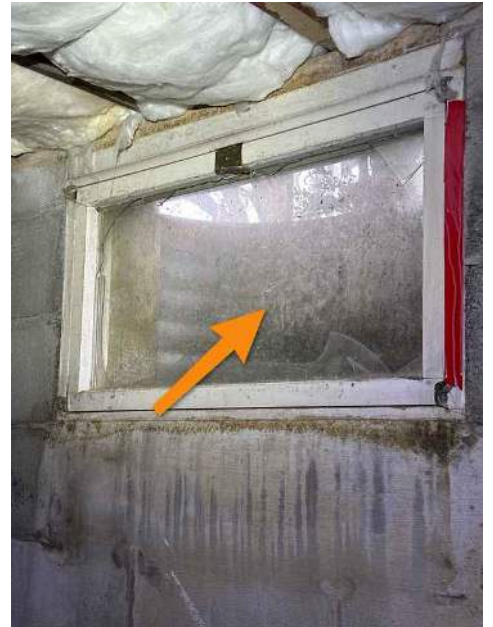
Front Basement Window

At the time of the inspection I observed a window or windows with broken glass. I recommend a qualified professional to repair.

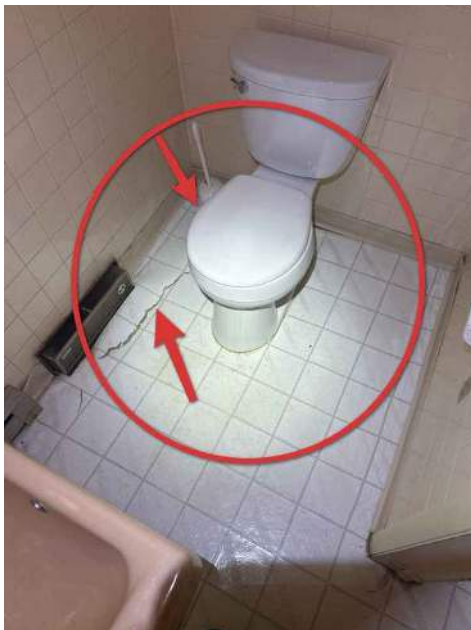
Around toilet

At the time of the inspection, I observed moisture damage to the subfloor. The area is soft and spongy making it unsuitable in its current condition. It should be evaluated by a qualified professional in order for proper repairs to be made.

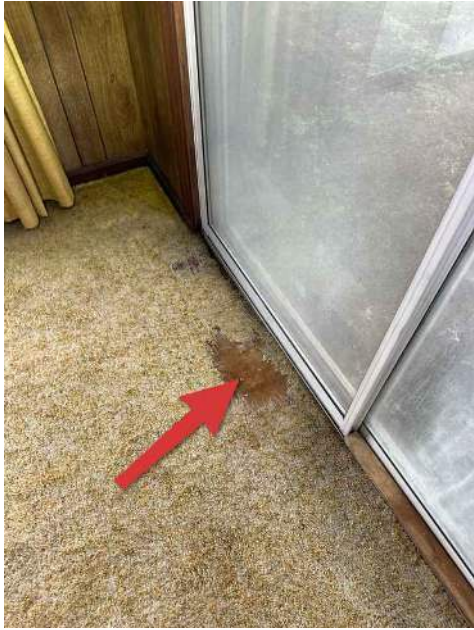
Sunroom

I observed carpet that was past it's useful life. See photo descriptions. I recommend a qualified professional to evaluate and replace.

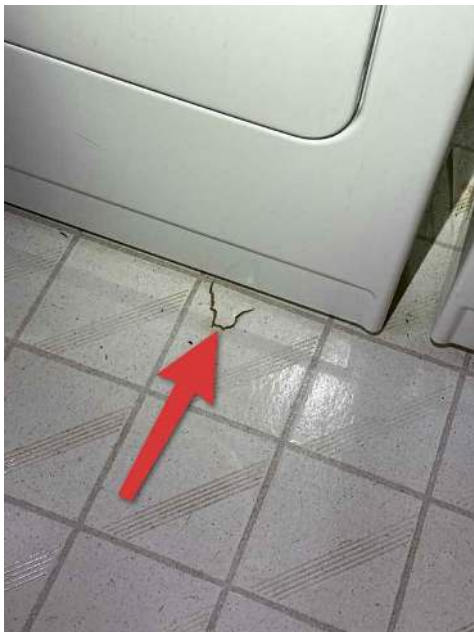
Laundry Room

At the time of the inspection I observed that the floor covering pictured here was beyond useful life. I recommend a qualified professional to evaluate and replace with a new floor.

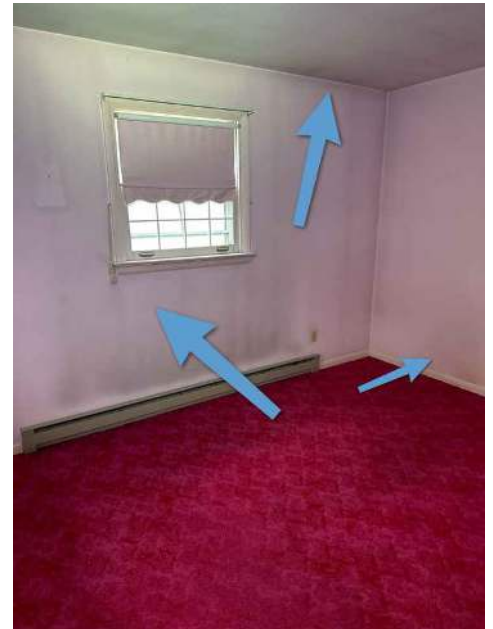
**PAINTING REFRESH OF ALL SURFACE**

The walls and ceiling were in need of a fresh coat of paint on all surfaces. This includes doors, windows, walls, ceiling and trim, including touch up of damaged areas.

Representative of walls and ceilings

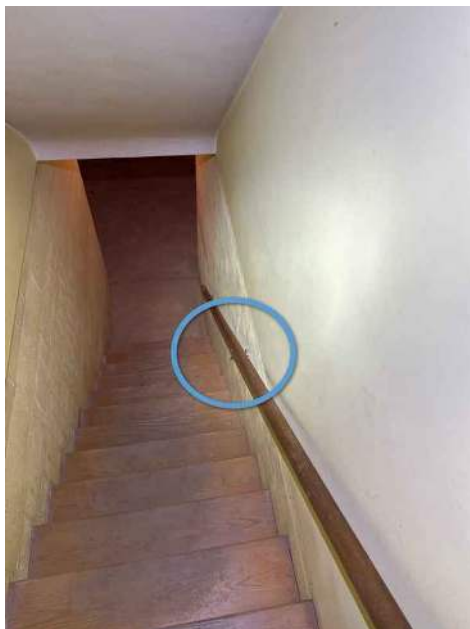
Middle

At the time of the inspection a portion of the hand railing was loose. Consult with a qualified professional to discuss repair.

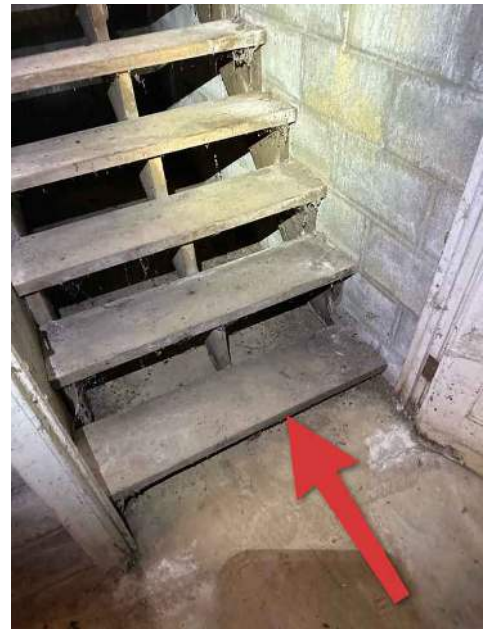
Basement access steps

### ROTTEN STAIR TREAD

**\*\*Safety Issue\*\*** - At the time of inspection I observed one or more stair treads that was loose, split or damaged. See photo description. Stair treads should be at least 1 inch thickness and 10 inches in width and of solid wood. This presents a safety hazard. I recommend a qualified professional to evaluate all the treads in this stairway and repair.

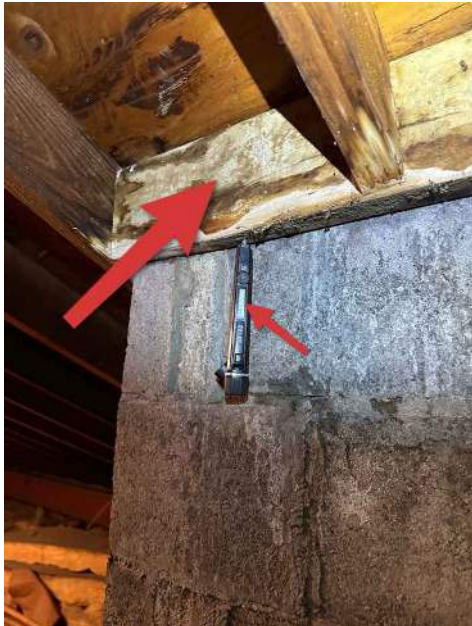
The chimney showed signs of moisture intrusion and visible staining. Masonry chimneys tend to absorb and hold moisture for up to four days before drying out. The moisture is often transferred inward, causing any material it comes into contact with to absorb moisture. I recommend a qualified contractor to examine the chimney and roofing material above and the framing below in order to identify the source of the moisture and to advise on a remedy.

High moisture reading at framing

Note: Consider applying a silicone product to the masonry chimney.

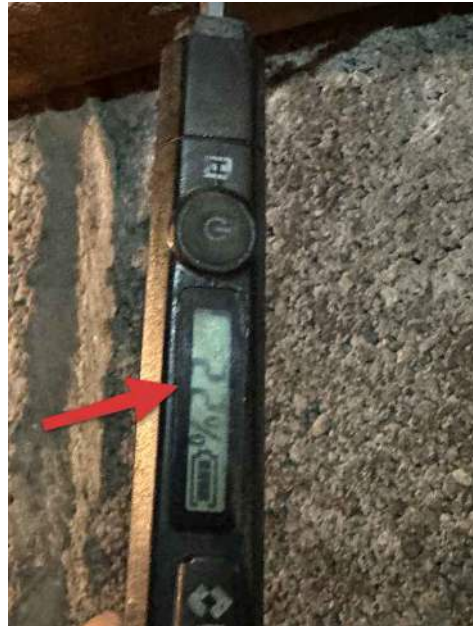
22% at framing

34% at floor

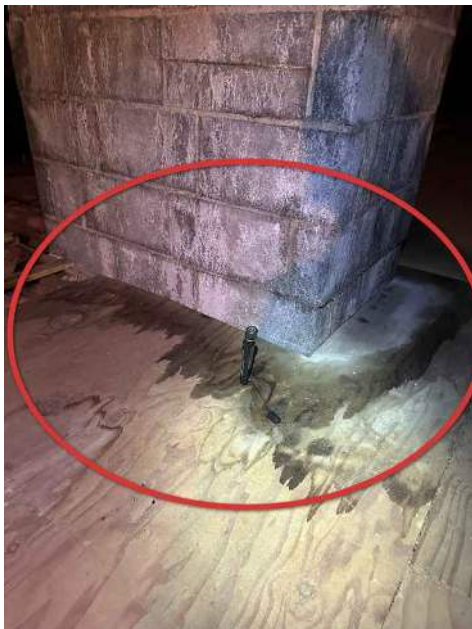
High moisture at floor

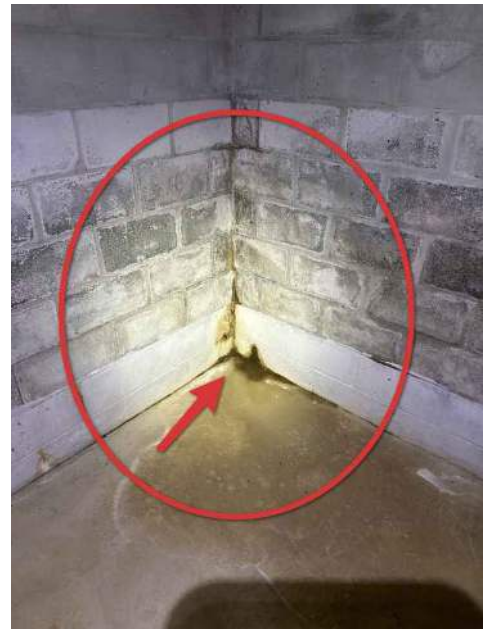
REAR CORNER

Moisture appeared to be entering the basement. See photos. Most moisture problems in basements originate on the exterior. If the source is not identified, this moisture can cause significant damage. I recommend the exterior be evaluated in order to determine where the water is coming from and so repairs can be made to stop future water penetration.

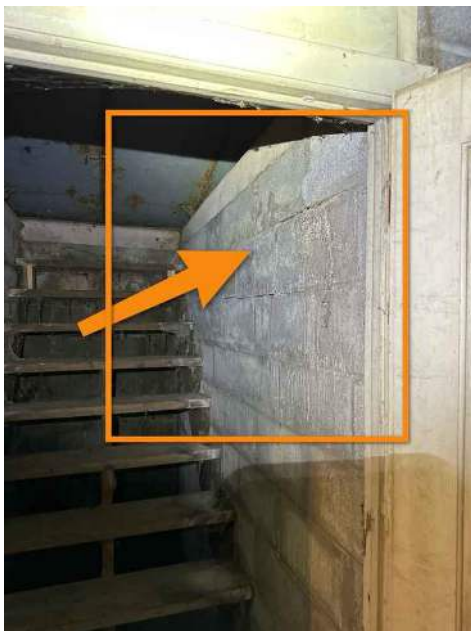
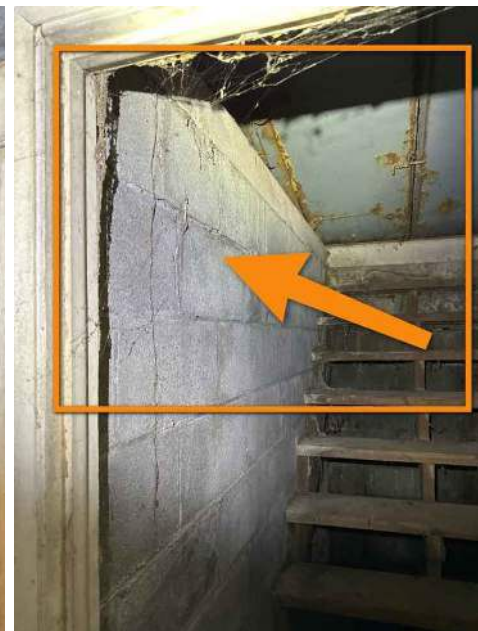
**FOUNDATION WALL PUSHING**

At the time of the inspection, the foundation wall appeared to be pushing inward. See photo descriptions. Often this is the result of hydronic pressure from water issues. In order to rule out a foundation wall that is failing, a proper examination of this area should be made in order to determine the cause. I highly recommend a qualified professional to evaluate the wall and to recommend repairs.

Upper section

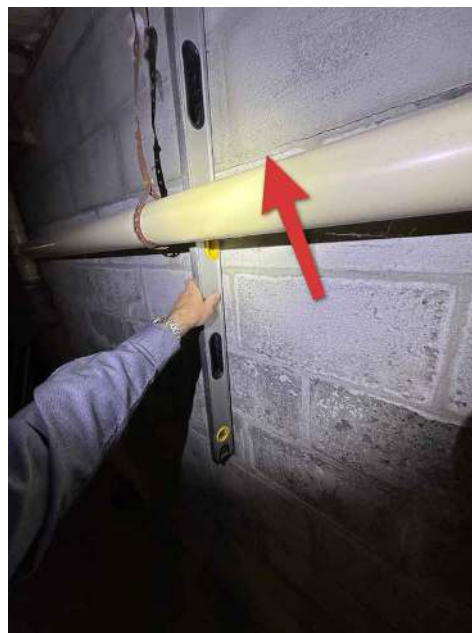
Close up Rear

1" in 4 feet average

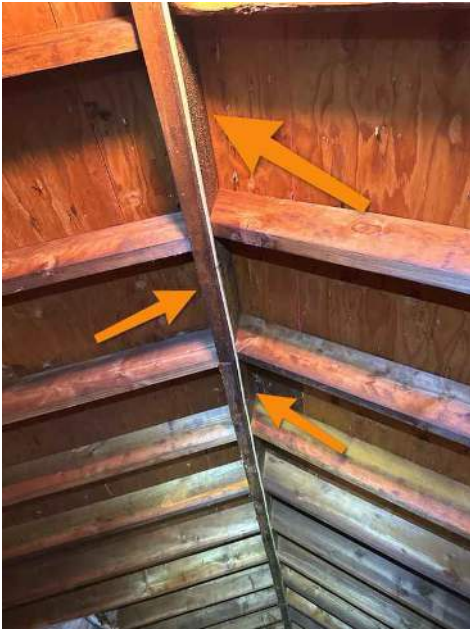
All along ridge

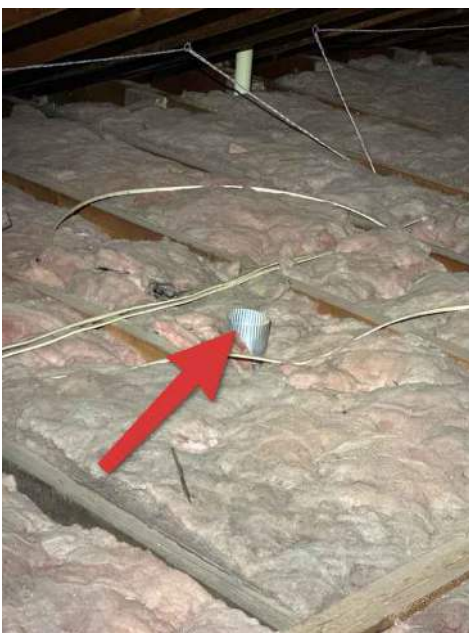
Above Bathroom

**\*\*Potential Mold issue\*\*** - At the time of the inspection, I found a bathroom exhaust fan venting into the attic. When a bath exhaust vent discharges into a basement, crawlspace, attic, or another building cavity, the potential for moisture-related damage and mold growth is significant. I recommend a qualified professional to 1) evaluate and re-direct the exhaust venting to the exterior and 2) request a professional test for the presence of mold, and 3) if mold is present seek a professional for mold mitigation.

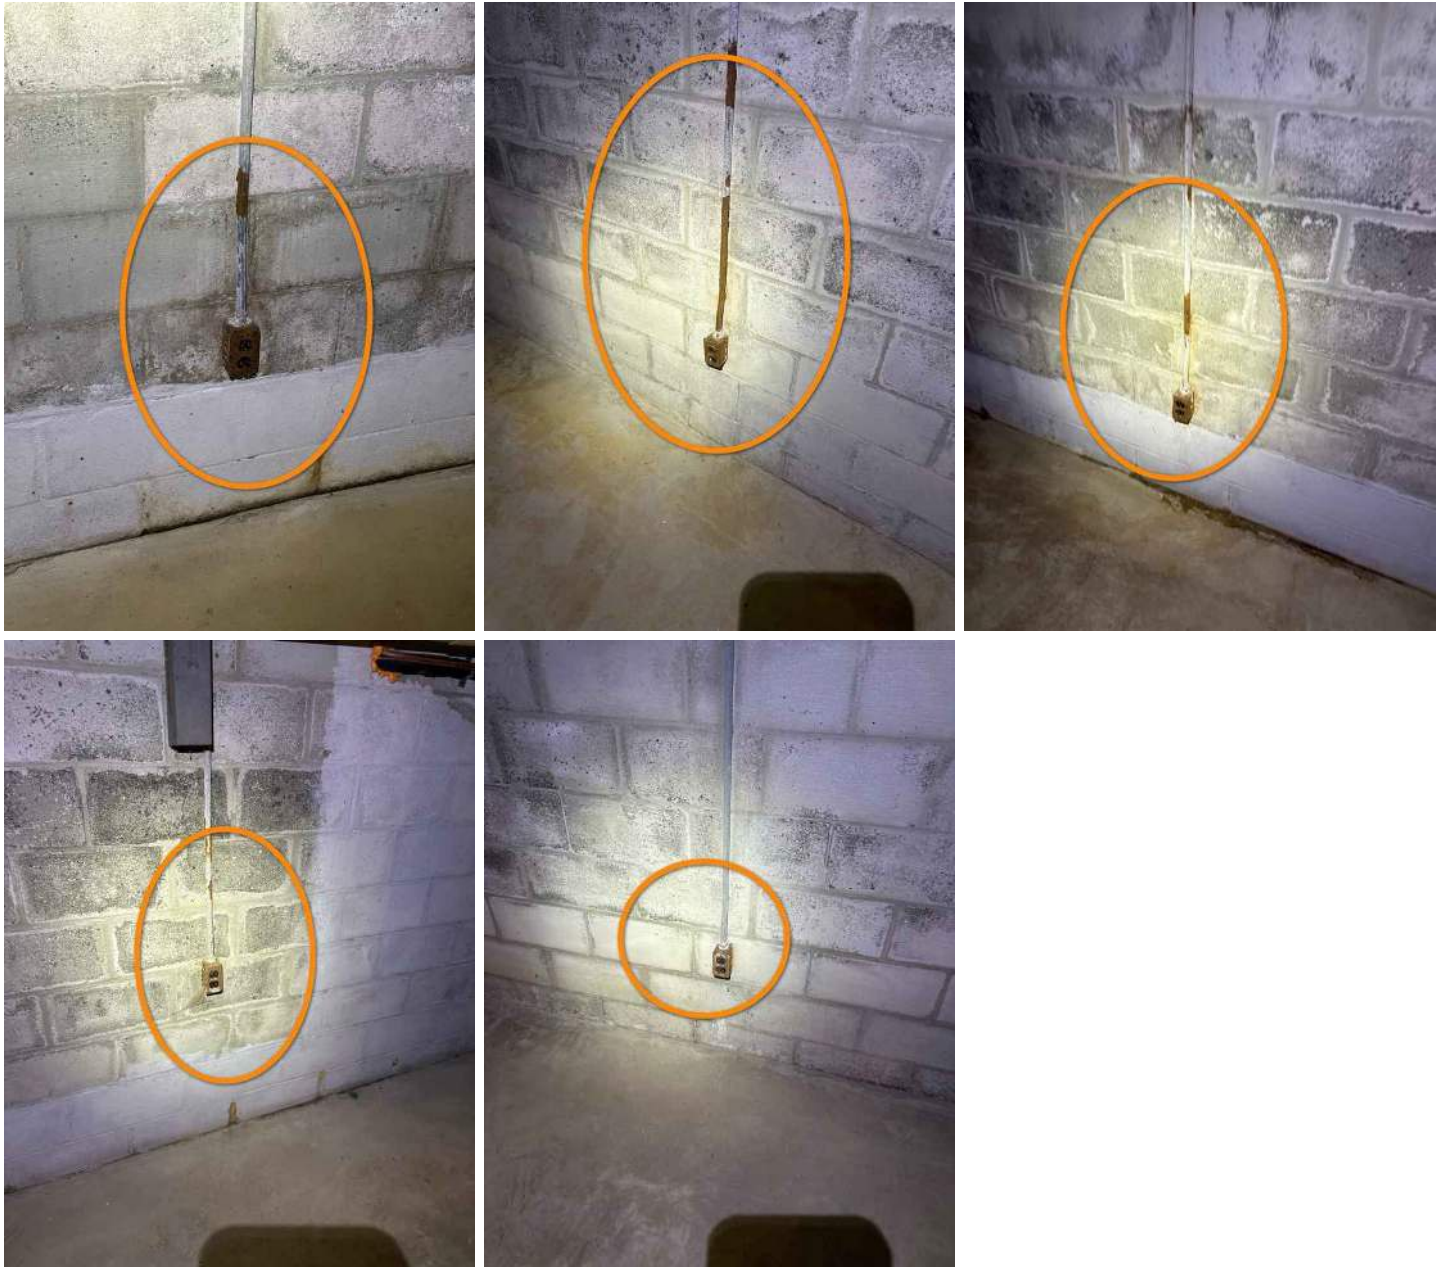
**\*\*Safety Issue\*\*** I observed a rusted receptacle. This is an indication of the presence of moisture. I recommend this be replaced by a professional.

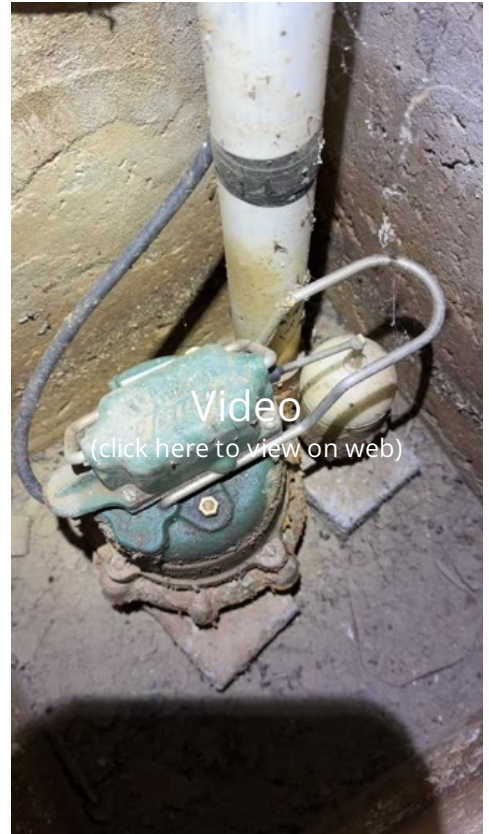
At the time of inspection, the sump pump was present, but no water was in the pit. The pump motor was dry tested to confirm operation. I recommend filling the pit with water to operate to confirm that the pump is actually taking water out.

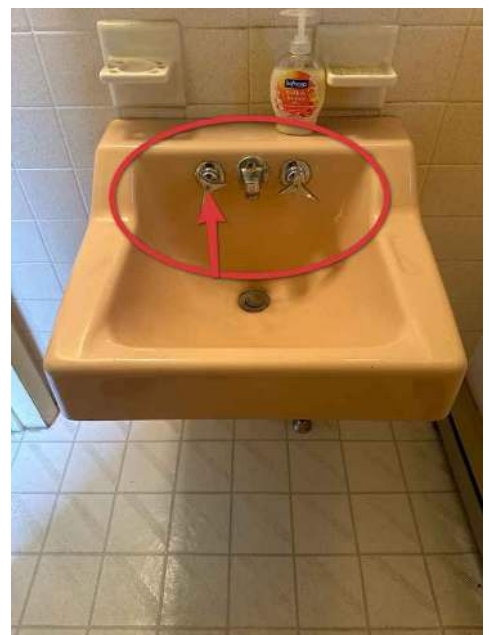
Hot faucet

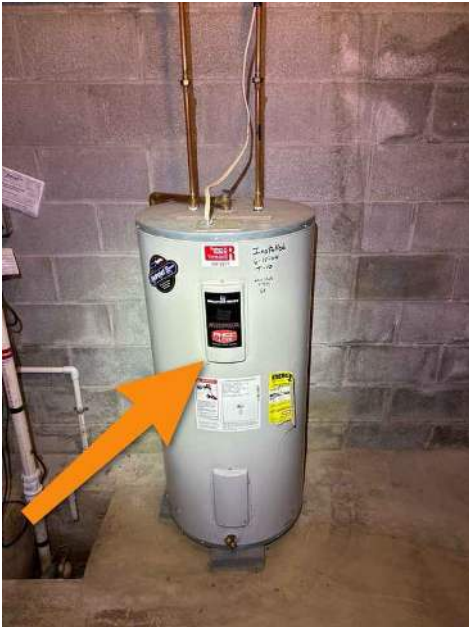
20 years old

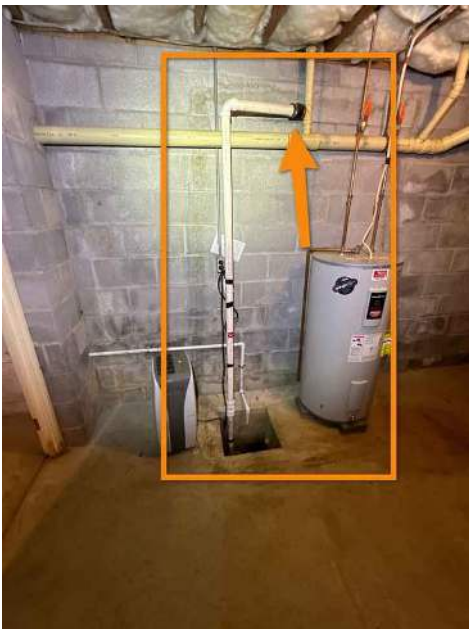
I observed sump pump, waste water draining into the home's septic system. Pumping groundwater into the septic system can prematurely age the drain field. I recommend this be evaluated by a professional and redirected outside to surface.

Drain to septic system

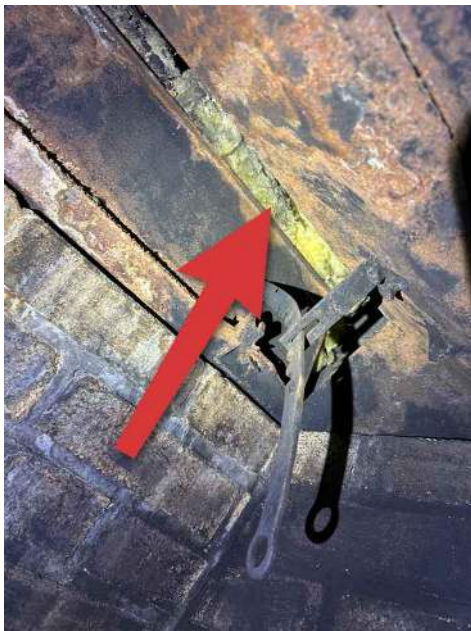
**\*\*\*Fire Hazard\*\*\*** The fireplace chimney was blocked or restricted. **This is a fire hazard and should be addressed immediately.** Contact a qualified professional to evaluate and open up the area so that the vent is not restricted.

Insulation in flue Living Room
