INSPECTION REPORT

46 Chestnut Grove Rd
Conestoga, PA 17516

Renee Weaver
05/06/2024

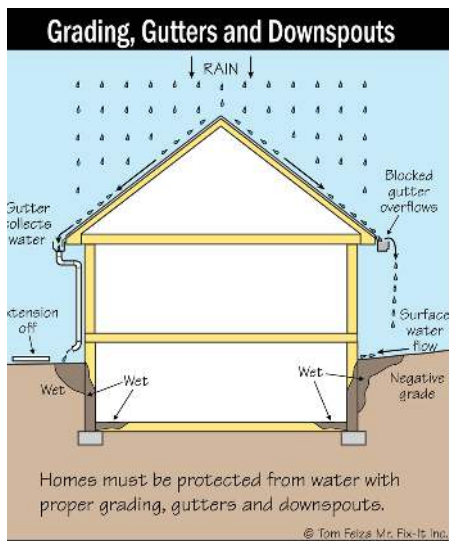
15BC

K style, Aluminium

At the time of the inspection the gutter and downspouts appeared to be functional. I recommend periodic cleaning to maintain open flow of water.

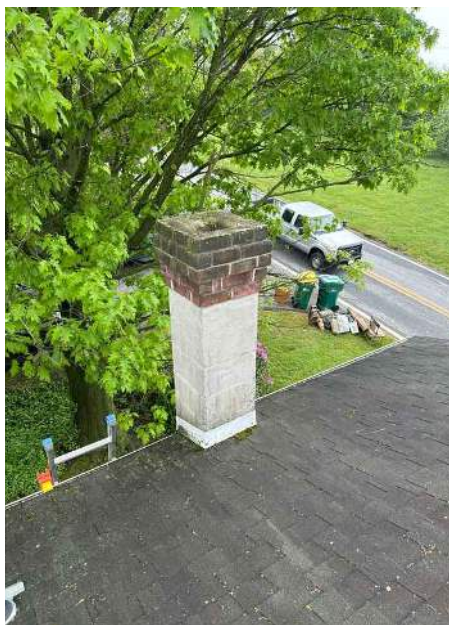
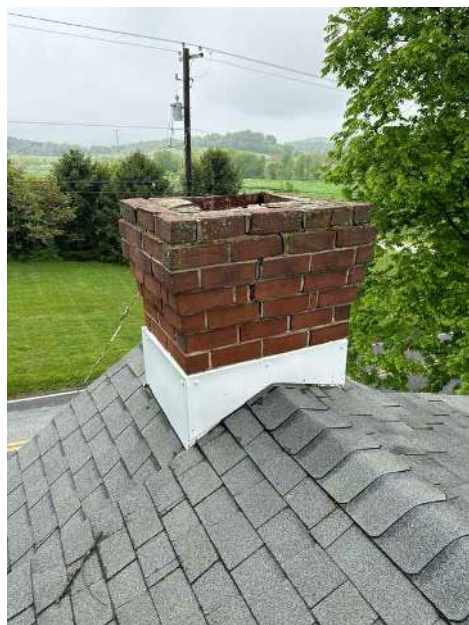
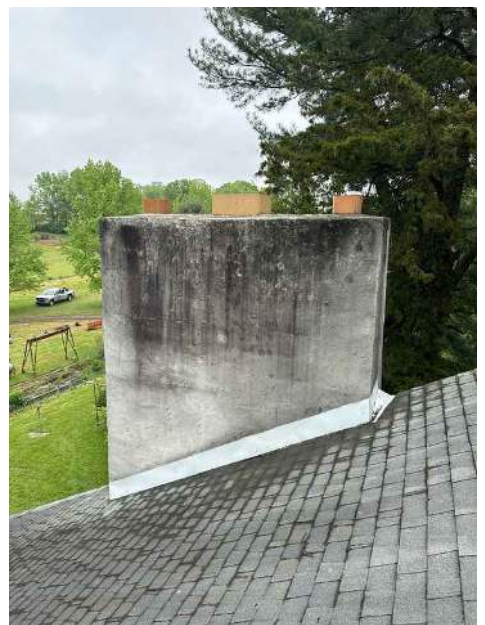
Brick chimney, Block chimney, W/ Parging

Front Chimney

Left Side Chimney

Right Side Chimney

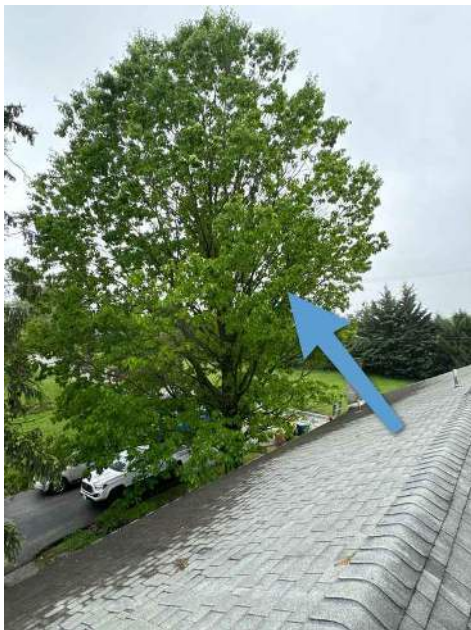
Front

2 LOCATIONS

I observed a tree(s) whose branches were overhanging the roof. This condition is not healthy for roof life. Moisture, insects and biological growth are encouraged to remain on and around the roof surface. I recommend this growth be cut back.

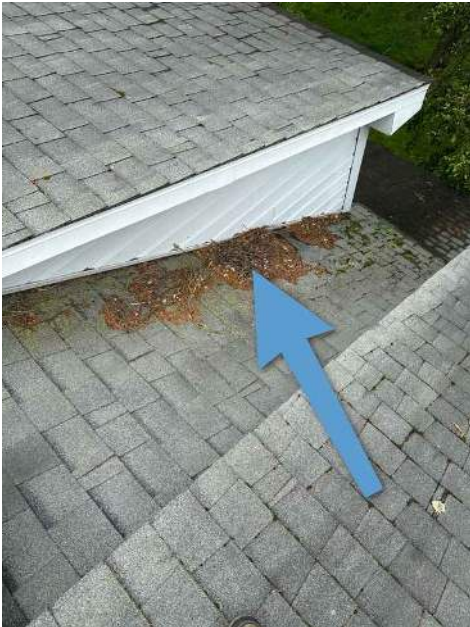
REAR ROOF

At the time of the inspection vegetation debris had collected on the roof. This condition allows for moisture to remain trapped close to the roof surface and can lead to early deterioration of the roof surface. I recommend removal.

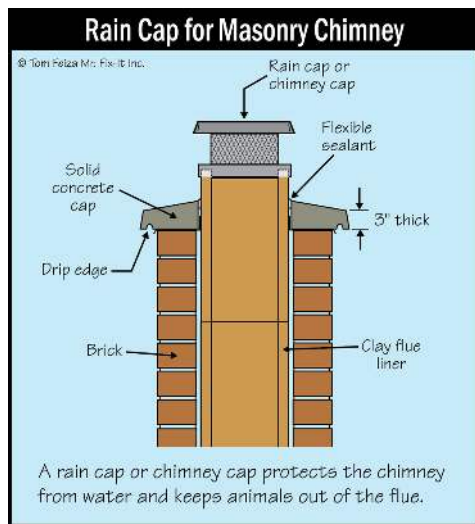
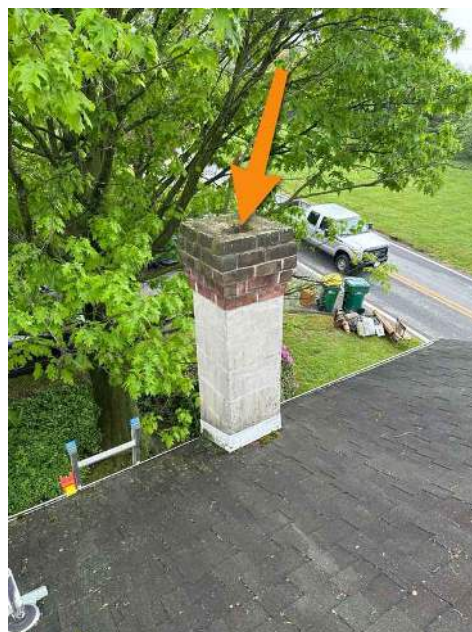
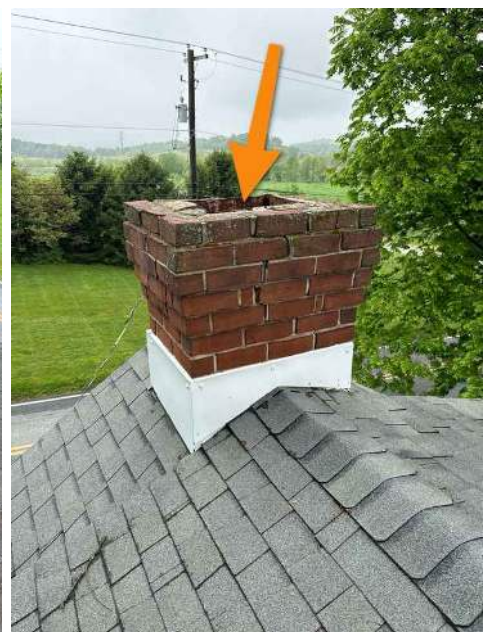
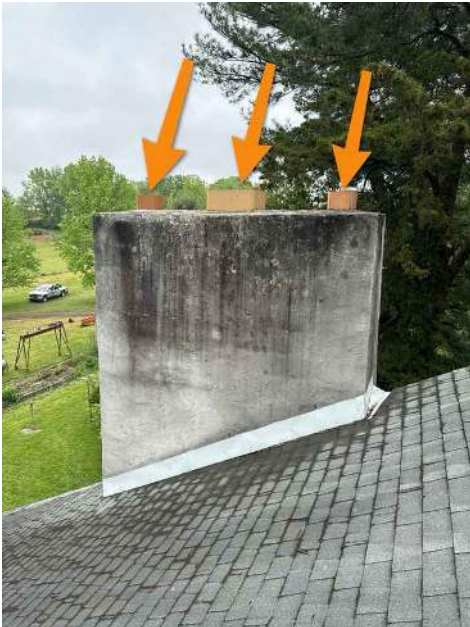
2.5.1 Skylights, Chimneys & Roof Penetrations

CHIMNEY CAP MISSING

CHIMNEY 5 LOCATIONS

The chimney vent did not have a cap. The absence of a cap can lead to potential damage to the flue through moisture penetrating into the home. I recommend installing a properly sized cap.

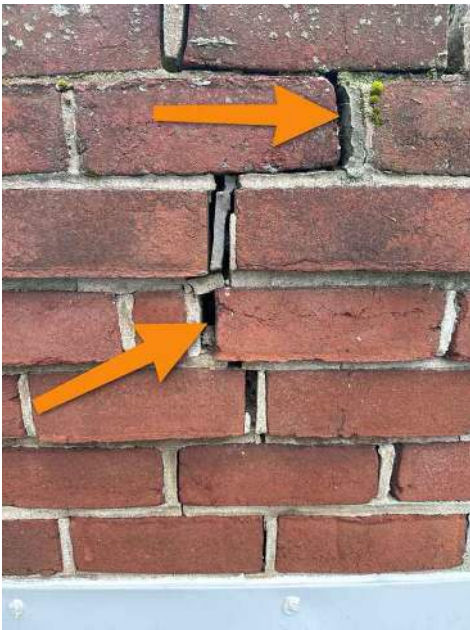
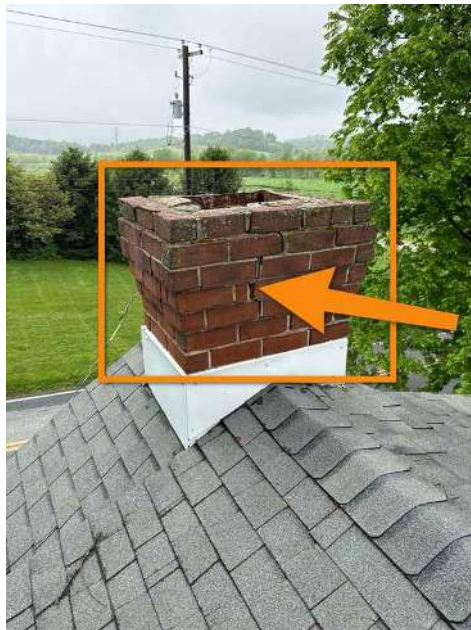
LEFT SIDE CHIMNEY

The chimney block was in need of repair due to loose, crumbling or missing mortar and/or brick. This condition allows the chimney to deteriorate over time. I recommend this be evaluated by a masonry specialist for advice on repair.

Close up

Brick repairs needed

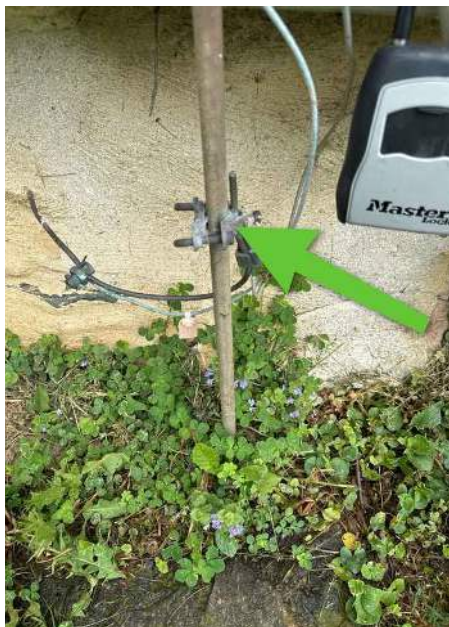
Ground to Galvanized Steel

Grounding is a method of giving electricity the most effective way to return to the ground through the service panel. When the electricity is on, current flows from the panel to the outlet or device to power it up. The neutral wire is the return path for unused current. The ground wire is an additional path for electrical current to return safely to the ground without danger to anyone in the event of a short circuit.

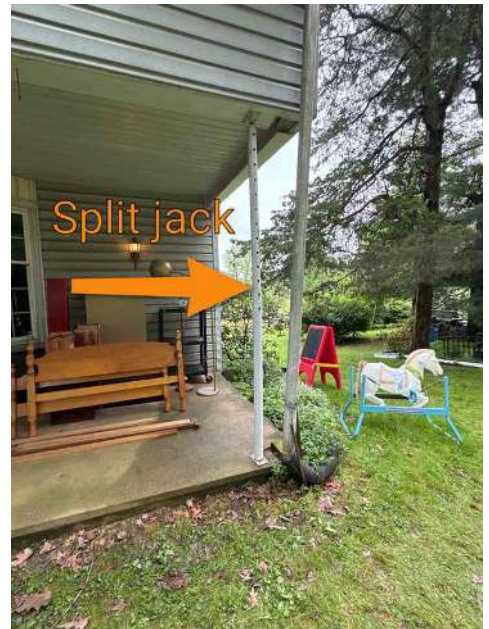
FRONT PORCH

At the time of inspection I observed the use of temporary post support used to support the porch. These are an inferior means of supporting the structure because they are considered temporary. I recommend a qualified professional to evaluate and replace.

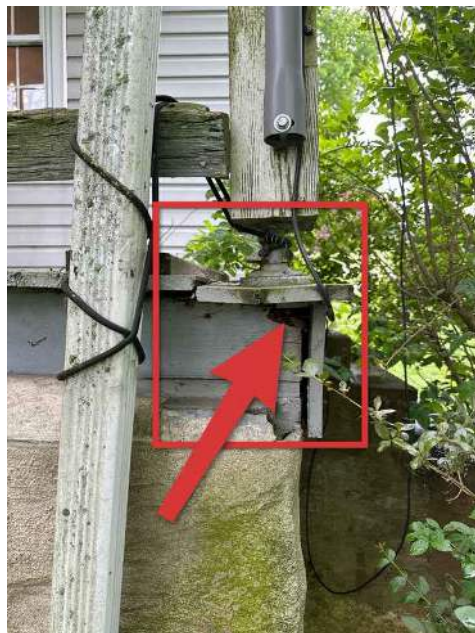
REAR PORCH

At the time of the inspection, I observed multiple areas of the porch that were deteriorating, worn or not constructed according to best porch standards. These may result in a safety issue or signal an early failure of the deck. See pictures for specific defects. I recommend a qualified professional to evaluate the entire porch and make recommendations for repair or replacement.

Post settlement due to rot

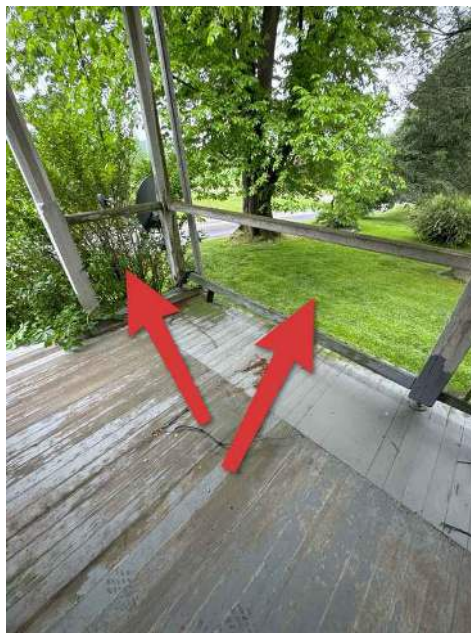
Railing balusters missing

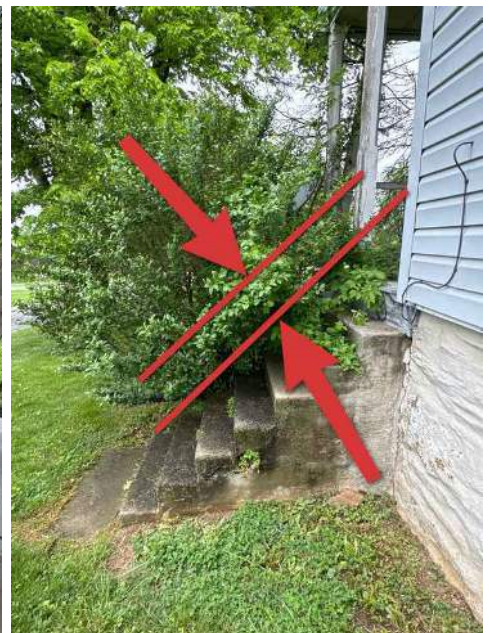
Stair railings and balusters missing

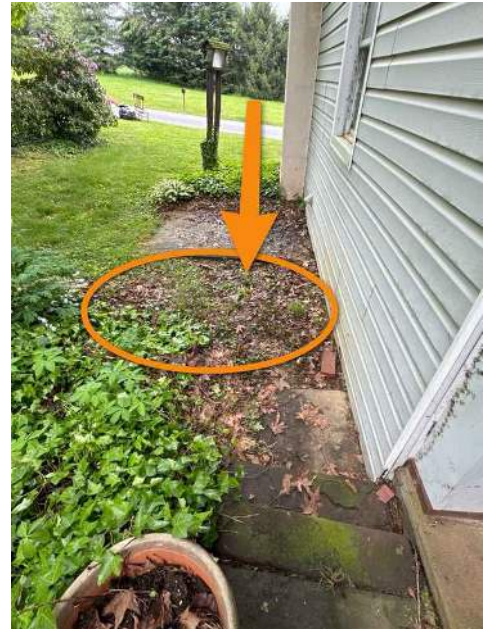
At the time of the inspection there was a potential low spot(s) around the foundation wall. The depressed area(s) creates a pathway for water to enter the home causing water damage. I recommend this area(s) be evaluated and re-graded to avoid this potential entry point.

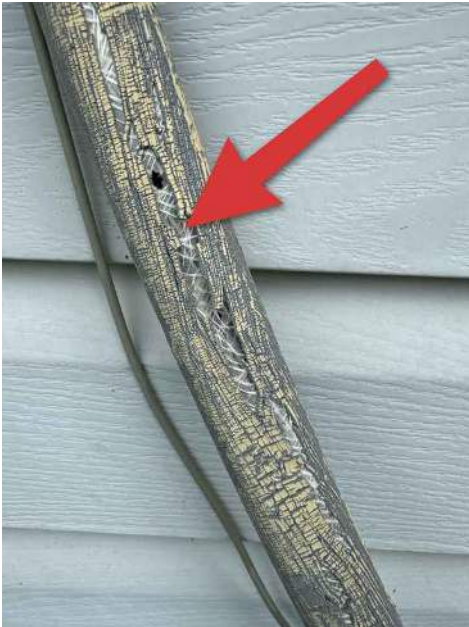
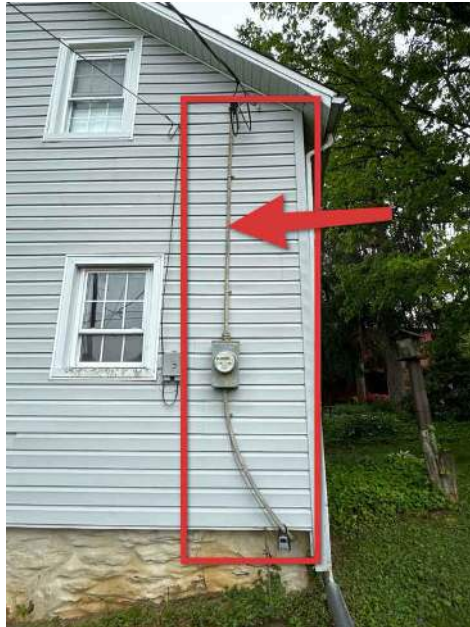
3.7.1 Service Entrance Conductors and Grounding

FRAYED SHEATHING

Close up

Jacket worn and frayed

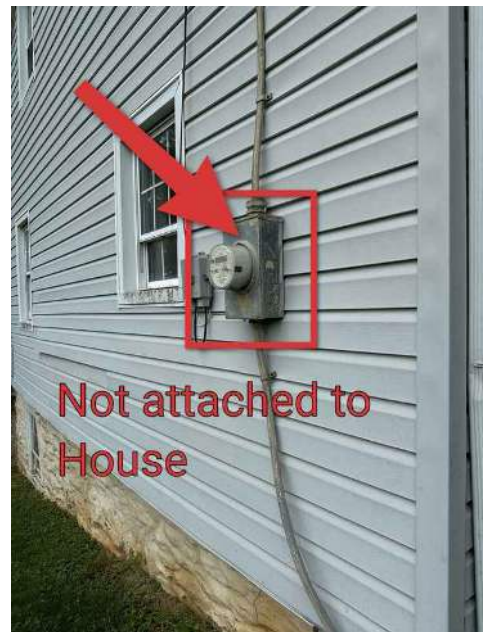
METER BASE

At the time of the inspection the service meter box was loosely connected to the house. This presents a safety hazard and also creates a pathway for moisture to enter the house. I recommend a professional to secure the meter base firmly.

Not attached to House

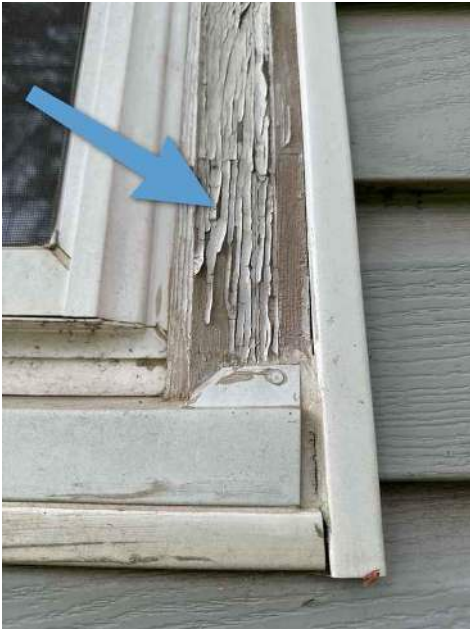
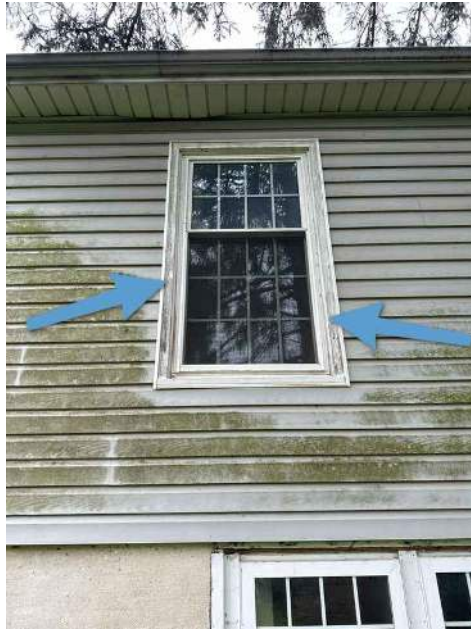
Close up

Peeling paint on some windows

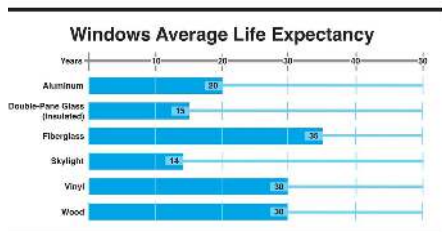
Averages

The life expectancy of windows can be 20-40 years depending upon materials, climate conditions and manufacturer. See charts of averages below.

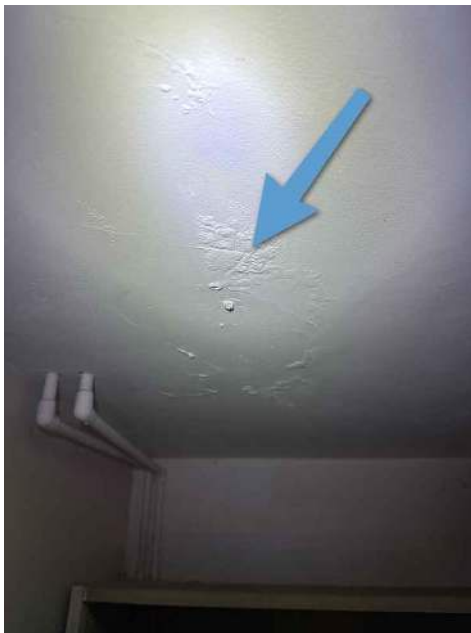
1ST FLOOR BATHROOM

I observed a section of the ceiling with evidence of past moisture penetration. There was no moisture evident at the time of the inspection and the area appeared to be dry. I recommend monitoring the spot for any evidence of any future moisture. If moisture occurs, take immediate action to repair.

Close up

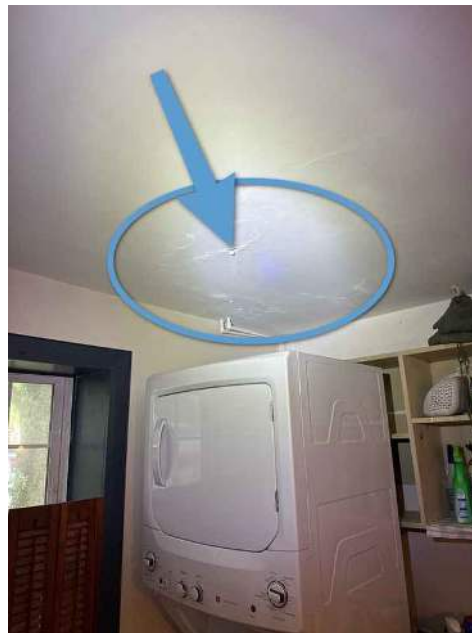
EVIDENCE OF PAST MOISTURE

Plaster crumbled

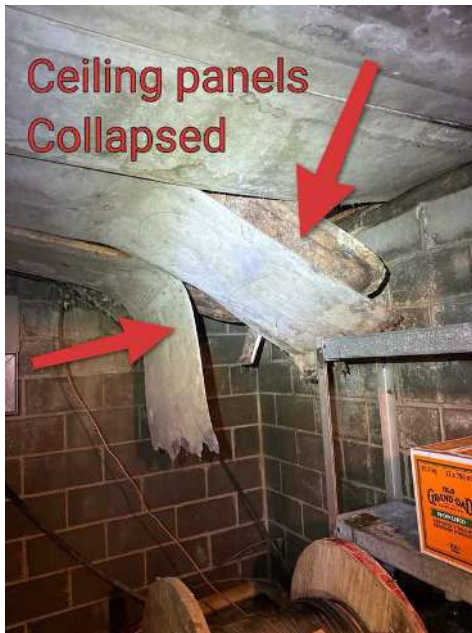
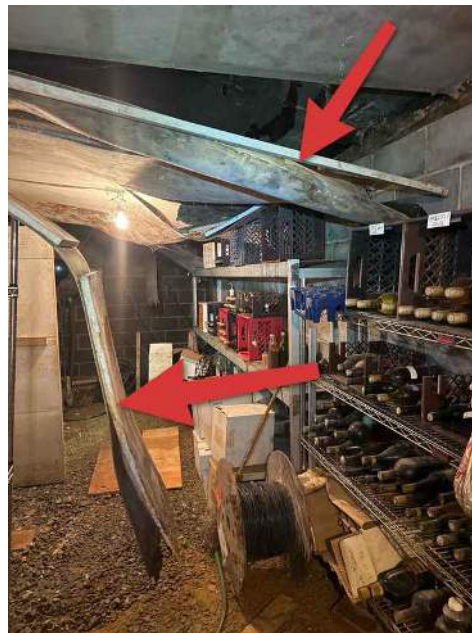
I observed ceiling damage. The area(s) pictured should be repaired. See photo description. I recommend a qualified professional to evaluate and make appropriate repairs.

NOTE: It appears that moisture from the vicinity of the front porch has migrated to this ceiling causing damage.

Insulation panels falling down

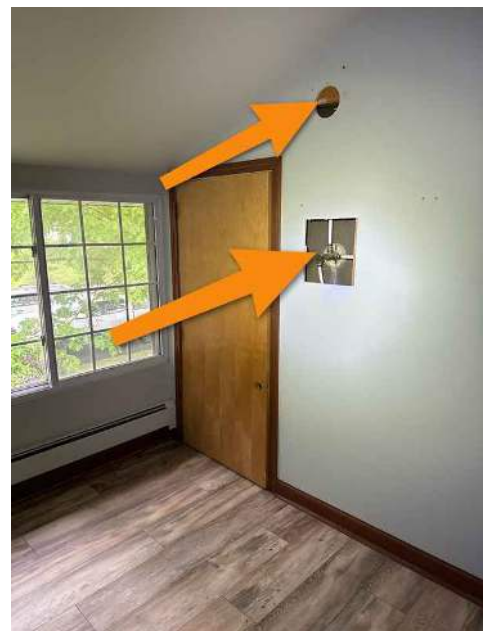
At the time of the inspection I observed one or more hole(s) in the wall. This area should be repaired by a qualified professional.

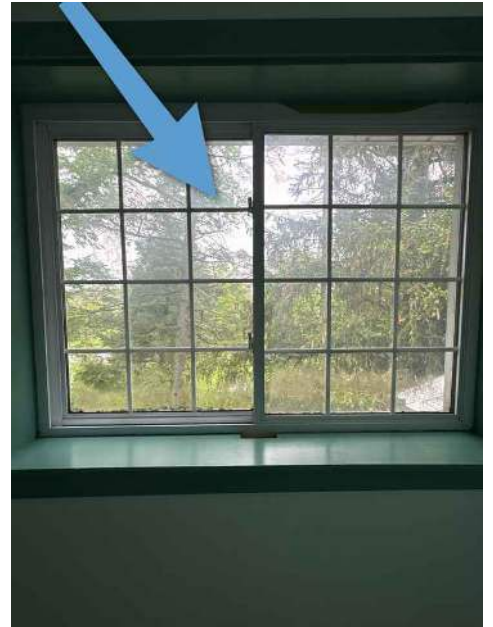
The National Association of Certified Home Inspectors reports that the predicted life expectancy of vinyl/aluminum windows can be 20-40 years depending upon climate conditions, the window manufacturer, and quality of installation.

I recommend a qualified professional to evaluate the condition of all the windows and make recommendations. You may want to consider budgeting for replacement.

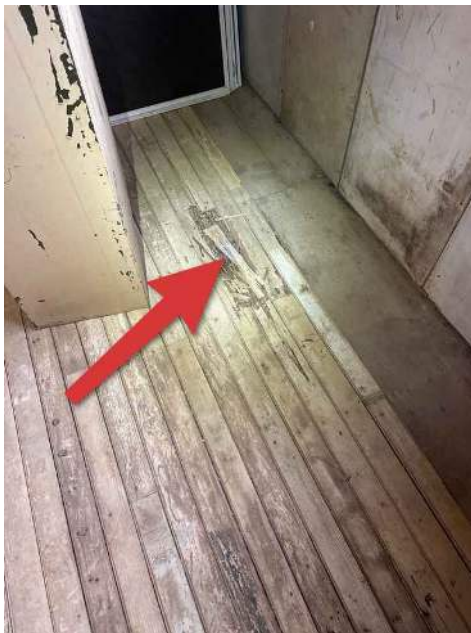
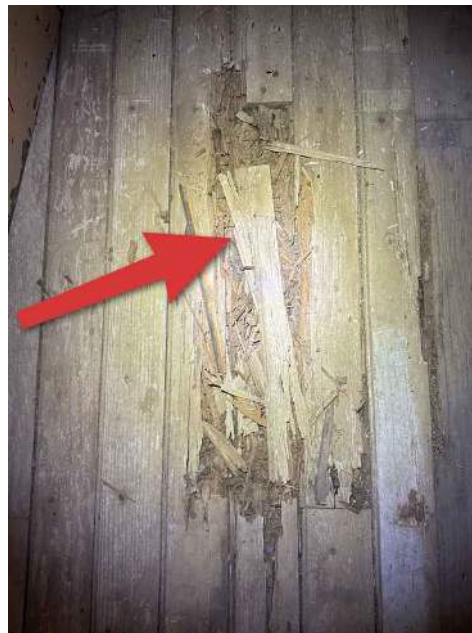
4.5.1 Floors

DAMAGED FLOORBOARDS

REAR BASEMENT

I observed damaged floorboards. I recommended a qualify, professional evaluate and repair.

Floorboards deteriorated

Close up

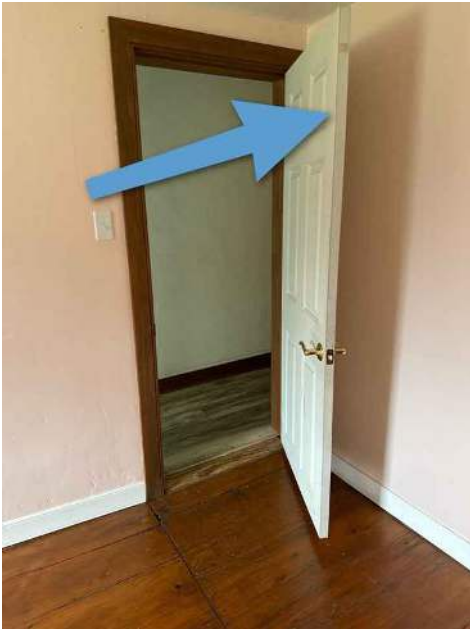
I observed a door(s) that was sticking. It was difficult to open and close. I recommend a professional to make adjustments so that it operates smoothly.

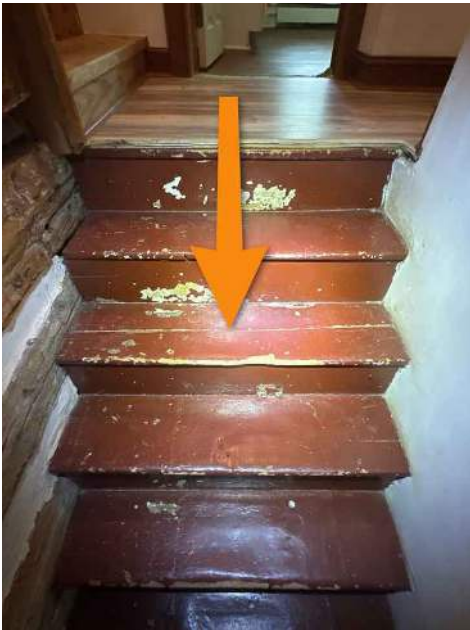
4.10.1 Steps, Stairways & Railings

STAIR TREAD SPLIT

At the time of inspection I observed one or more stair treads that were split. This could present a safety hazard. I recommend a qualified professional to evaluate and repair.

Top stair

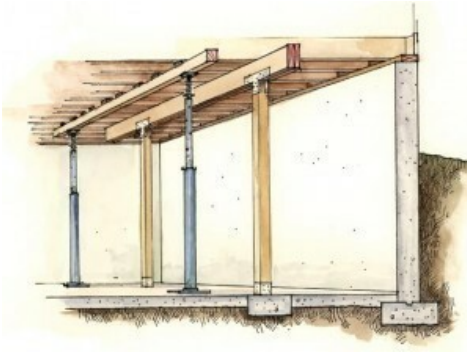
At the time of the inspection, I found one or more split-jack posts that were being used to support the main structural components of the home. These support posts were not approved for permanent use in supporting main beams in structures. When used, they represent a temporary support system. I recommend a qualified professional to evaluate and replace.

Problems with Split Jacks

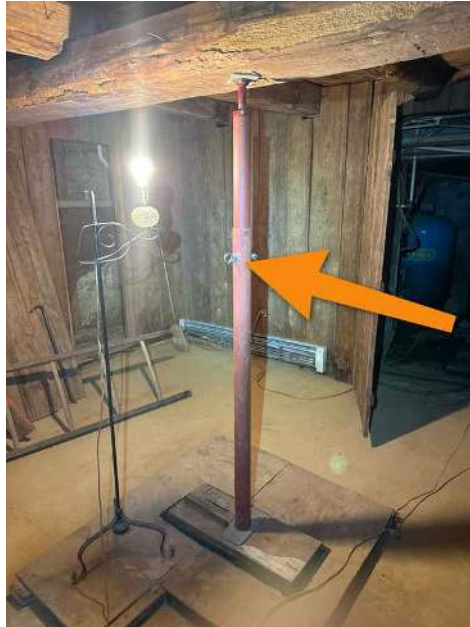
Proper replacement for split jacks

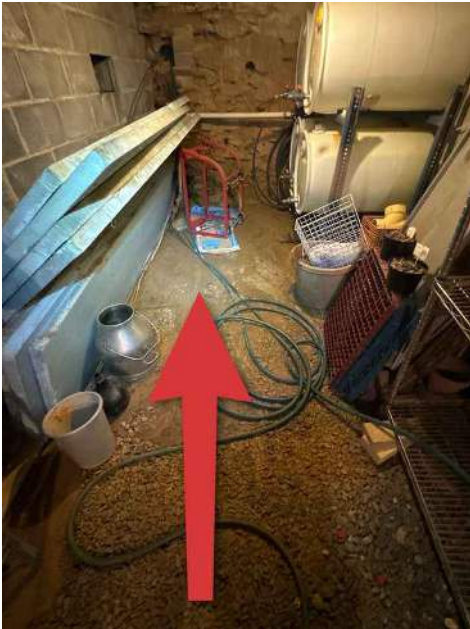
5.5.1 Foundation Structure

MOISTURE PENETRATION

Mud on floor

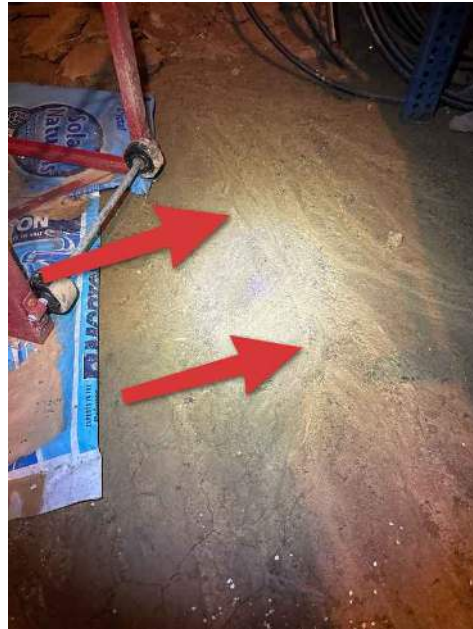
Moisture appeared to be entering the foundation. See photos. Most moisture problems originate on the exterior. If the source is not identified, this moisture can cause significant damage. I recommend the exterior be evaluated in order to determine where the water is coming from and so repairs can be made to stop future water penetration.

Mudflow across floor

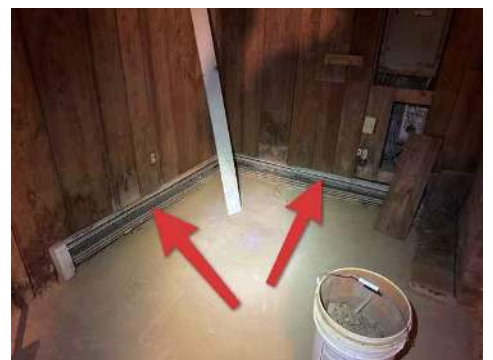
At the time of the inspection, one or more radiators appeared not to be delivering heat through the system. I initiated readily accessible switches and thermostats, and other radiators were working and the heating system was operational. I recommend a qualified professional to evaluate to determine if this (these) radiator(s) can be repaired or replaced.

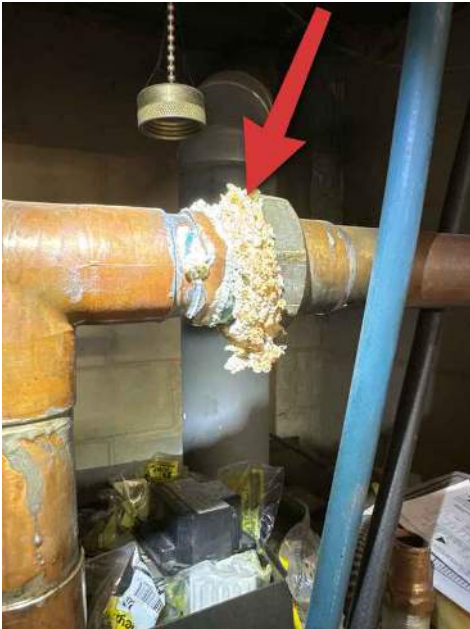
At the time of the inspection I found corrosion at the fittings of the heat distribution piping. If not repaired this could develop into a leak. I recommend a qualified HVAC contractor to repair.

Close up

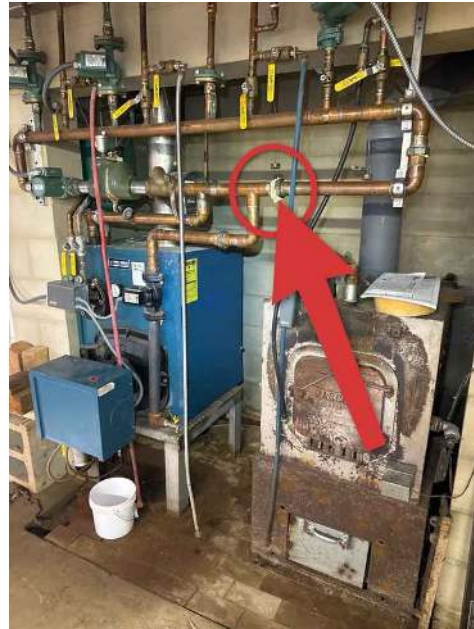
Calcification on fitting

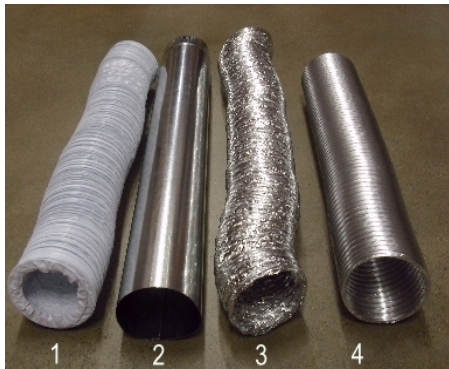
Ducting material is a key component in moving harmful moisture from the home to the outside. The quality of the material used for this ductwork is important. See more info on [Ducting Material](#) as referenced in the picture below.

Types of exhaust ducting

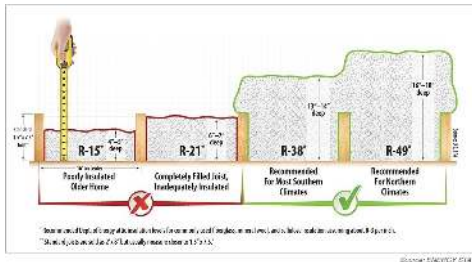
At the time of the inspection, the R-value of the insulation in the attic was below current standards. See photo. New construction calls for R-49. Energy savings can be captured by bringing the R-value up to today's standards. I recommend a qualified insulation contractor or DIY install additional insulation where possible.

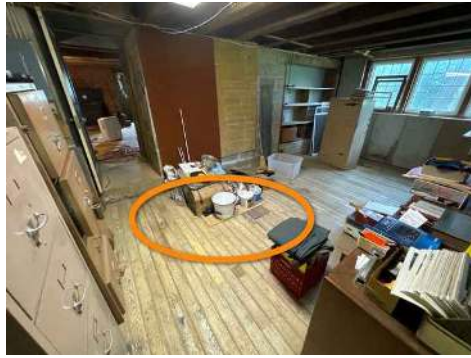
- FLOOR-WALL JOINTS
- FLOOR CRACK AND CRAWL SPACE
- SUMP PIT
- SHOWER WELL WATER

Radon entry points

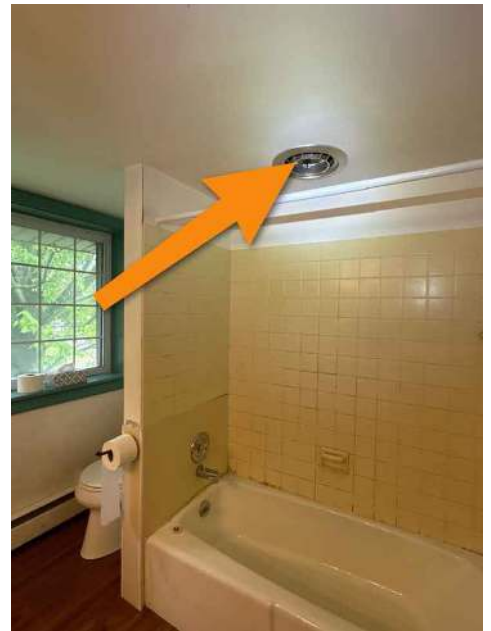
At the time of the inspection the bath exhaust fan was not working. This may indicate that the motor has reached the end of its serviceable life or that there is an electrical problem. I recommend a professional evaluate and repair or replace.

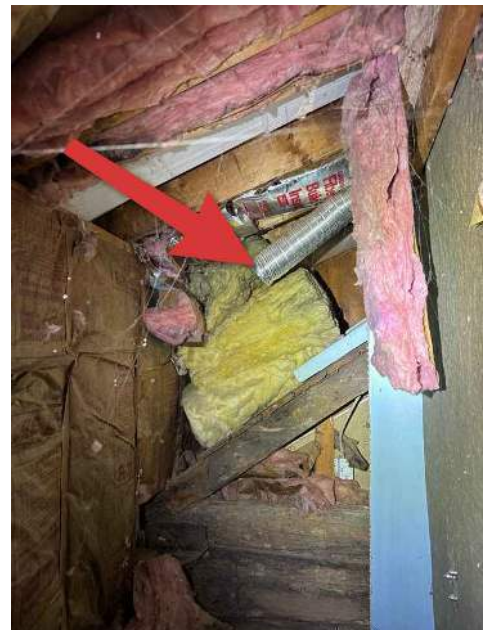
At the time of the inspection, I found the dryer venting into the attic. A clothes dryer will vent about a gallon of water for each load of laundry. If the dryer vent discharges into an attic, or another building cavity, the potential for moisture-related damage is significant. I recommend a qualified professional evaluate and redirect the dryer venting.

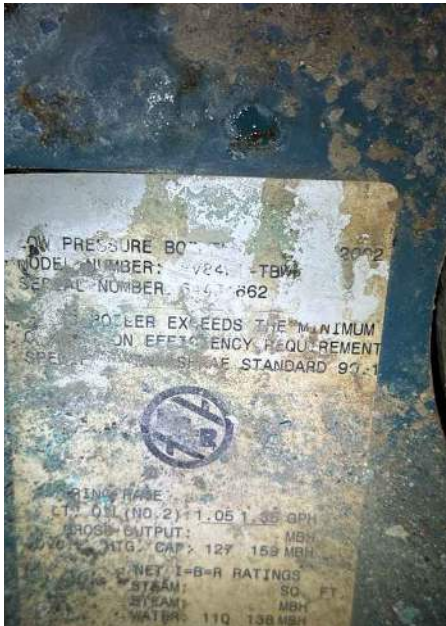
Water Heater: Age

2002

Based on the manufacturer's suggested service life, the life expectancy of a gas water heater is about 8 to 14 years and an electric water heater is 10-18 years. I recommend having a qualified professional evaluate the condition of the water heater to best determine its life expectancy.

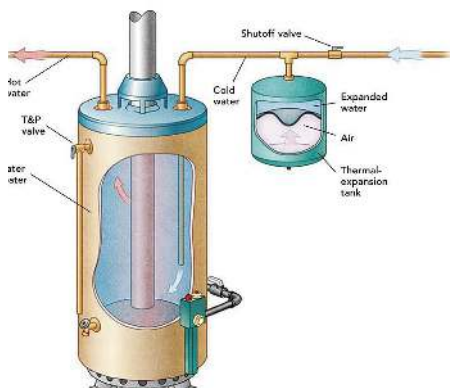
Water Heater: Expansion tank

Present

A pressurized expansion tank is a sealed cylinder divided by a flexible diaphragm. An expansion tank provides space for the water to expand as it is heated and assists in keeping the water pressure in the normal pressure range while the water heater is operating. These have been required in certain areas for new installations or replacement since 2012.

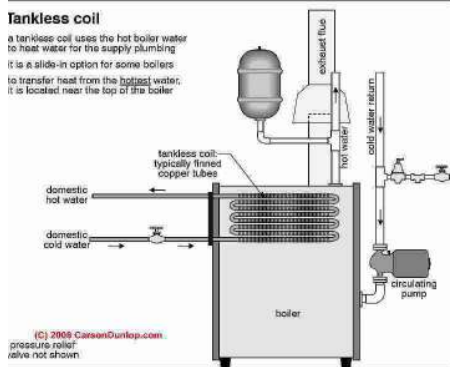
Domestic Hot Water System

At Furnace

The hot water to the home was served through the boiler. This is considered a domestic system. The hot water is heated by the boiler and distributed to the fixtures. Normally by way of copper piping. As long as the boiler is working the hot water should be delivered consistently to the home.

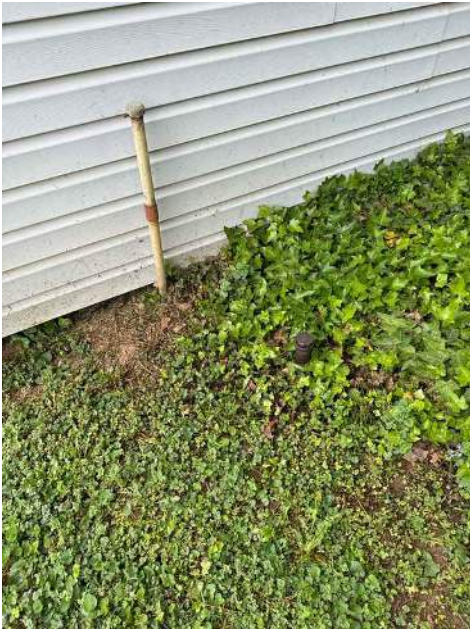
FRONT LEFT SIDE

At the time of inspection I observed that the oil tank was underground. Underground oil tanks like this, are not part of the home inspection. I recommend a qualified professional evaluate if it exists and if it has been abandoned correctly.

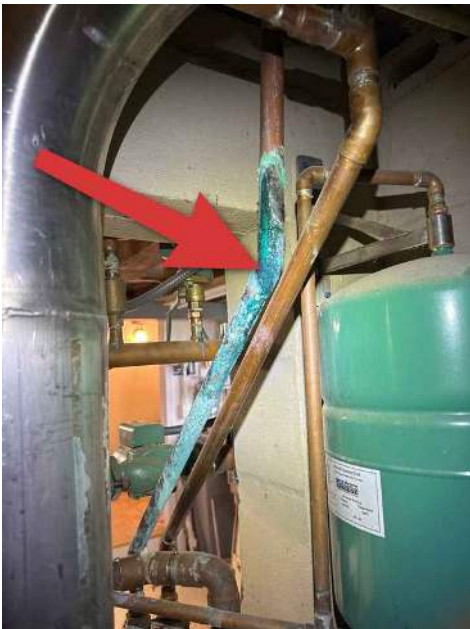
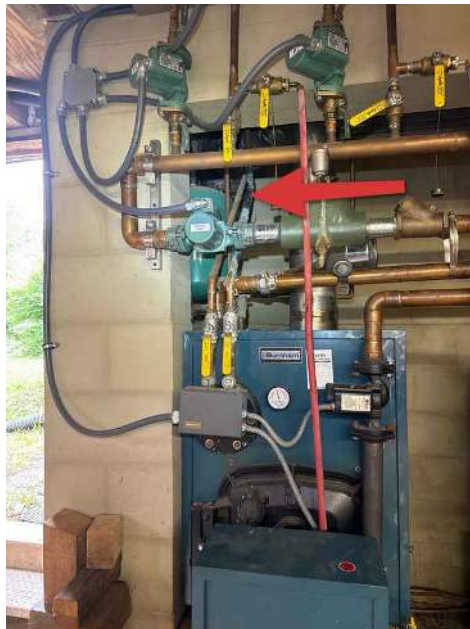
8.2.1 Water Distribution lines

At the time of the inspection, I observed an active leak in a water line. If not repaired this can cause significant damage. I recommend a qualified professional to evaluate and repair.

Close up

Domestic line leaking

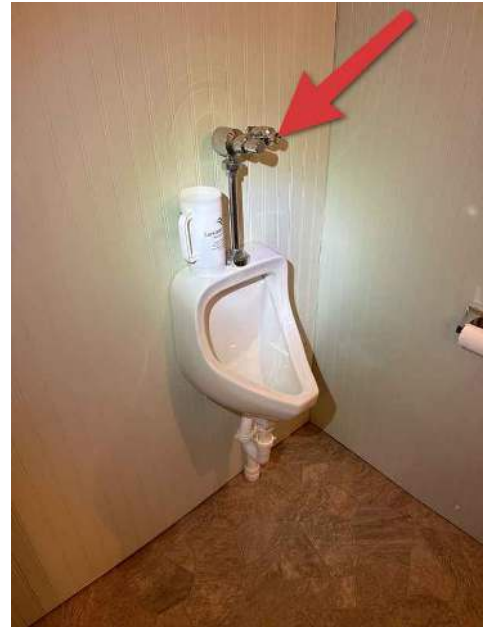
I observed a urinal that did not have water running to it. A qualified plumber should evaluate and repair.

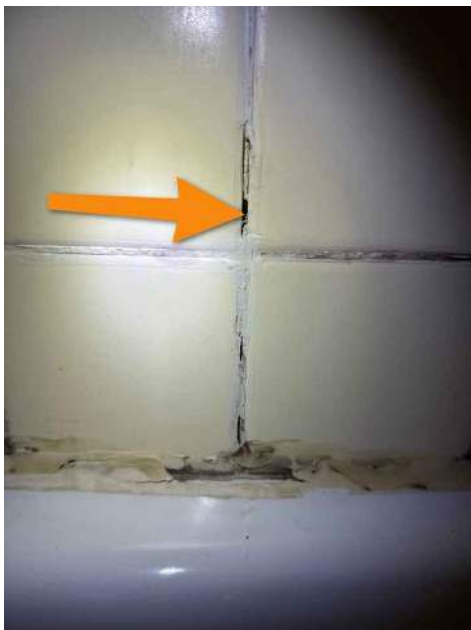
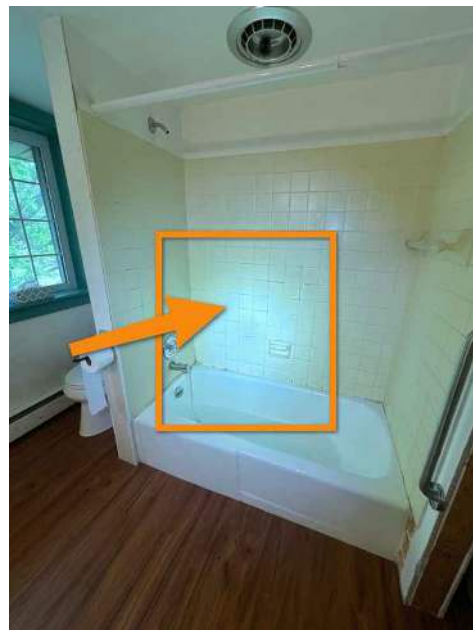
8.4.1 Sinks, Tubs, Showers

LOOSE OR MISSING GROUT

Close up

Grout repair needed

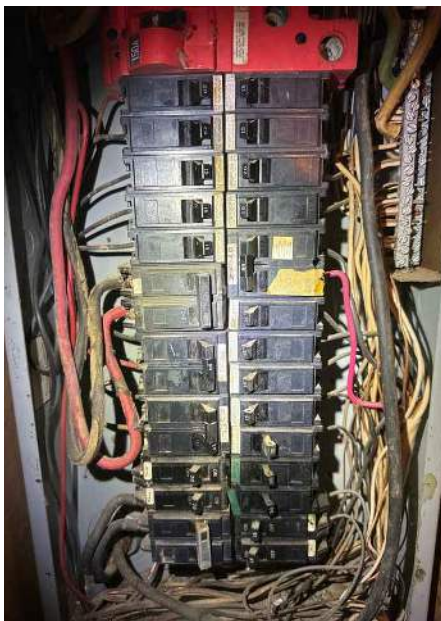
Main Distribution Panel: Panel Capacity
150 AMP

Main Distribution Panel: Panel Disconnect
150 amp breaker at panel

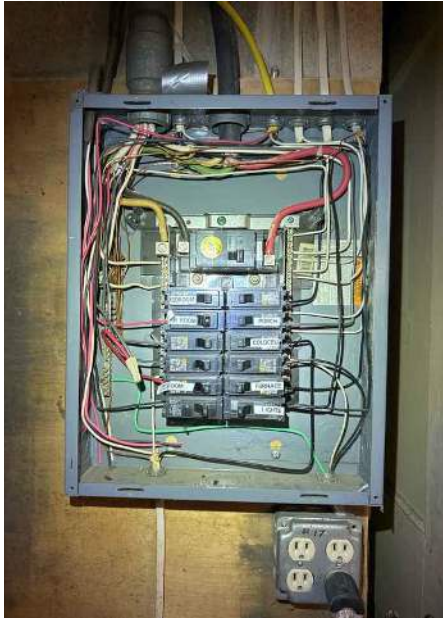
Sub Panel: Panel Location

Basement

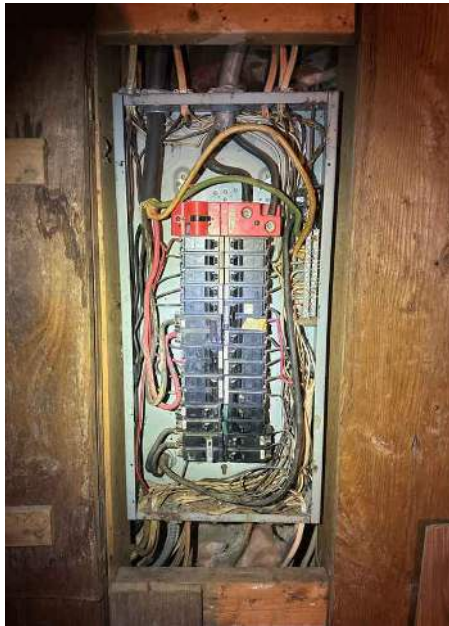
Basement

Electrical panels are considered continuous-use appliances because they are always on. They experience daily heating and cooling of their components. As such, they should be replaced periodically. The average life of a panel is 30-50 years depending upon many factors. I recommend a qualified professional to evaluate this panel to determine if this panel should be updated to a newer panel.

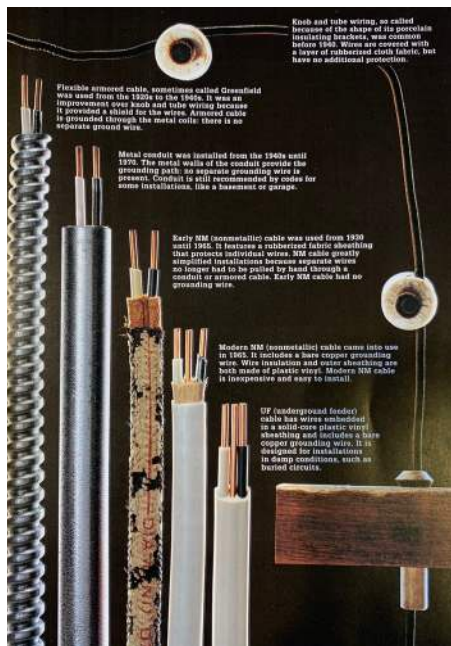
Copper, Non-metallic sheathed (Romex), Armored cable

At the time of the inspection, the predominant, visible branch wiring appeared to be in good condition. Any visible defects will be listed separately in the report.

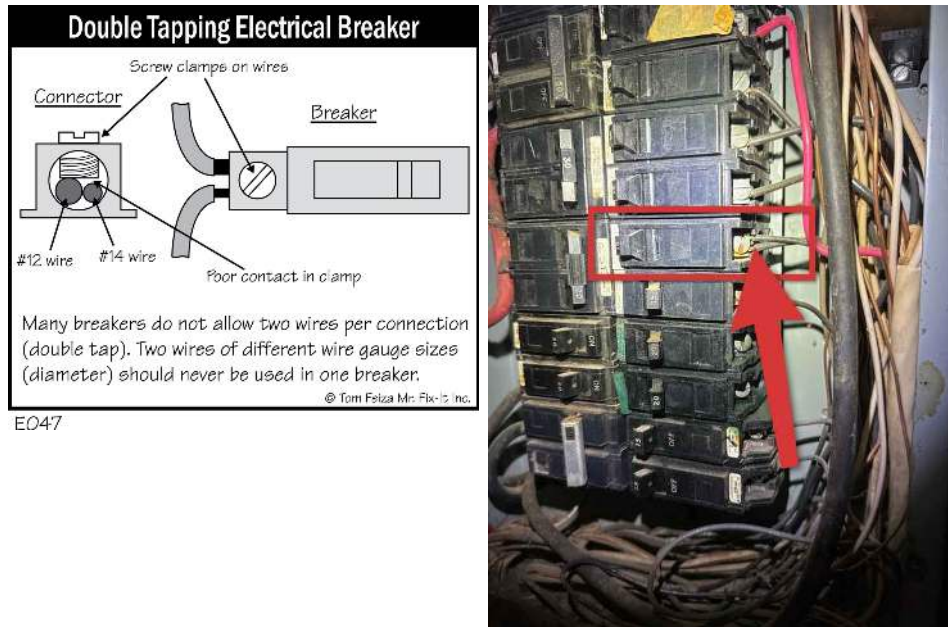
IMPROPER DOUBLE TAPPED BREAKER(S)

****Safety issue**** - Most circuit breakers are only designed for 1 conductor (wire) to be connected at the lug. This condition prevents a reliable connection which can lead to arcing (and fire) or an intermittent or overdrawn circuit. In some cases double taps are allowed but must be installed in a manner in keeping with the panel's manufactures' instructions. I recommend an evaluation by a qualified professional.

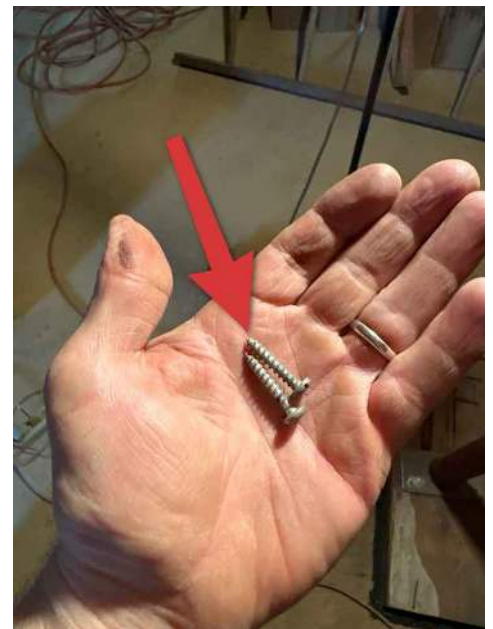
PANEL SCREWS WITH POINTED TIPS

****Safety issue**** - At the time of the inspection I noted that the electrical panel cover screws had pointed tips instead of blunt tips. These can cause electrical shock or arcing if the screw perforated a wire in the panel. I recommend a qualified professional to evaluate and replace with standard electrical panel screws.

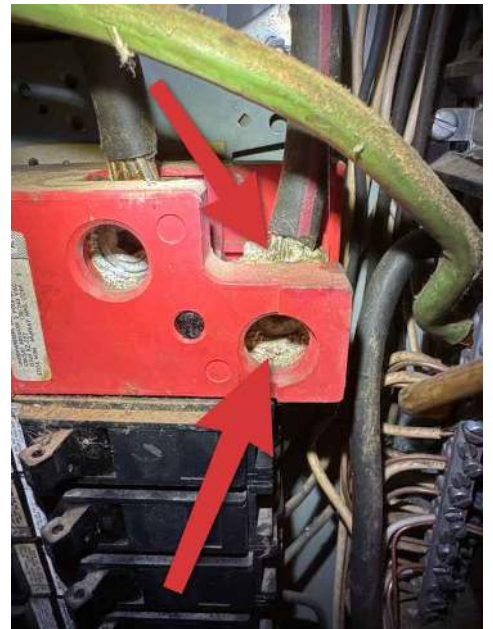
9.2.4 Main Distribution Panel

ELECTRIC PANEL - CORROSION AT MAIN LUG

At the time of the inspection the main power supply lugs showed signs of corrosion. This is evidence that moisture has probably entered the panel and could be a fire hazard. I recommend a qualified professional to evaluate the condition of the panel prior to settlement and recommend repair.

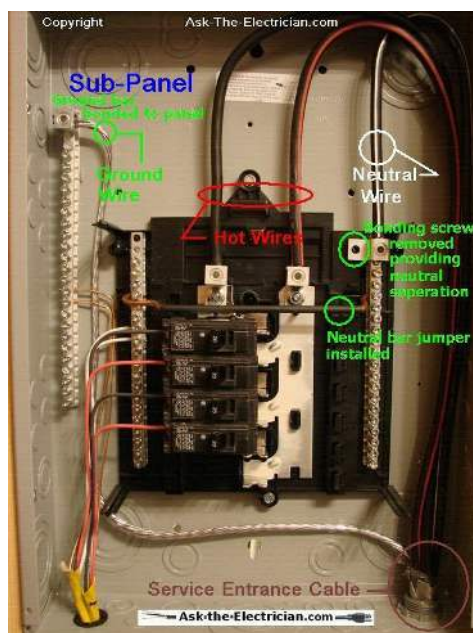
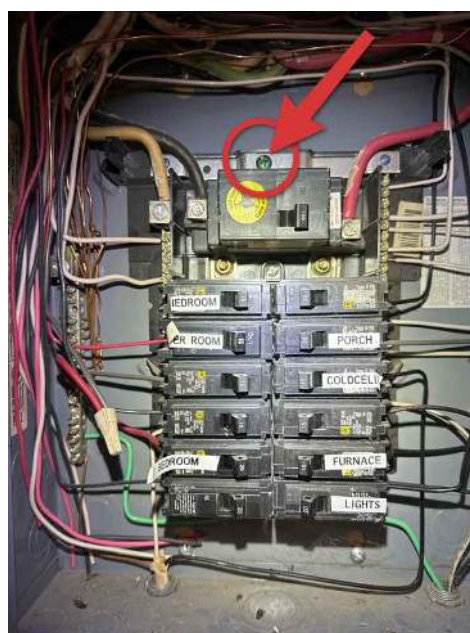
9.3.1 Sub Panel

I observed a sub panel that appeared to be incorrectly wired. In a sub panel neutral and ground wires should not share the same ground bar. In this situation, the current will flow on both the neutral AND on the ground wire. If you do not keep the ground wires separate from the neutral wires, you will be allowing return currents to flow on the ground wires back to the main. A sub panel acts as a pathway between the main service panel and branch circuits down the line. It needs separate ground bars for neutral and ground wires and typically has no main breaker. I recommend a qualified professional to evaluate in order to determine if the panel is not wired properly and if reconfiguration is necessary.

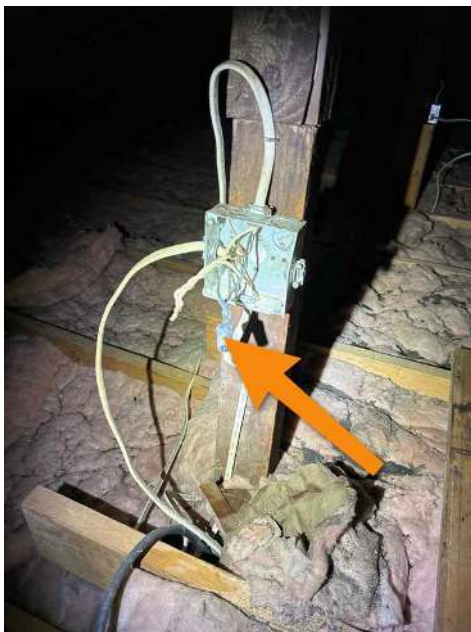
Attic - 2 locations

JUNCTION BOX COVER(S) MISSING

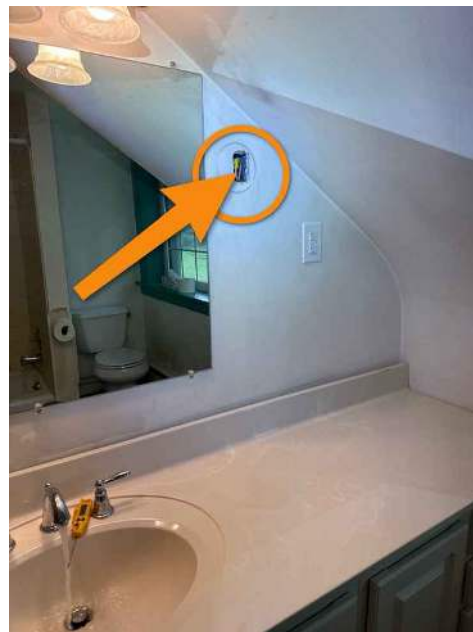
At the time of the inspection one or more junction boxes were without covers. This presents a potential shock hazard. I recommend a qualified professional evaluate and install cover plates where absent.

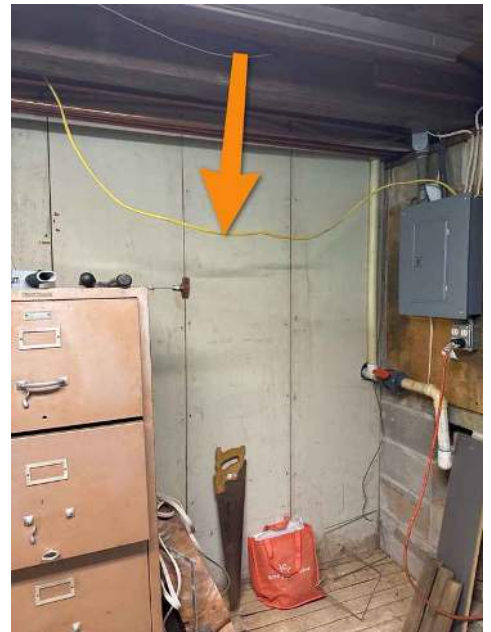
I observed places where the branch wiring was not fastened according to standard electrical installation practices. This presents a shock/fire hazard because wires can easily be damaged. I recommend a qualified professional to evaluate and fasten properly.

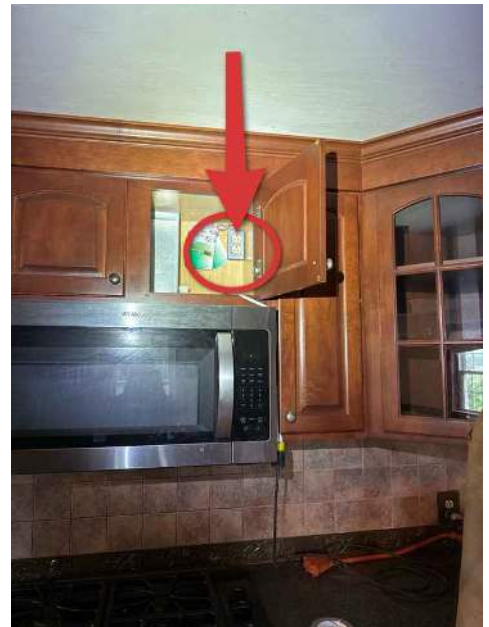
RECEPTACLE NOT WORKING

At the time of the inspection, I observed one or more receptacles that were not working. I was unable to trace its power source or the root cause. There are various reasons why receptacles fail or don't work (see typical causes below). I recommend a qualified professional to evaluate and repair.
