INSPECTION REPORT

46 Chestnut Grove Rd
Conestoga, PA 17516

Renee Weaver
05/06/2024

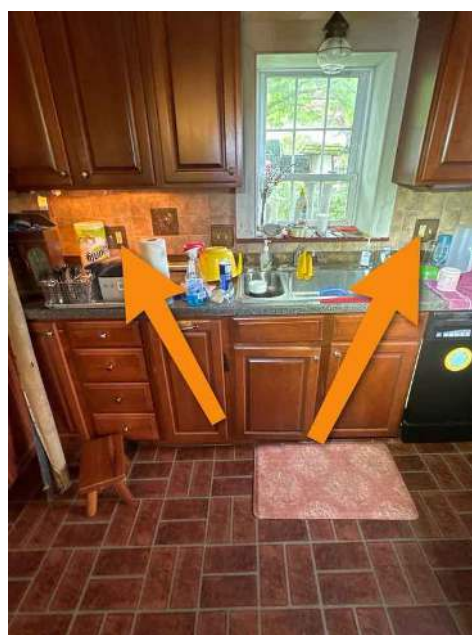
Kitchen

GFCI NOT TRIPPING

****Safety issue**** - At the time of the inspection one or more GFCI receptacles were not tripping. In this condition the safety features of the GFCI are ineffective. Typically GFCI outlets have a limited lifespan. I recommend replacing this receptacle with a new one.

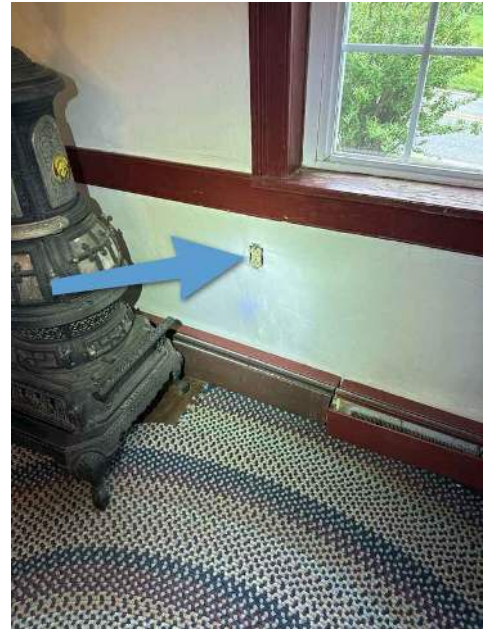
Safety issue -- I observed an electrical box(es) that had missing cover plate(s). If completely missing, this presents a shock hazard. In the case of exterior outlets water may get into the outlet causing a short. I recommend replacing all missing cover plates.

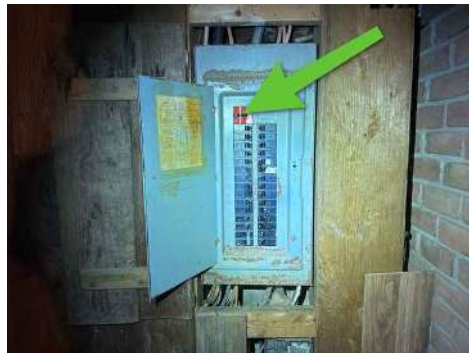
002

Electric: Electric shut off

Basement

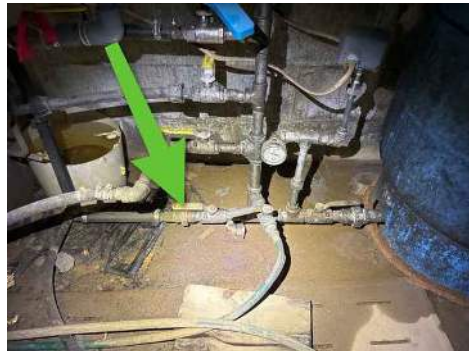
005

Water: Water Shut-off

Basement

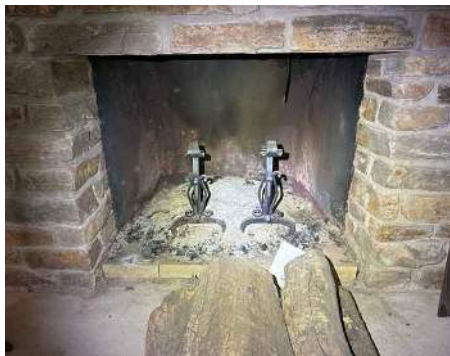
Family Room fireplace

Fireplaces, Stoves & Inserts: Type

Masonry fireplace, Woodstove

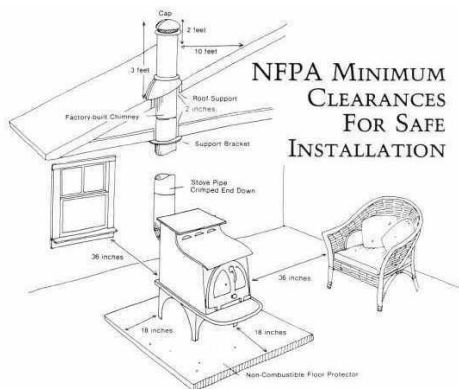
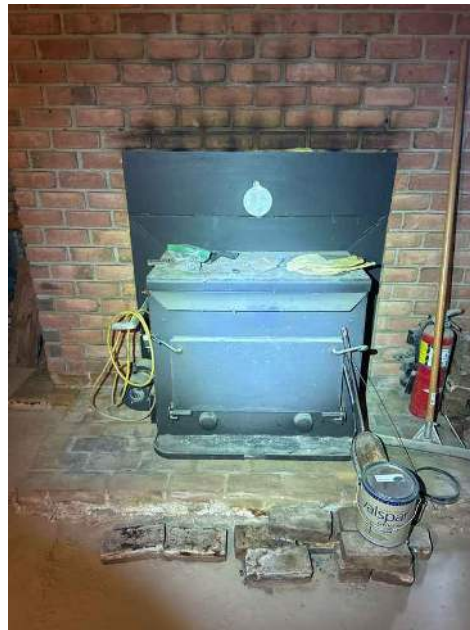
BASEMENT

At the time of the inspection a wood stove was present. A full inspection of the stove and internal chimney lies beyond the scope of a home inspection. For a full inspection to more accurately determine the condition of the fireplace and to ensure that safe conditions exist, I recommend that you have the fireplace inspected by an inspector certified by the Chimney Safety Institute of America (CSIA).

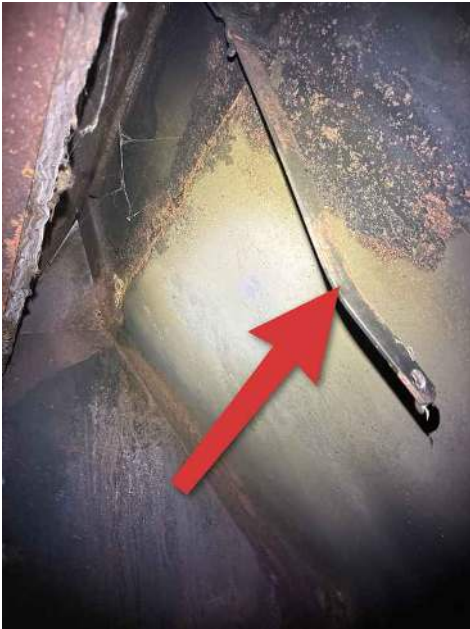
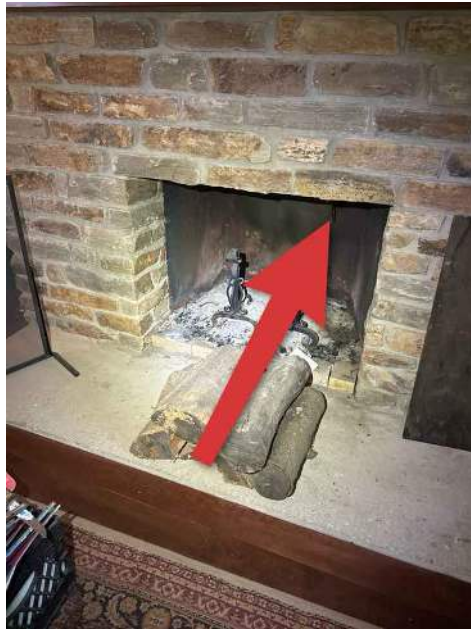
11.1.1 Fireplaces, Stoves & Inserts

At the time inspection I observed at the fireplace damper was not working. Using this fireplace without a working damper is a fire hazard. I recommend a qualified professional evaluate and repair.

Close up

Damper not working

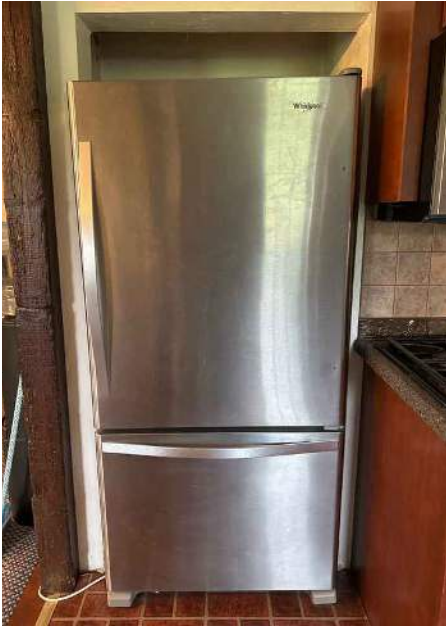
Refrigerator: Water/Ice Supply Line

Certain material (i.e. plastic) is subject to early failure which could result in significant water damage.

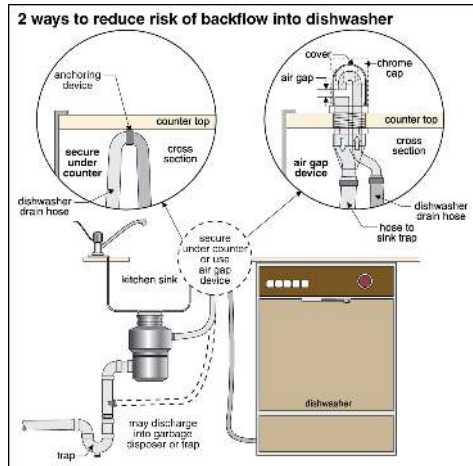
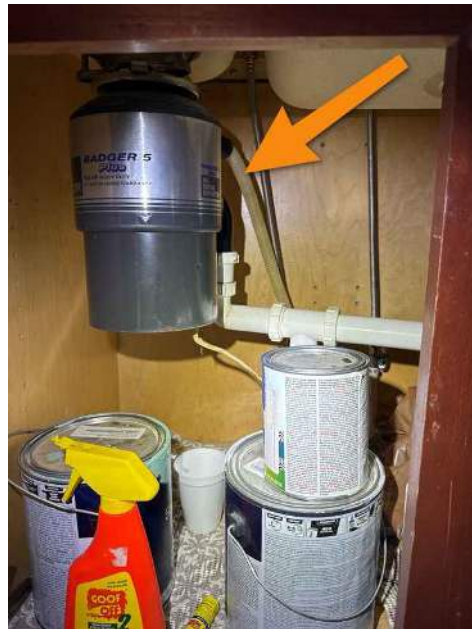
12.1.1 Dishwasher

AIR GAP MISSING

The dishwasher drain pipe was installed improperly. Without a high drain line loop or air gap, risk of a potential back-flow of water into the dishwasher and incomplete drainage of water is increased. Manufacturer's instructions typically require the line loop up to a point 32 inches from the floor. Some local codes require air gaps to be installed.

I recommend a qualified plumber evaluate and repair as necessary.

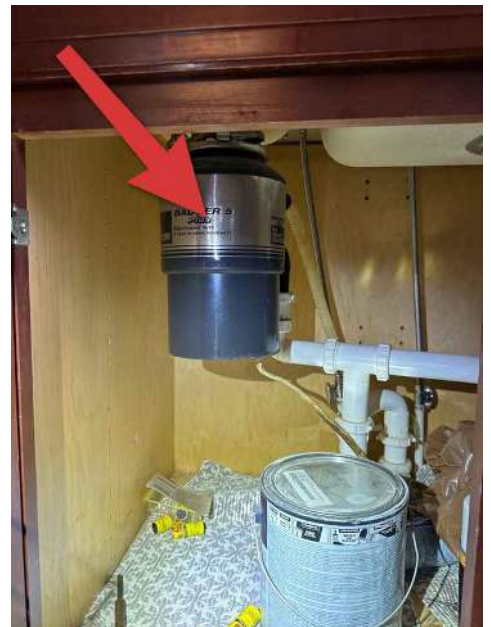
12.3.1 Garbage Disposal

Garbage disposal was inoperable (or not easily operable) at the time of inspection. The reset button may be tripped, the motor may need to be reset, or it may need to be replaced. I recommend that a qualified handyman repair or replace it.

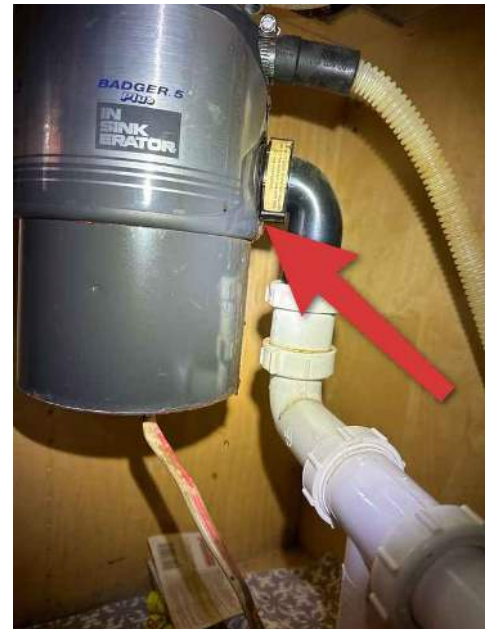
12.3.2 Garbage Disposal

At the time of the inspection, the garbage disposal was leaking. I recommend a qualified professional to evaluate and repair or replace.

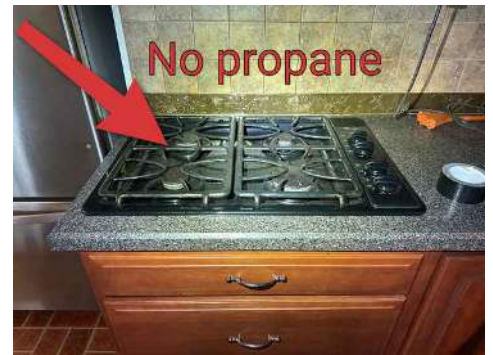
BURNER(S) NOT WORKING

****Safety issue**** - One or more burners were not functioning when turned on. Gas burners are often slow to light or will not light at all because the burner or burners are wet or dirty, the electrode is not seated properly, or because the burner head and cap are not matched up properly. I recommend a qualified professional to evaluate & repair.

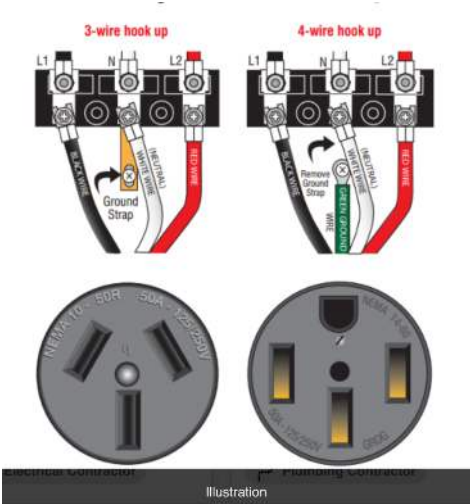
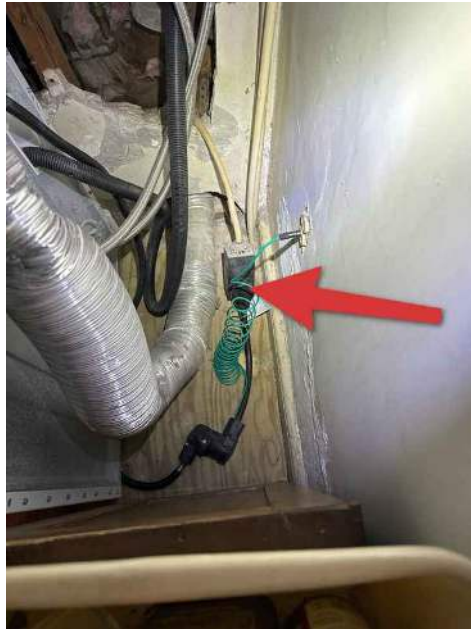
12.7.1 Washer/Dryer

3-PRONG DRYER OUTLET

****Shock Hazard**** - At the time of the inspection, there was a 220v three-pronged outlet present. Industry safety standards now call for four-pronged outlets at washers and dryers and ranges in order to prevent potential electrical shock. Important: This allows for the neutral wire and the ground wire to move on separate lines, thus removing the potential shock hazard. I recommend a licensed professional to evaluate and to bring the outlet up to current standards. A proper installation will require a new four wire to be installed from the electric panel to the appliance and terminated in a four wire plug.
