## INSPECTION REPORT

16a Manor Ave  
Millersville, PA 17551

Renee Weaver  
07/17/2024

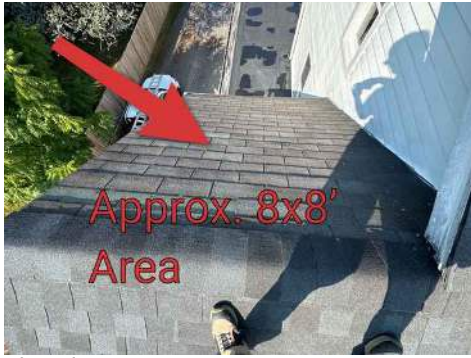
#### ROOF NEARING END OF LIFE

Shingles wearing out

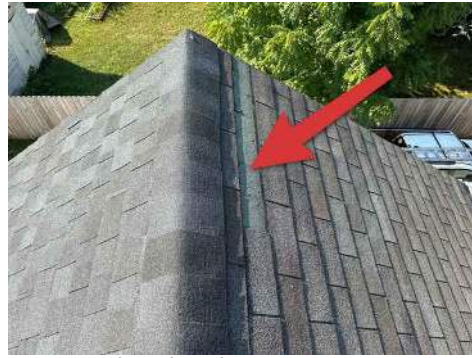
Missing shingle tabs

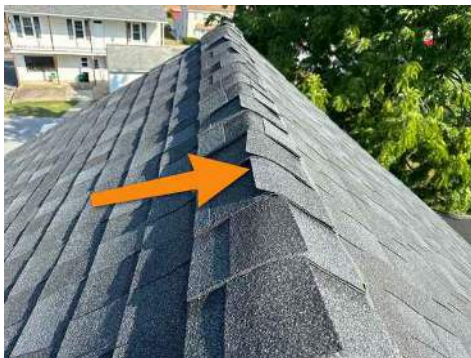
#### ARCHITECTURAL RIDGE SHINGLES

Not designed for Ridge application

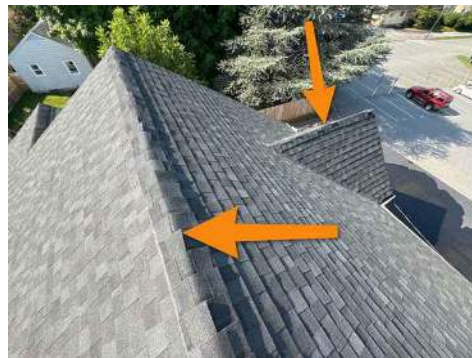
Architectural shingles used on ridge

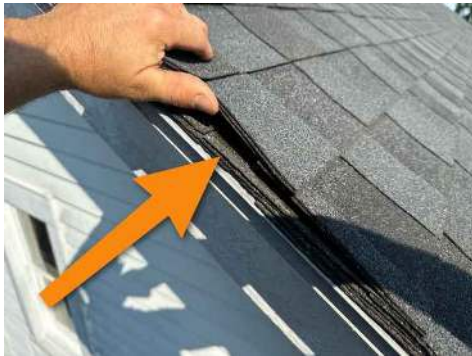
The roof appeared to have multiple layers of shingles. This is an unprofessional reapplication that leads to early roof failure. Although some shingle manufactures allow for roofing over top of existing roof materials, it is not ideal and can reduce the life expectancy of the new roof. I recommend a qualified professional to examine and evaluate the condition of this roof.

Multiple roof layers

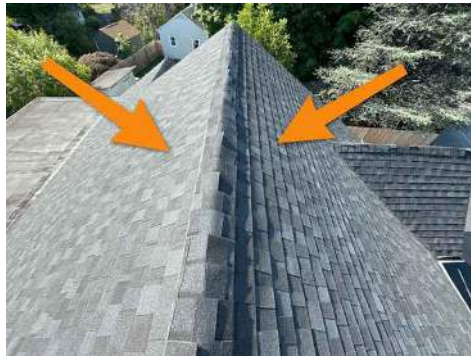
New roof installed over top of old roof

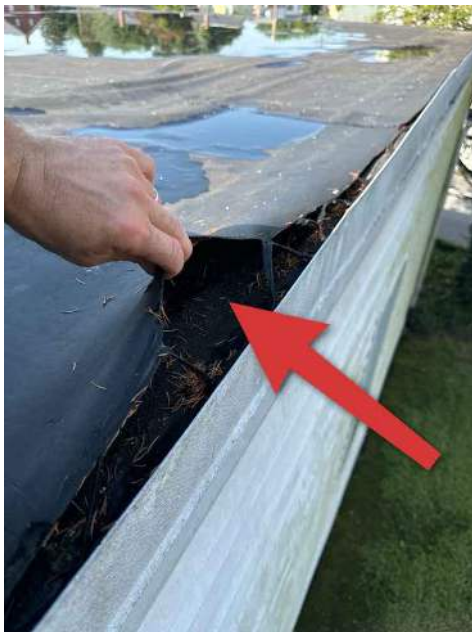
At the time of the inspection, the rubber lap sealant was missing. According to manufacture's specifications a proprietary lap sealant is required to be applied along all lap joints. The potential for an early roof failure exists. I recommend a qualified professional to evaluate and recommend repairs.

No adhesive at edge seam

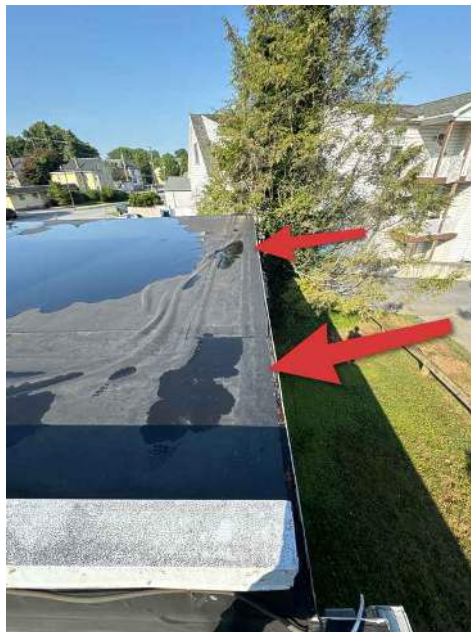
Edge of rubber, not sealed to roof

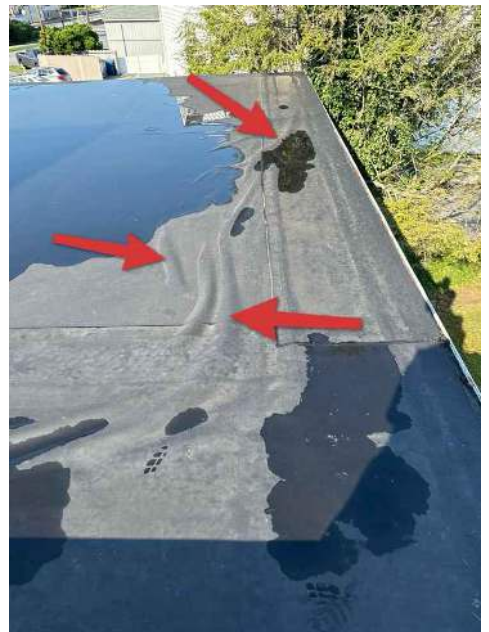
Visible wrinkles - sign that rubber has pulled back

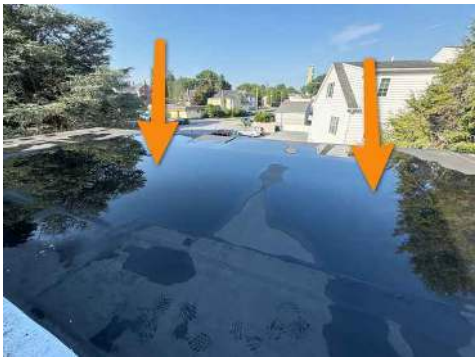
Observed ponding in one or more areas of the roof. If it is allowed to persist over time, ponding can begin to wear on the roofing membrane. This leads to a decline in the membrane's lifespan and accelerated deterioration of the roofing material. Ponding for 24-48 hours is acceptable, however I recommend a qualified roofing contractor evaluate and repair as necessary.

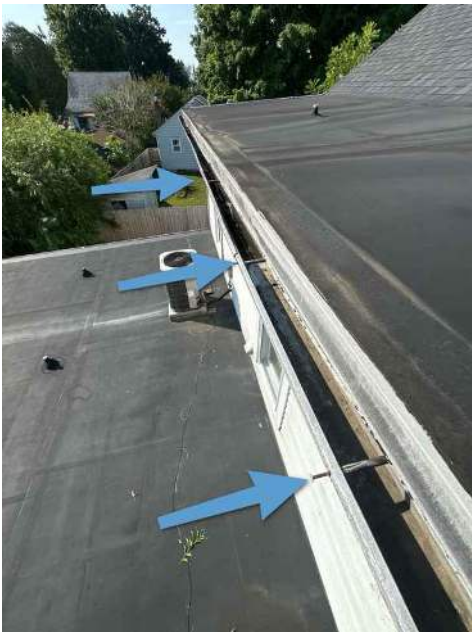
At the time of the inspection there was one or more missing gutter clips/spikes. Without the clips the gutters will rotate when full of water. This could result in moisture entering the foundation, which could lead to moisture entering the basement. I recommend a qualified professional to install new gutter clips at these locations.

Gutter nails backing out

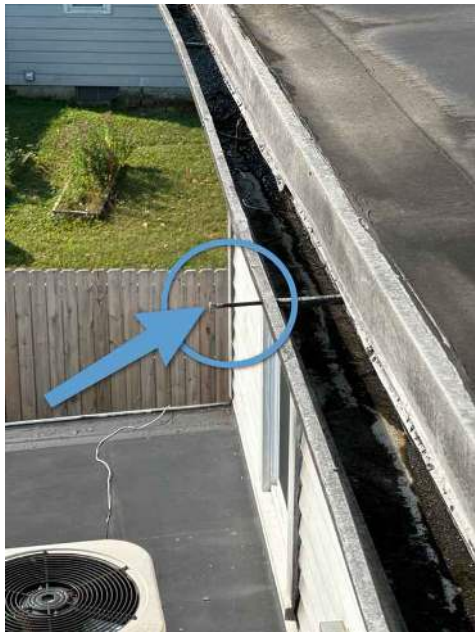
**GUTTER FASTENERS MISSING/LOOSE**

Close up

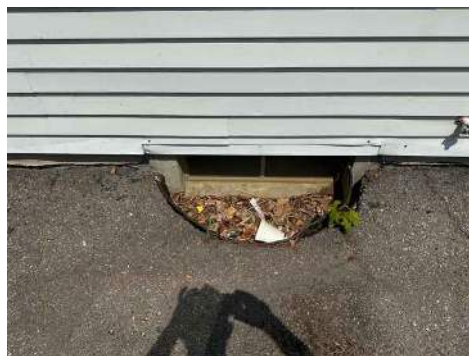
I observed one or more window wells at the exterior of the home. Basement window wells may become vulnerable to moisture problems. Consider installing window well covers to repel excess water if they do not already have covers.

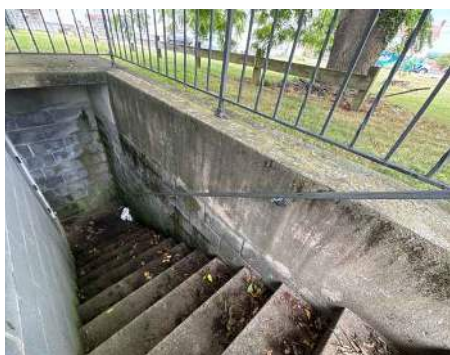
At the time of inspection the retaining wall appeared to be in good condition. Any recommendations will be listed separately in the report.

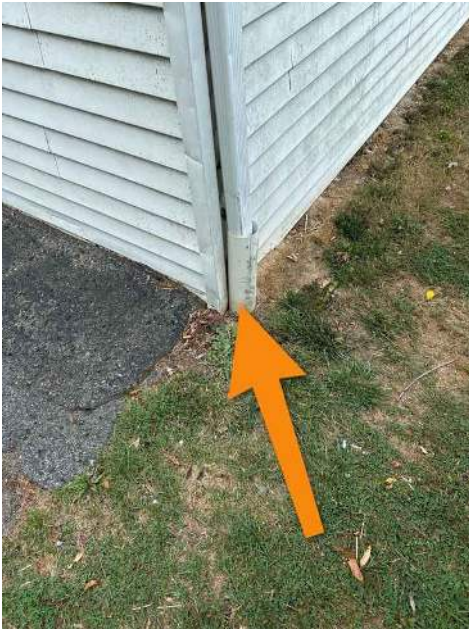
Rear Right Side

At the time of inspection I observed downspout drainage that entered underground piping in one or more places. In certain municipalities storm drains are connected to the public sewer system. It is not always possible to determine where these underground pipes deposit their water. I recommend a qualified professional to investigate with a video scope where these underground pipes empty and to confirm that adequate drainage is taking place away from the house.

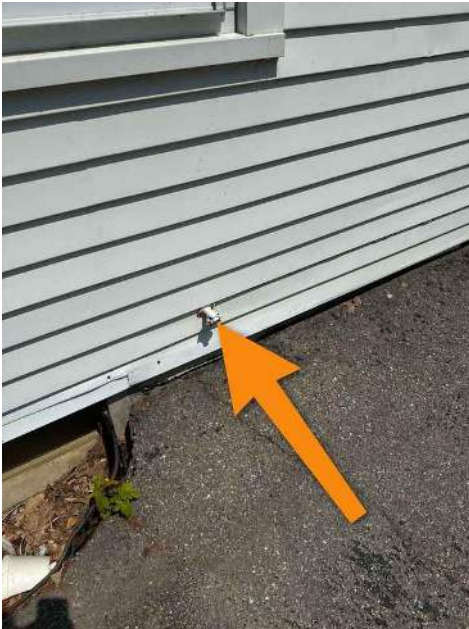
Right Side

At the time of the inspection, there was no handle on the hose bib therefore I was unable to inspect it. I recommend the hose bib be inspected prior to settlement in order to confirm there are no defects.

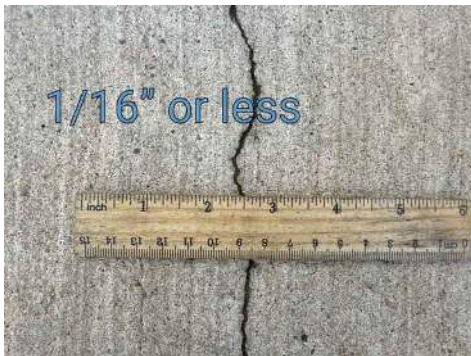
At the time of the inspection the walkway showed signs of minor cracking. In many cases this kind of cracking is superficial and stress or settlement related. A qualified professional can provide a more accurate evaluation and recommend repair options, if necessary.

Hairline cracks on walk

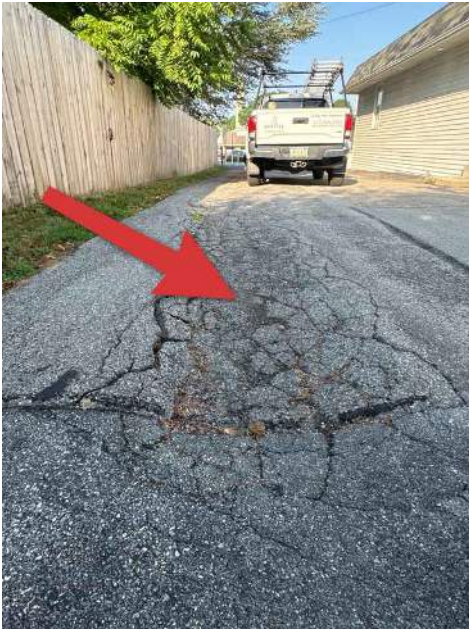
Rear

At the time of the inspection the driveway showed signs of significant cracking. In order to maintain a serviceable surface, the driveway should be free from cracking and maintained with top coating.

Because the photo is representative of more than one crack I recommend a qualified professional to evaluate the entire driveway and repair.

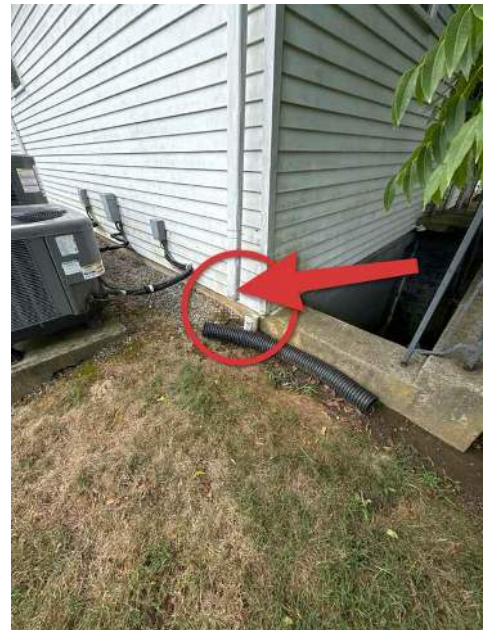
I observed one or more disconnected downspout(s). This can allow water to enter the foundation causing damage to the foundation wall and foundation. Drainage spouting should be run a minimum of 4 feet away from the foundation. I recommend a qualified professional to properly extend the downspout.

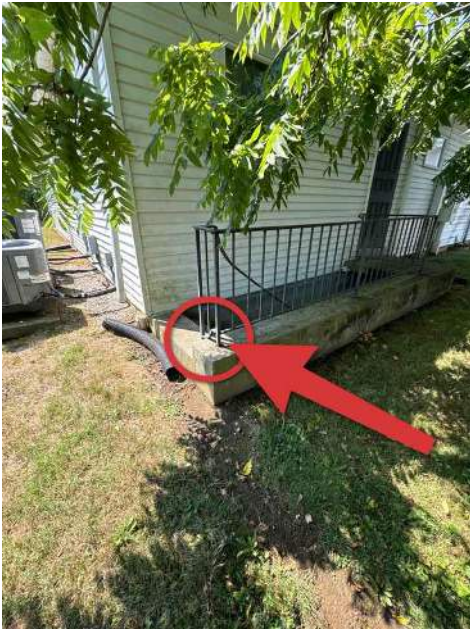
#### **RUSTING METAL RAILINGS**

Base of post rusted

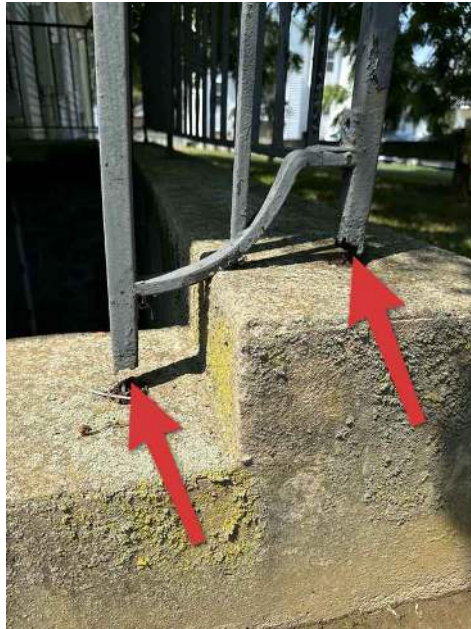
Rusted all the way through

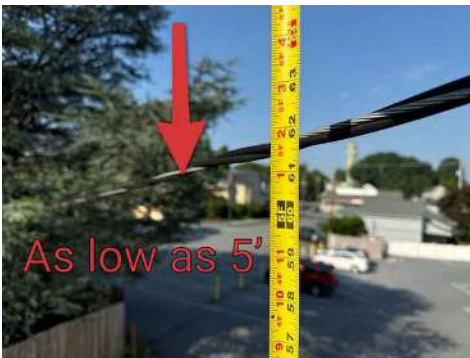
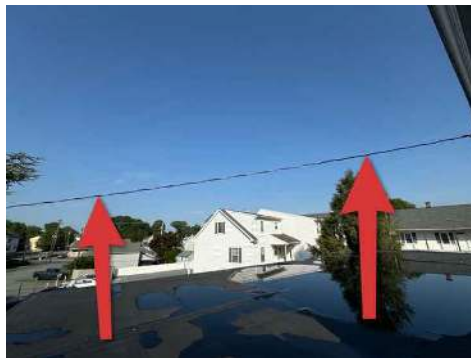
When inspecting the home I observed the electrical supply wire was less than the recommended distance away from human touch. Clearance should be 3' horizontally away from a stair landing, deck or balcony and 10' above a walking service deck or balcony. I recommend a qualified professional to evaluate and safely relocate the service entrance drop.

Power cable too close to roof

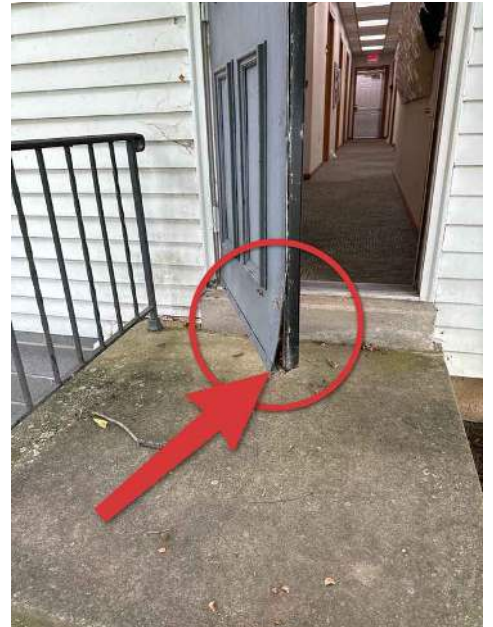
Metal skin detached from door

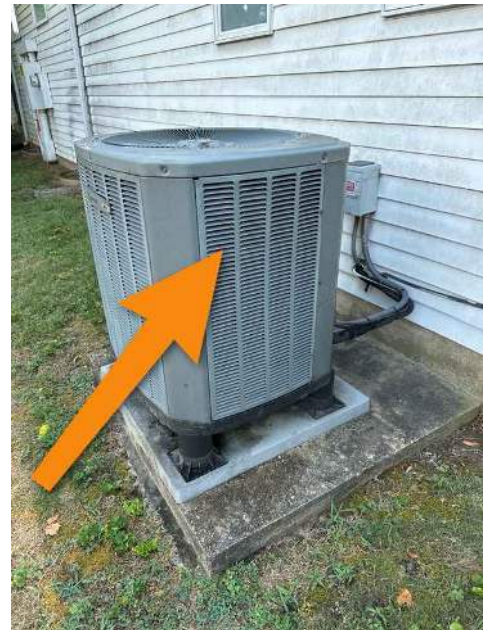
Have a licensed HVAC technician fully evaluate this unit prior to settlement. Discuss the pros/cons of replacement at this time vs. waiting. If replacement is not elected at this time, **consider budgeting for replacement in the future.**

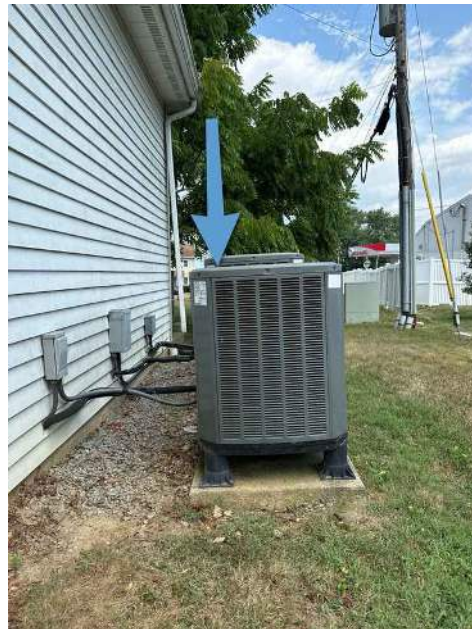
At the time of the inspection, I observed the AC outside unit to be out of level. For a condenser unit to function effectively and to avoid damage it is important that the unit is installed and maintained in a level position. I recommend a qualified professional to level the unit.

Out of level

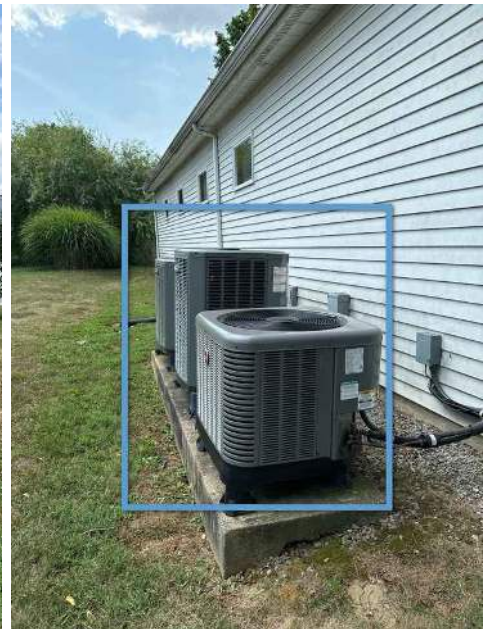
All three units tilted backward

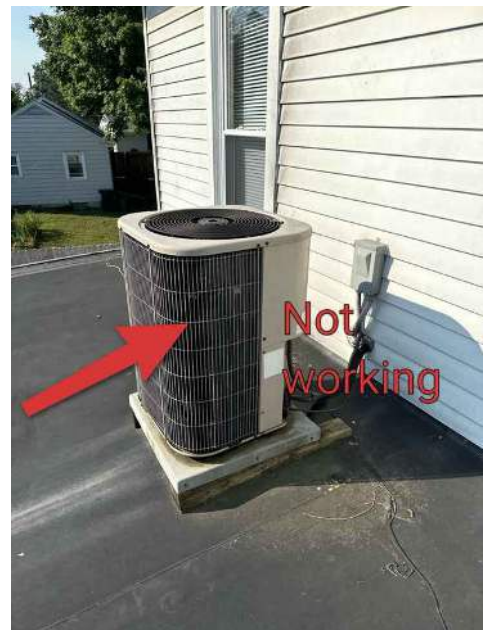
At the time of the inspection, the outside A/C compressor was at **the end of its useful life**. The average replacement life of a unit is 15-20 years depending on the manufacturer. Some units may last longer.

Have a licensed HVAC technician fully evaluate this unit prior to settlement. Discuss the pros/cons of replacement at this time vs. waiting. If replacement is not elected at this time, **consider budgeting for replacement in the future.**

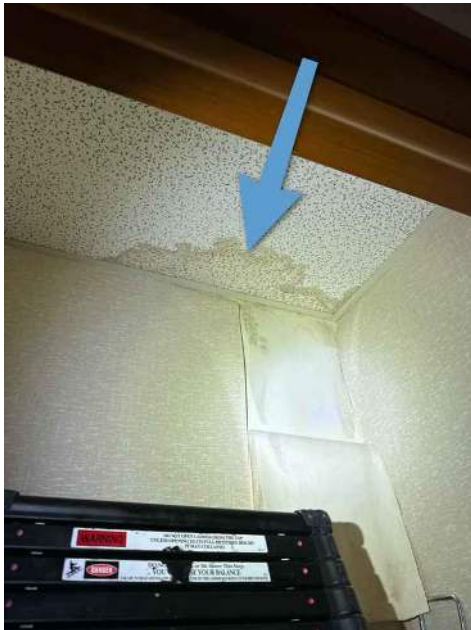
Close up stain close up

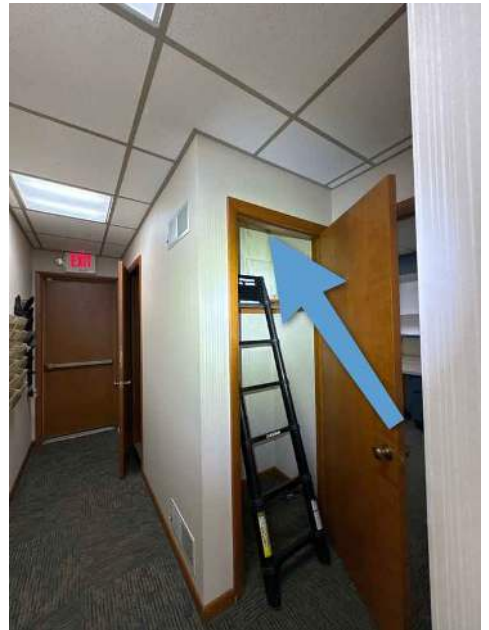
I observed a ceiling stain that appears to be the result of a past leak above. There was no moisture evident at the time of the inspection and the area appeared to be structurally sound.

Dry on Meter

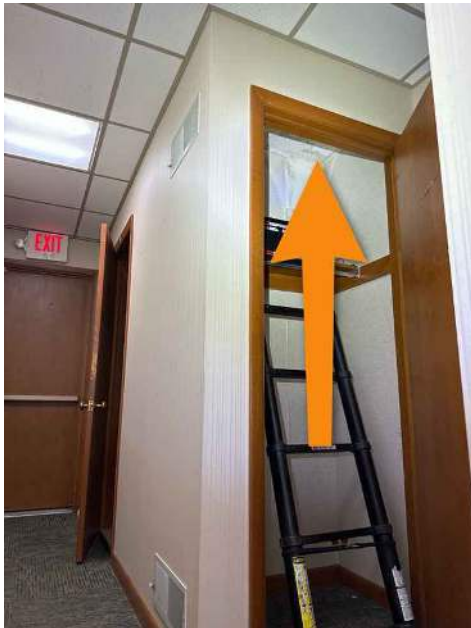
Possible mold spots in closet

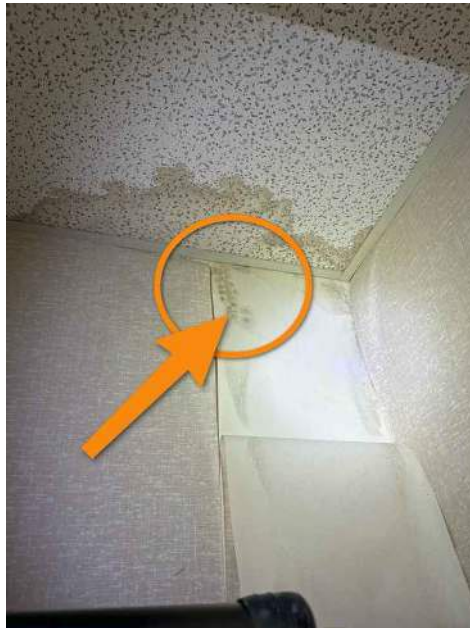
Close up

At the time of the inspection, I observed a mold like substance. Mold has the potential to cause health problems. Molds produce allergens and irritants. Inhaling or touching mold or mold spores may cause allergic reactions in sensitive individuals. I recommend an evaluation by a qualified professional to evaluate and recommend a treatment plan.

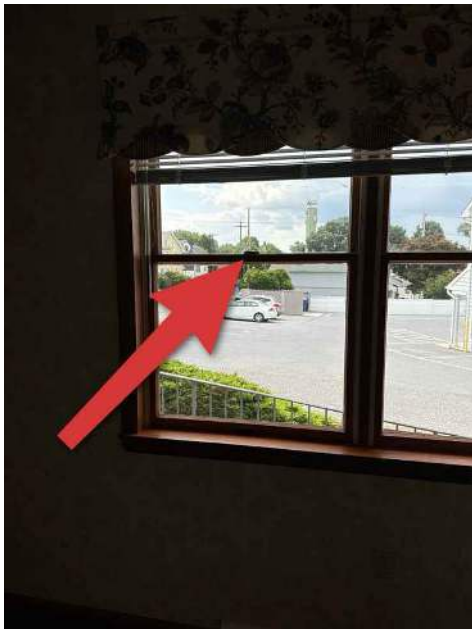
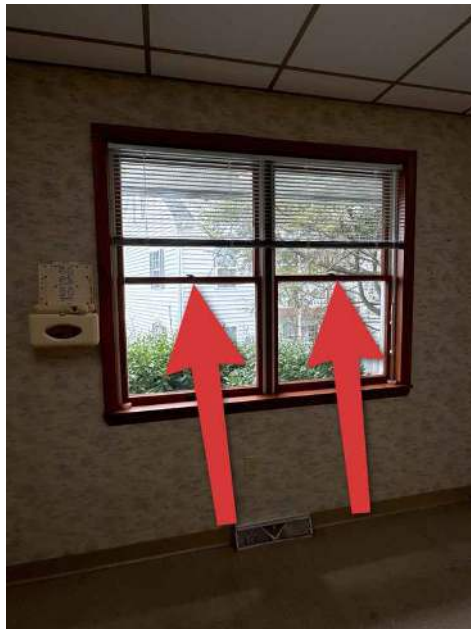
**\*\*Safety Issue\*\*** - At the time of the inspection the sash mechanism was significantly worn or broken on one or more windows. The window(s) opened, but would not stay open correctly. Operable windows should have smoothly operating hardware. I recommend having the window evaluated and repaired or replaced by a qualified professional.

Front waiting room

Exam room 1

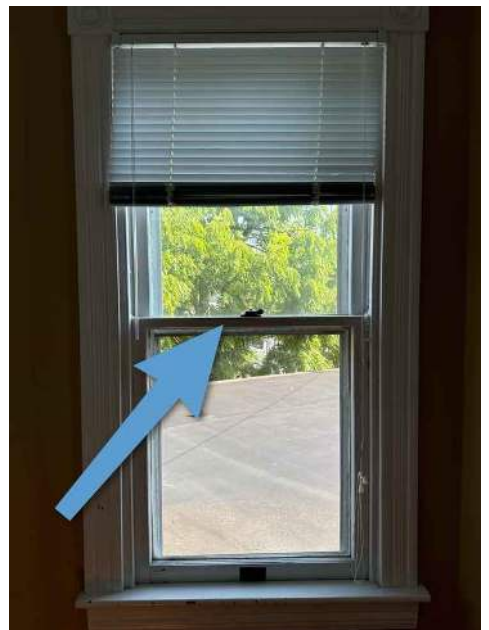
At the time of the inspection, the home had one or more older wooden windows. These windows can last 50 -100 years or more. They may even outlast vinyl windows but they are less efficient and require more maintenance. For example, broken glass, periodic painting, re-glazing and sash chord replacement are necessary. I recommend a qualified professional to evaluate all the wooden windows to assure that they are operational. In addition, ask the professional to offer cost comparisons on replacement vs. repair.

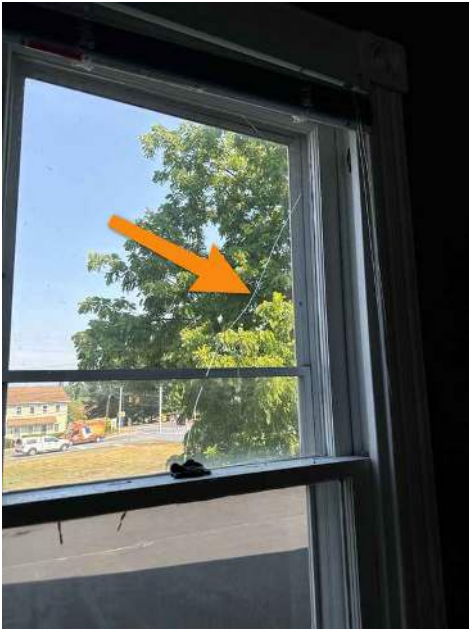
At the time of the inspection I observed a window with cracked glass. I recommend a qualified professional to repair.

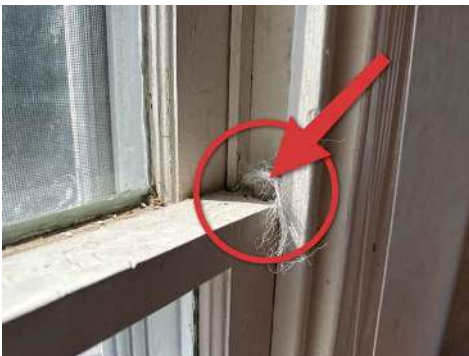
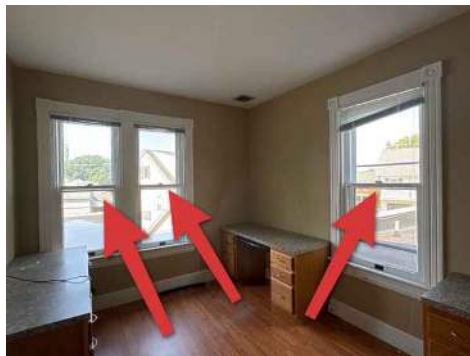
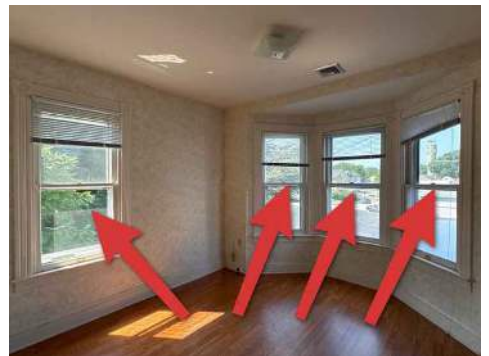
At the time of the inspection both sash cords were broken on one or more windows. Sash cords are necessary for a window to open and close properly. When both cords are missing the heavy sash can crash down causing bodily injury. I recommend a licensed professional to replace the sash cord or install hardware that will repair the sash. See link below.

Example sash cord broken

2nd Floor Office

2nd Floor Front room

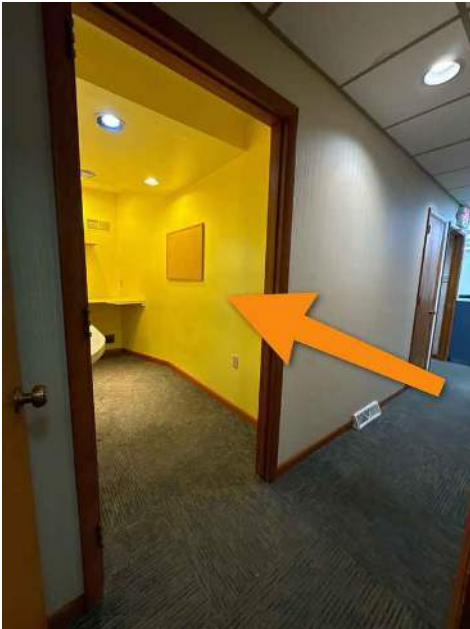
At the time of the inspection there was one (or more) interior door that was missing. I recommend a qualified professional to install a new door in this location.

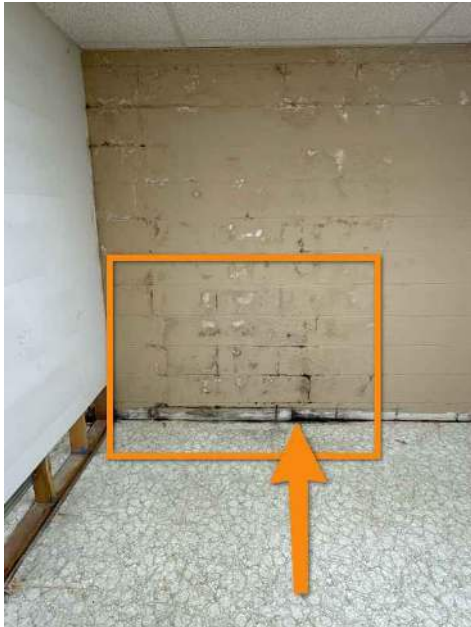
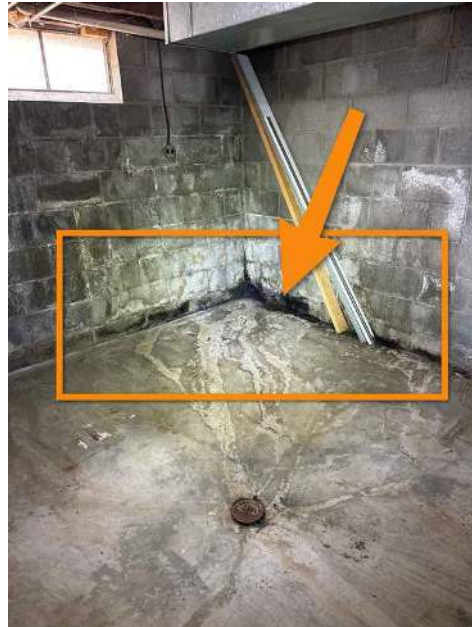
I observed a mold like substance. See photos. Mold has the potential to cause health problems. Molds produce allergens and irritants. Inhaling or touching mold or mold spores may cause allergic reactions in sensitive individuals. I recommend an evaluation by a qualified professional to evaluate and recommend a treatment plan.

Rear Basement

Right Side Basement

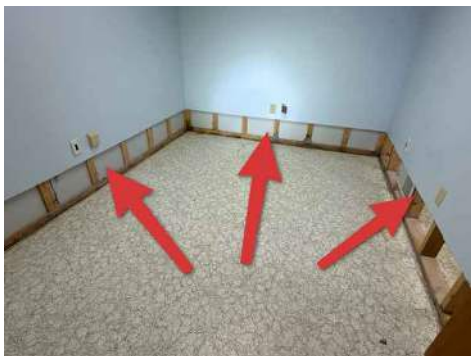
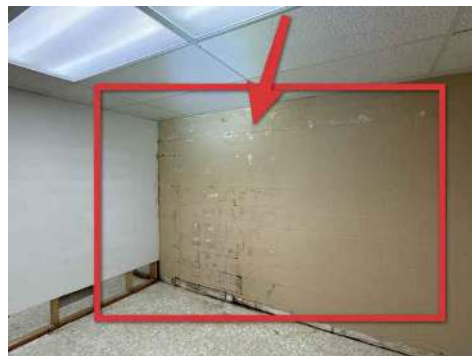
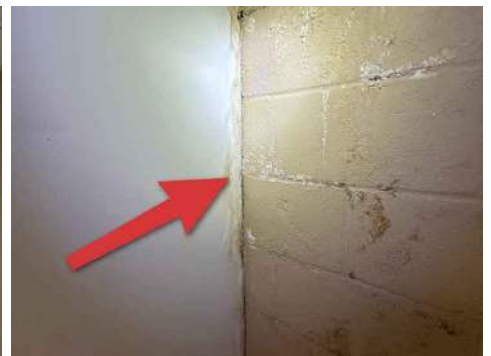
I observed signs of water damage in portions of the basement. It is not entirely clear where the water came from or if it will continue to be an issue. Contact the seller for information on the damage and a qualified professional to evaluate and repair these areas.

Base of finished walls removed

Moisture stains on rear basement wall

Close up of moisture stains on block and drywall

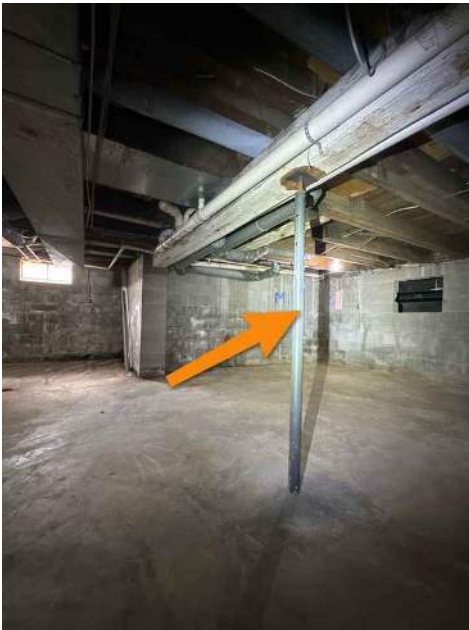
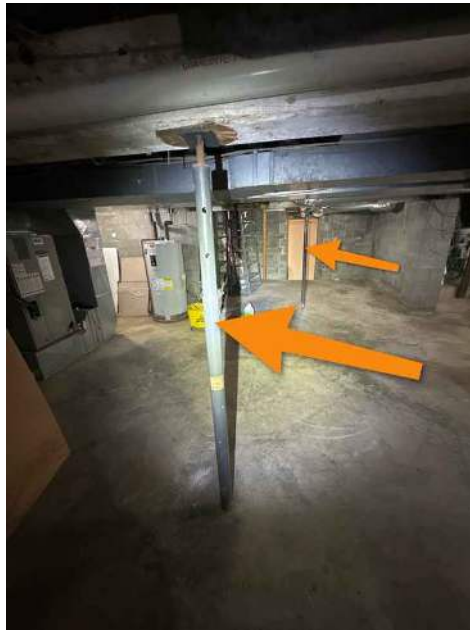
At the time of the inspection, I found one or more split-jack posts that were being used to support the main structural components of the home. These support posts were not approved for permanent use in supporting main beams in structures. When used, they represent a temporary support system. I recommend a qualified professional to evaluate and replace.

Appear to be load bearing

Split jacks supporting beams

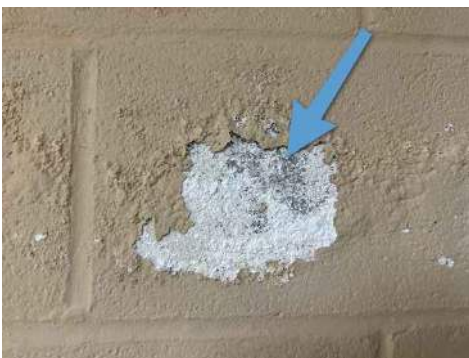
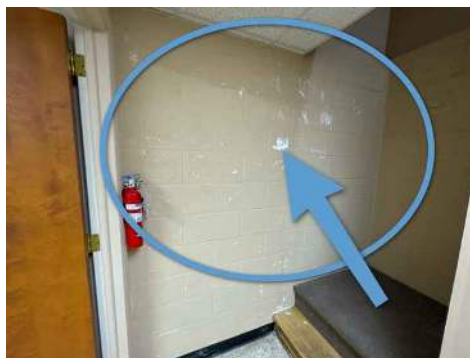
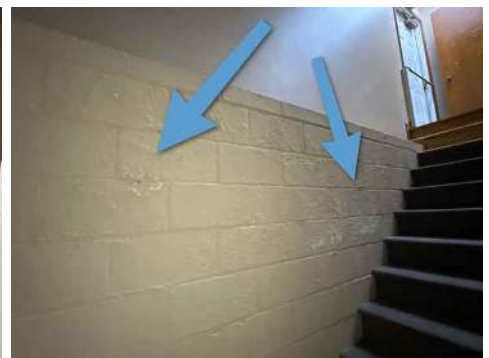
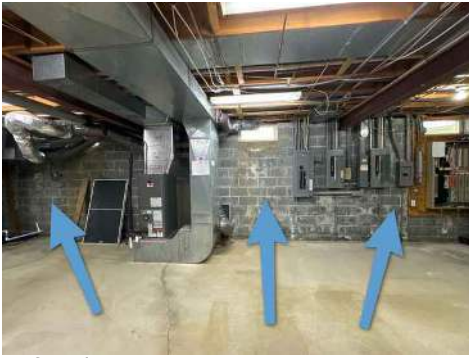
At the time of the inspection, I observed the presence of efflorescence on the foundation walls. Efflorescence is the term most commonly used to describe the deposit of crusty white mineral salts that appear on a masonry surface (concrete, render, brick or mortar) that have leached out from within the substrate when moisture migrates through it.

It is important to distinguish between "moisture" penetration and "water" penetration. Efflorescence result from moisture transfer. This problem should be evaluated by a professional because there are multiple reasons why it occurs.

Close up

Rear Right Side Basement

Basement Stairs

Left Side Basement

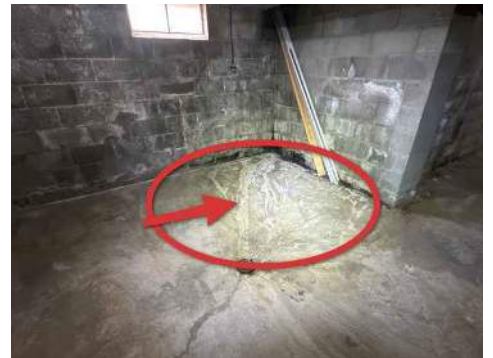
Moisture appeared to be entering the foundation. See photos. Most moisture problems originate on the exterior. If the source is not identified, this moisture can cause significant damage. I recommend the exterior be evaluated in order to determine where the water is coming from and so repairs can be made to stop future water penetration.

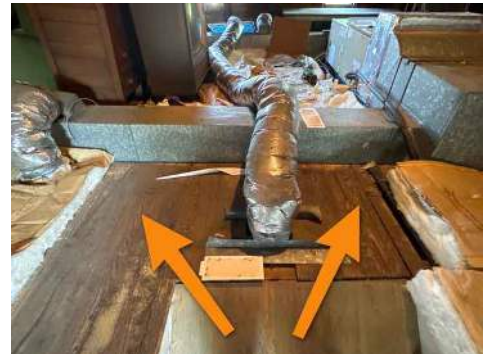
Part or all of the attic, basement and or crawlspace ceilings and walls were covered at the time of the inspection and inaccessible. I was unable to inspect the insulation in that location. The insulation may be minimal or absent completely. Hidden damage may exist. I recommend a qualified professional evaluate the attic space to determine if insulation is present or should be added.

No visibility under floorboards

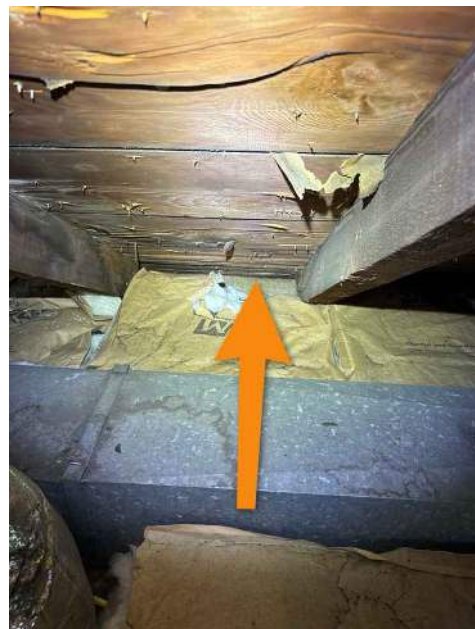
**ATTIC RIDGE AND SOFFIT VENT MISSING**

Does not appear to be any soffit vent

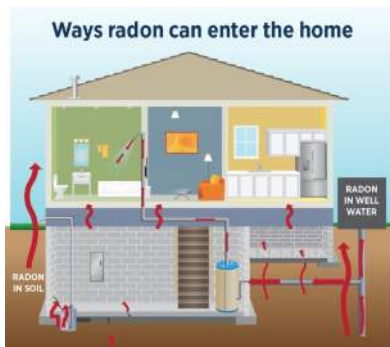
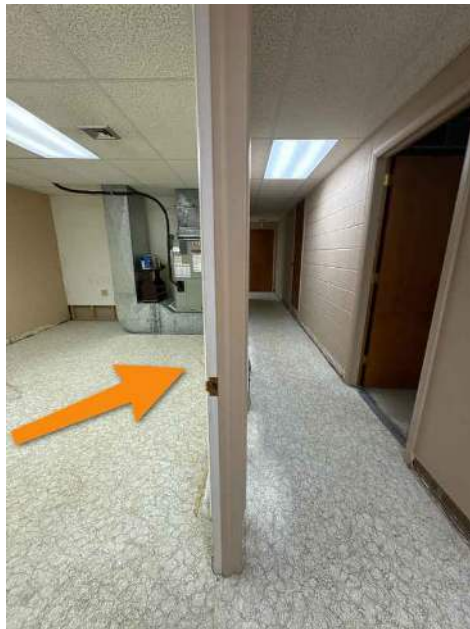
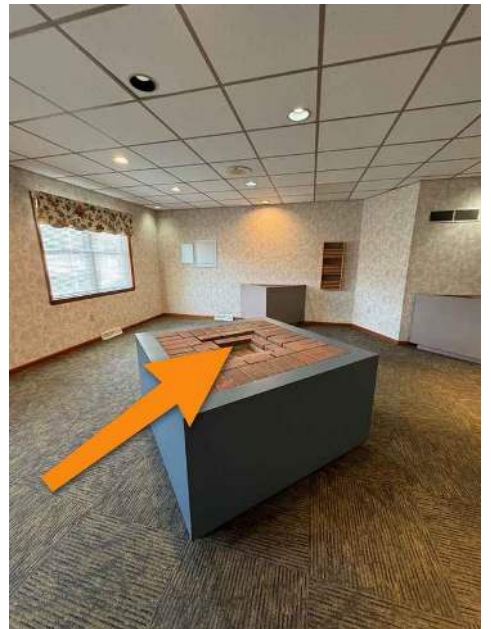
Radon entry points

Basement

Waiting room over crawlspace

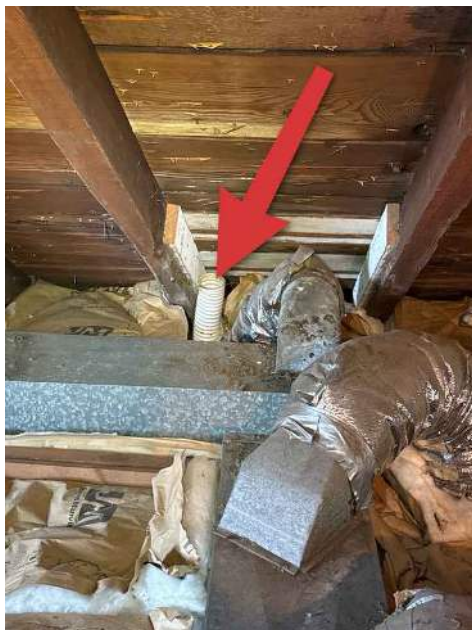
**\*\*Potential Mold issue\*\*** - At the time of the inspection, I found a bathroom exhaust fan venting into the attic. When a bath exhaust vent discharges into a basement, crawlspace, attic, or another building cavity, the potential for moisture-related damage is significant.

In addition, the vent pipe material was vinyl flex which is an inferior product that is subject to cracking and leakage from moisture. I recommend a qualified professional evaluate and re-direct the exhaust venting to the exterior.

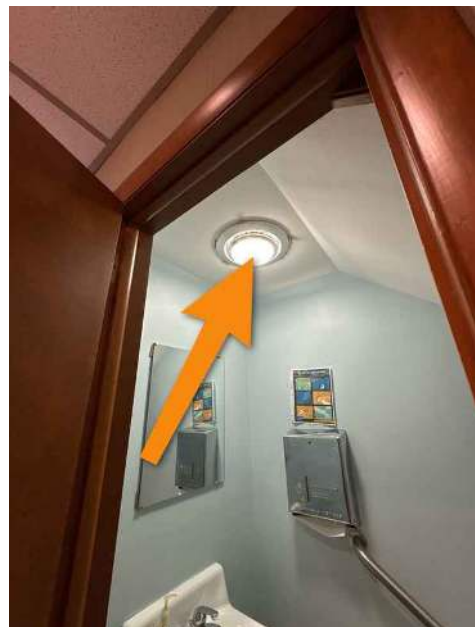
At the time of inspection I observed a fan that was very noisy when operated. The fan may be in need of maintenance or repair. I recommend a qualified professional to evaluate and provide recommendations.

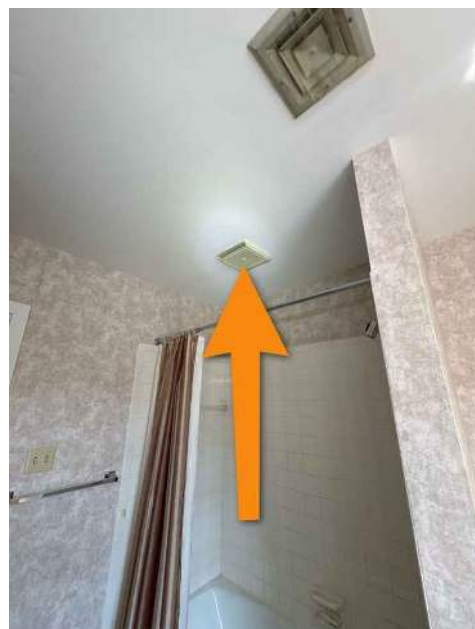
At the time of the inspection the bath exhaust fan was not working. This may indicate that the motor has reached the end of its serviceable life or that there is an electrical problem. I recommend a professional evaluate and repair or replace.

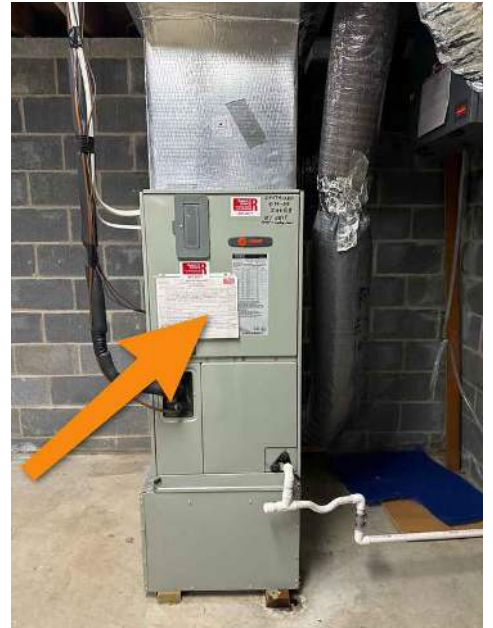
At the time of the inspection, the heat pump was operating but was nearing the end of its useful life. Most heat pumps have an average life of 15-20 years. I recommend the unit be serviced prior to settlement in order to determine more accurately its serviceable life.

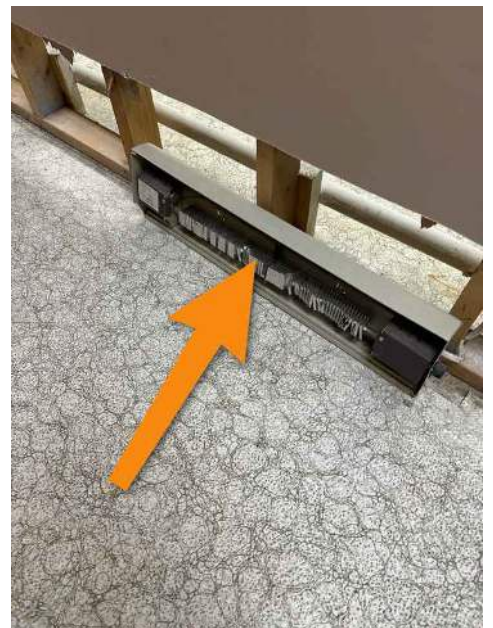
The electric baseboard metal covers were loose, damaged, dented or missing. I recommend replacement by a qualified contractor.

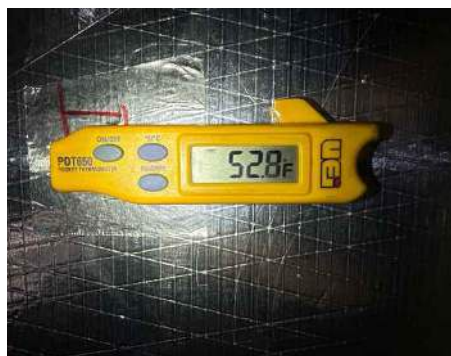
Supply temp refers to the temperature of the conditioned air after it has passed through the cooling coil of the AC unit on it's way to cooling the home.

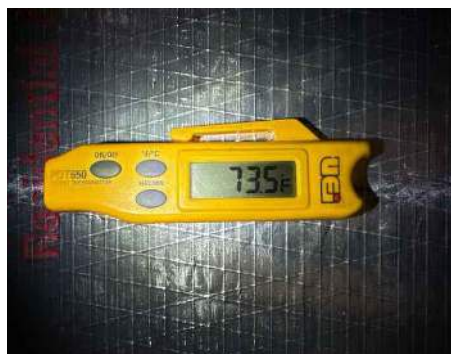
Return temp refers to the temperature of the warmer air as it returns to the AC unit to be cooled again.

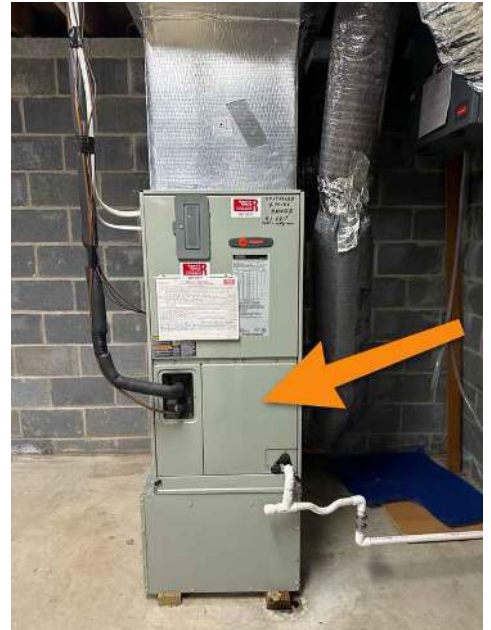
### 8.1.1 Cooling Equipment

The interior air conditioning condenser appears to be nearing the end of its useful life. Most air conditioning systems have an average life of 15-20 years. Geothermal 20-25 years. I recommend having the unit evaluated by an HVAC professional prior to settlement. If recommended by the HVAC professional, begin to budget for replacement.

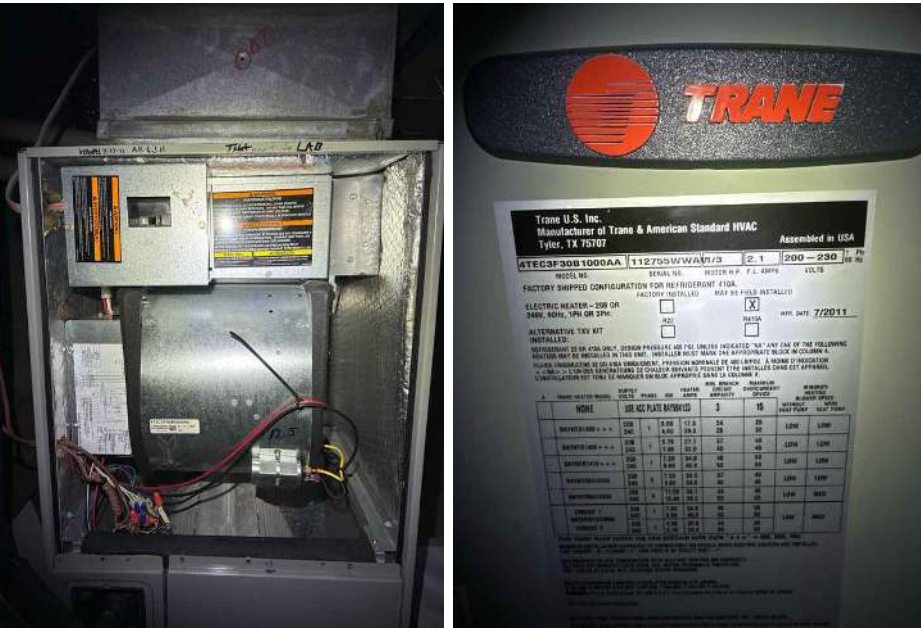
Heating Equipment: Age  
2011

Furnace age

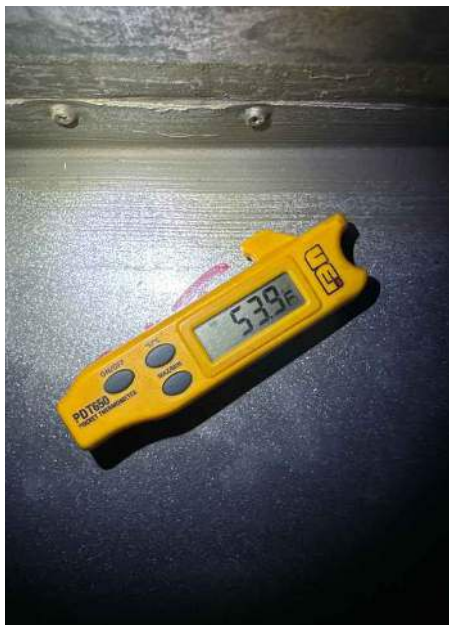
Supply temp refers to the temperature of the conditioned air after it has passed through the cooling coil of the AC unit on it's way to cooling the home.

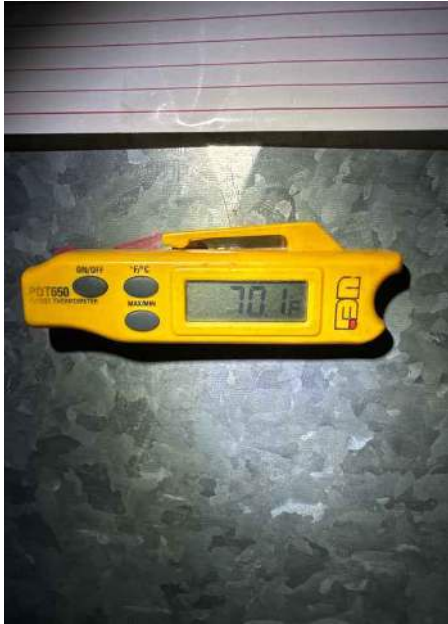
Return temp refers to the temperature of the warmer air as it returns to the AC unit to be cooled again.

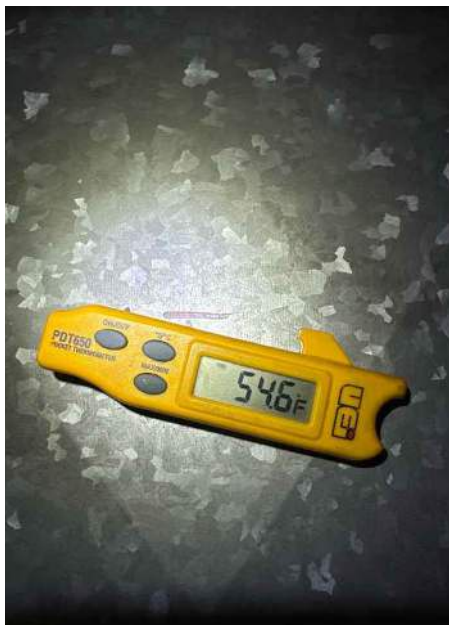
Supply temp refers to the temperature of the conditioned air after it has passed through the cooling coil of the AC unit on it's way to cooling the home.

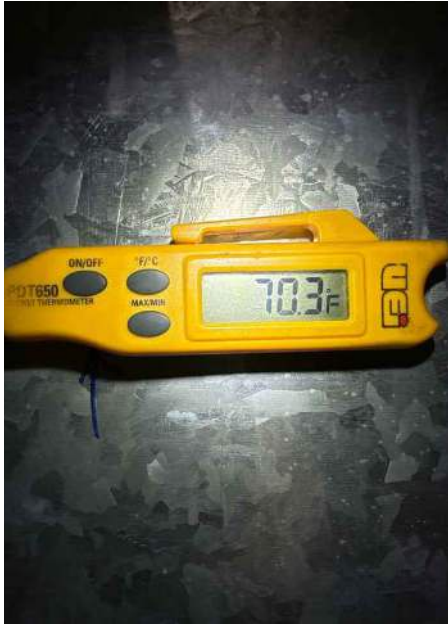
Return temp refers to the temperature of the warmer air as it returns to the AC unit to be cooled again.

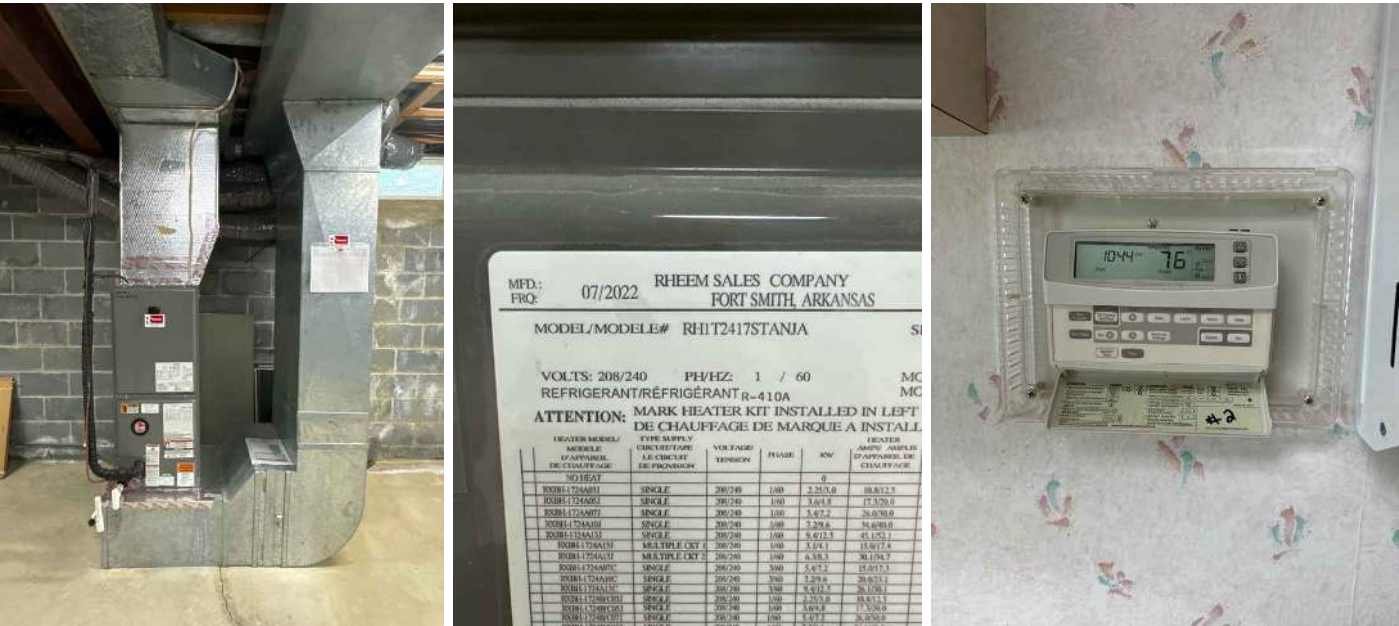
Thermostat in exam room 4

2022

Air conditioning systems require proper and regular maintenance in order to work efficiently. With proper care most components will last 15 to 20 years. If the unit is approaching the later end of its life, I recommend budgeting for a new unit.

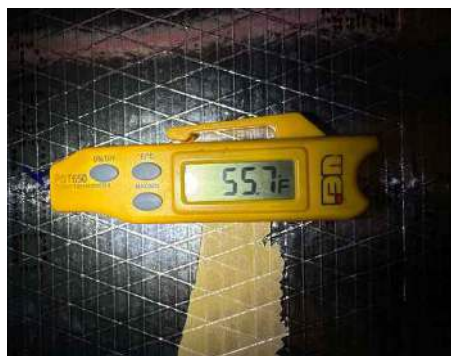
Supply temp refers to the temperature of the conditioned air after it has passed through the cooling coil of the AC unit on it's way to cooling the home.

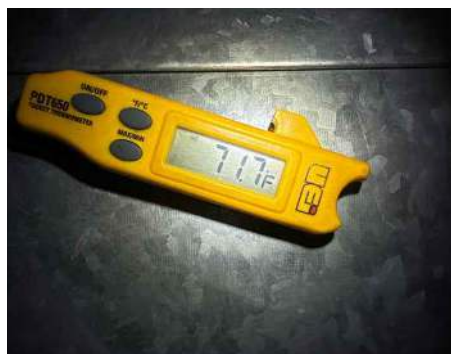
Return temp refers to the temperature of the warmer air as it returns to the AC unit to be cooled again.

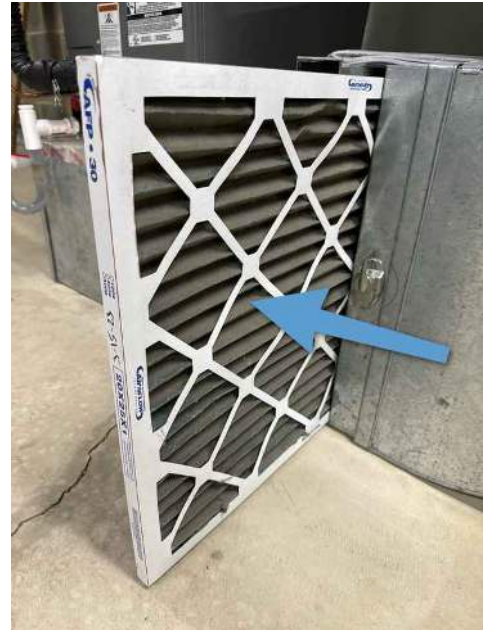
### 14.2.1 Distribution System

At the time of the inspection the HVAC air filter was dirty. This condition will restrict air flow through the air handler causing potential damage to the unit. I recommend installing a new filter. Filters should be changed or cleaned monthly during the cooling season.
