## INSPECTION REPORT

16a Manor Ave  
Millersville, PA 17551

Renee Weaver  
07/17/2024

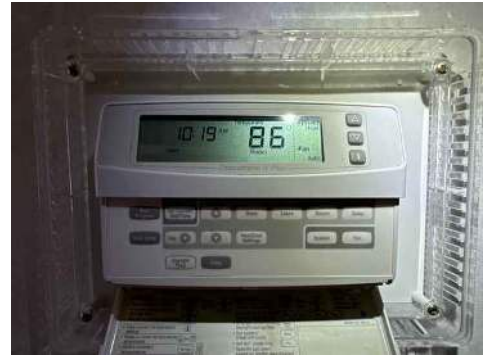
## 2ND FLOOR THERMOSTAT

I was not able to inspect the heat pump equipment due to high temperatures. I did inspect the AC unit and its distribution flow. Therefore the ducting systems are functioning. I recommend a qualified HVAC contractor examine the heating portion of the HVAC system prior to settlement.

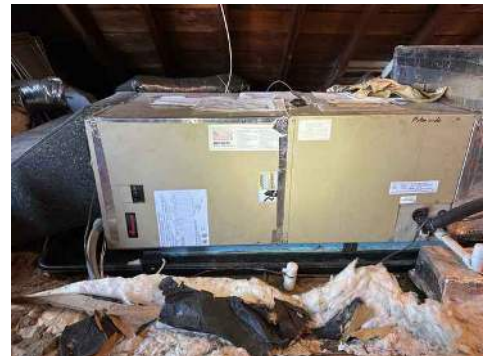
**DISTRIBUTION SYSTEM NOT INSPECTED**

At the time of the inspection, the heat distribution system could not be checked because the system was not operational. I recommend a qualified professional to evaluate prior to settlement in order to confirm that there are no leaks.

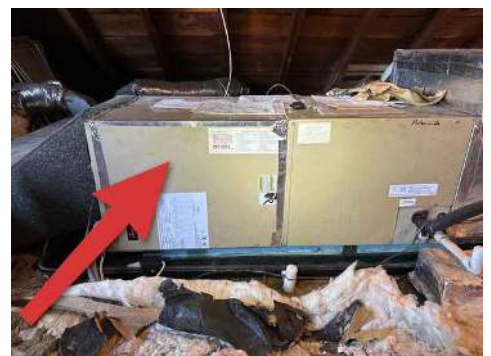
## 15.1.1 Heat System

At the time of the inspection, the heat pump was nearing the end of its useful life. Most heat pumps have an average life of 15-20 years. I recommend the unit be serviced prior to settlement in order to determine more accurately its serviceable life.

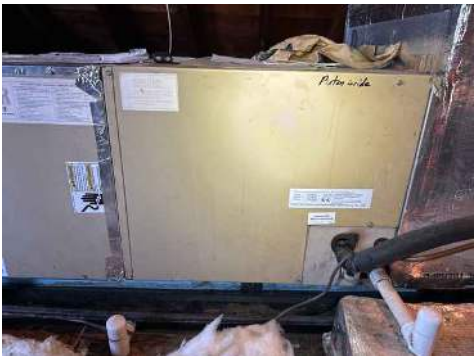
ATTIC

At the time of the inspection the air conditioning system was not working. A good faith effort was made to operate the system. The thermostat, breakers, disconnects, fuses and switches were all checked. As a result I recommend a qualified professional be consulted to inspect the system in order to determine the problem prior to settlement.

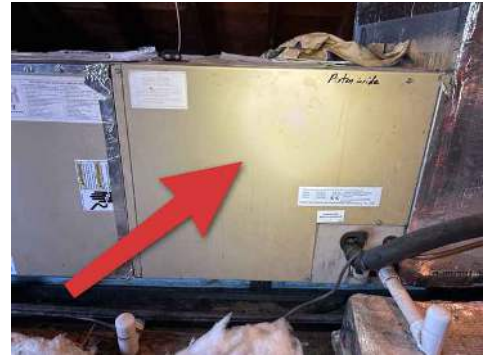
At the time of the inspection the AC condenser (indoor unit) did not appear to respond to normal thermostat controls. The electric breaker and the disconnect both appeared to be on. The unit did not respond to the blower (fan) controls or cooling controls. I recommend a qualified professional to evaluate to determine whether the unit itself is defective or the electronic control system is malfunctioning.

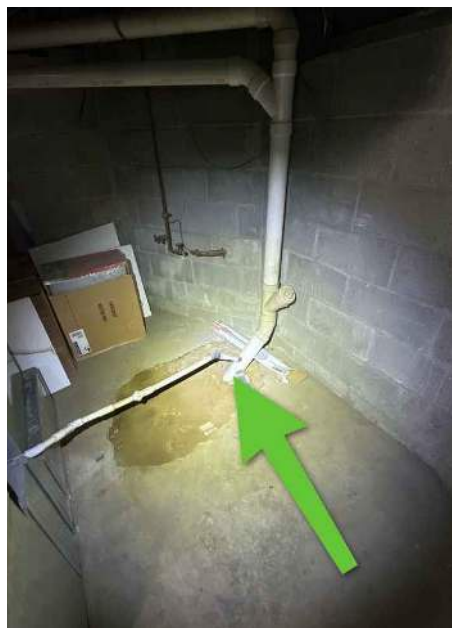
Middle Basement

**I highly recommend a video inspection of the main sewer line (from the house to the street) be done by a qualified professional, using professional equipment, prior to settlement.**

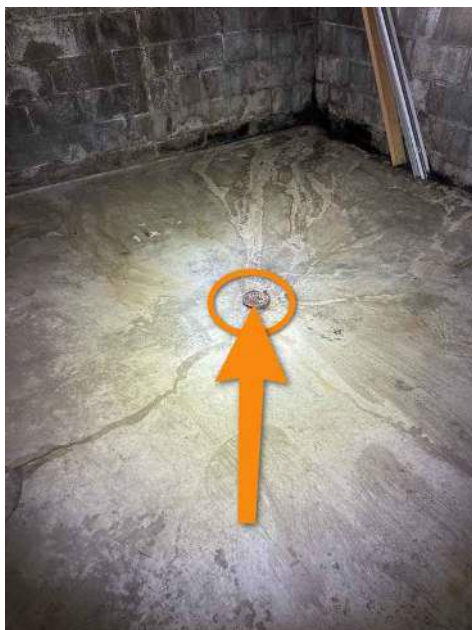
At the time of the inspection, I observed a floor drain in the concrete floor. I could not determine where the wastewater was draining to. Because of this, there may be hidden problems. At the time there did not appear to be any defects. I recommend a qualified professional to evaluate.

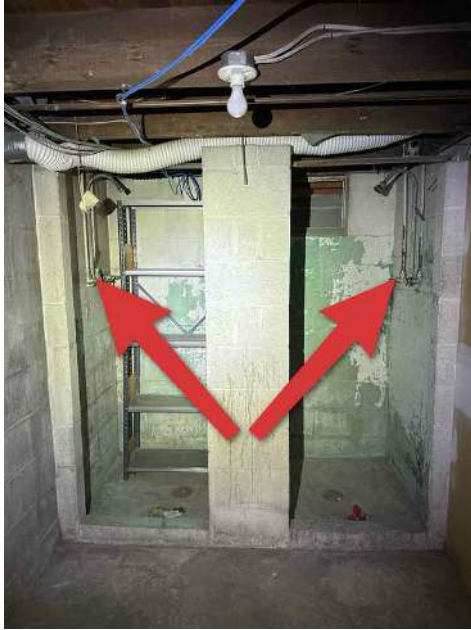
Showers disconnected

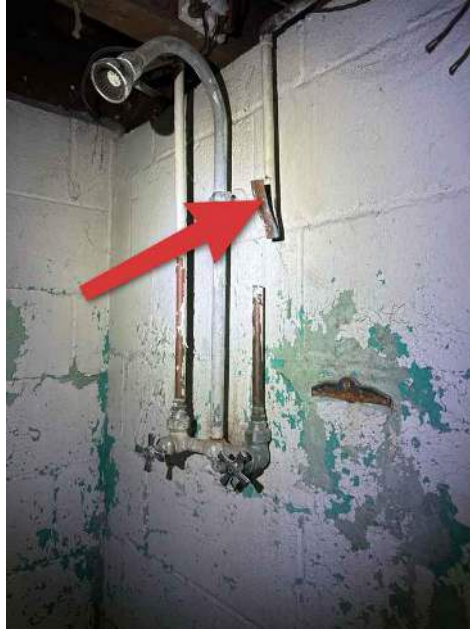
Waterlines cut and crimped

At the time of the inspection, I observed abandoned or disabled plumbing fixtures. The piping and fixtures present were not functioning and appeared to be in disuse. I recommend a qualified professional to remove these fixtures and terminate the plumbing properly.

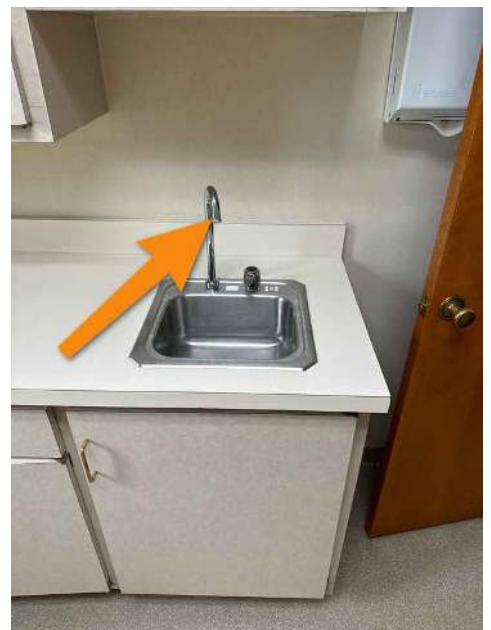
Exam room Representative Locations

\*\*\*Safety Hazard\*\*\* At the time of the inspection the hot and cold lines were reversed. This presents a potential scald hazard. I recommend a qualified professional to switch the lines to correct the defect.

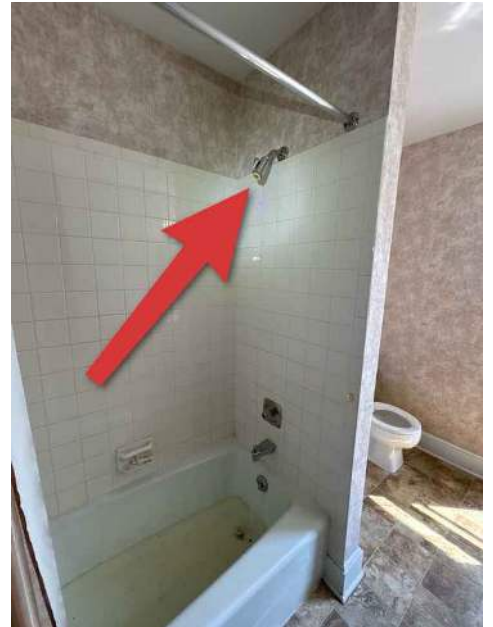
No water to showerhead

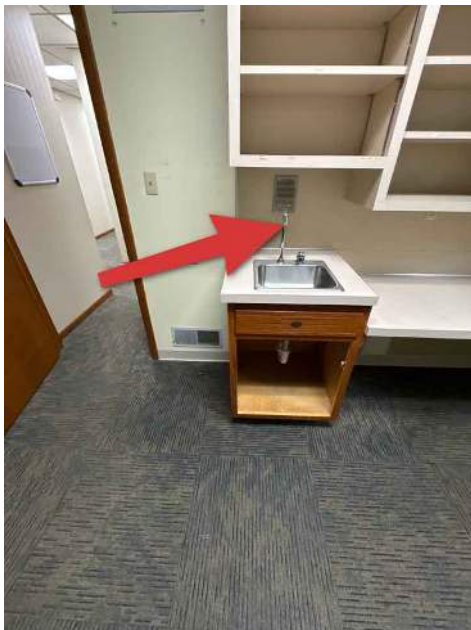
Rear Left Side room

At the time of the inspection it appeared that the plumbing fixture pictured here was not operating. I attempted to operate it using normal turns. A qualified professional should evaluate and repair.

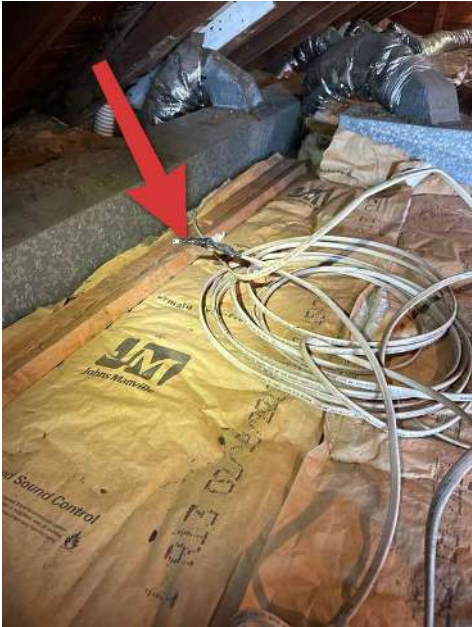
Attic

EXPOSED ENDS AND SPLICES

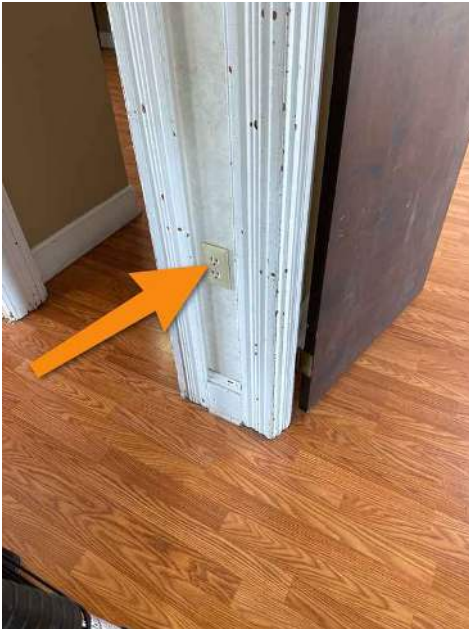
2nd Floor Hall

**\*\*Safety issues\*\*** - At the time of the inspection, I observed a receptacle that was loose in its box. This presents a shock hazard to the user. I recommend a qualified professional to repair.

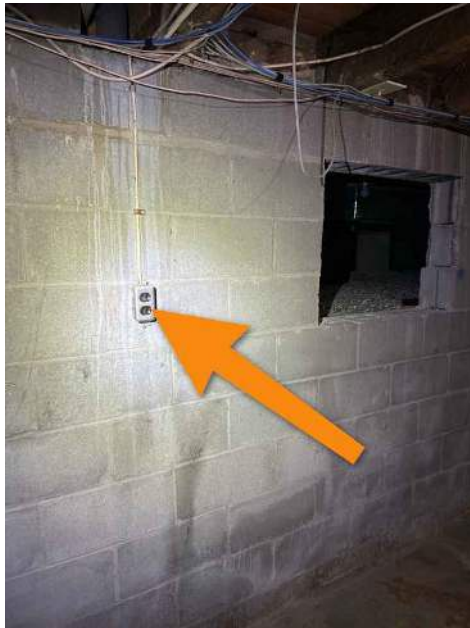
2-slot receptacles (outlets) were installed in one or more areas. This is considered old wiring and does not have an equipment ground and is considered unsafe by today's standards. Appliances that require a ground should not be used with 2-slot receptacles. Examples of such appliances include computers and related hardware, refrigerators, freezers, portable air conditioners, clothes washers, aquarium pumps, and electrically operated gardening tools. The client should be aware of this limitation when planning use for various rooms, such as an office. Upgrading to grounded receptacles typically requires installing new wiring from the main service panel or sub-panel to the receptacle(s), in addition to replacing the receptacle(s). The NEC (National Electric Code) also allows these outlets to be replaced with GFCI protection as a repair to use grounded appliances with them. Consult with a qualified electrician about upgrading to 3-wire, grounded circuits or installing GFCI protection.

I recommend a professional be consulted who can offer an opinion on the current condition of these outlets and their circuits.

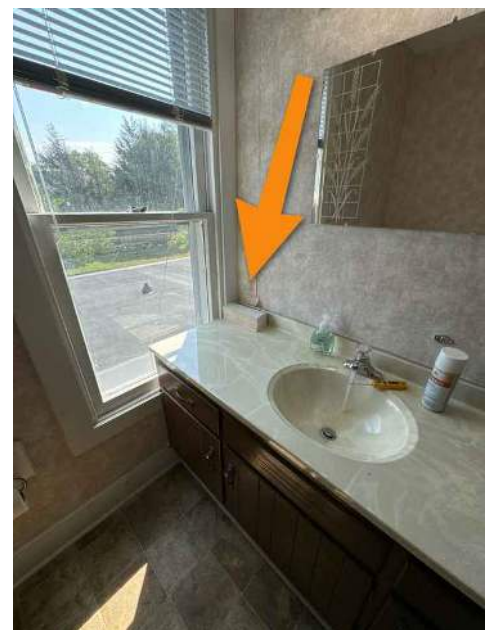
At the time of the inspection, I observed one or more receptacles that were not working. I was unable to trace its power source or the root cause. There are various reasons why receptacles fail or don't work (see typical causes below). I recommend a qualified professional to evaluate and repair.

- Tripped circuit breaker
- Tripped GFCI outlet
- Burned out receptacle
- Faulty or worn out
- Wiring defects
- Switch faulty in a switched receptacle circuit

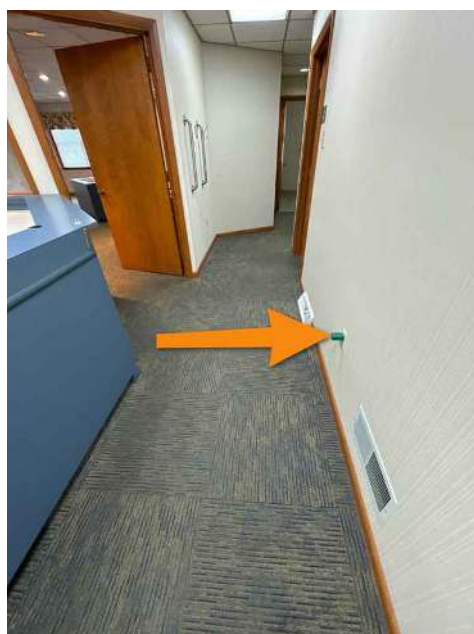
Reversed Polarity

**REVERSE POLARITY (HOT/NEUTRAL)**

If the receptacle has the black wire where the white wire should be, an electric device like a drill could get "energized" or hot. If you touched the drill at the same time you were standing on a wet floor, electricity could go right through you!

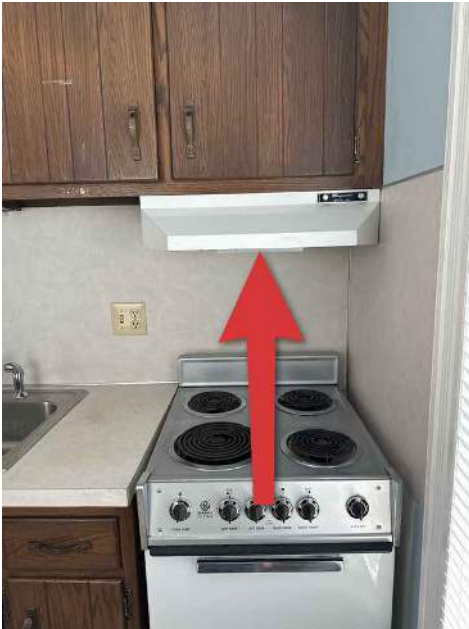
At the time of the inspection I noted the stove exhaust fan was not working. I recommend a qualified professional to repair.

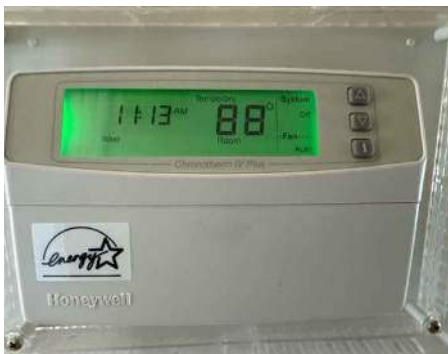
**Reset Thermostat?**  
Yes, See photo
