INSPECTION REPORT

755 Long Ln
Lancaster, PA 17603

Chris Payton
10/04/2024

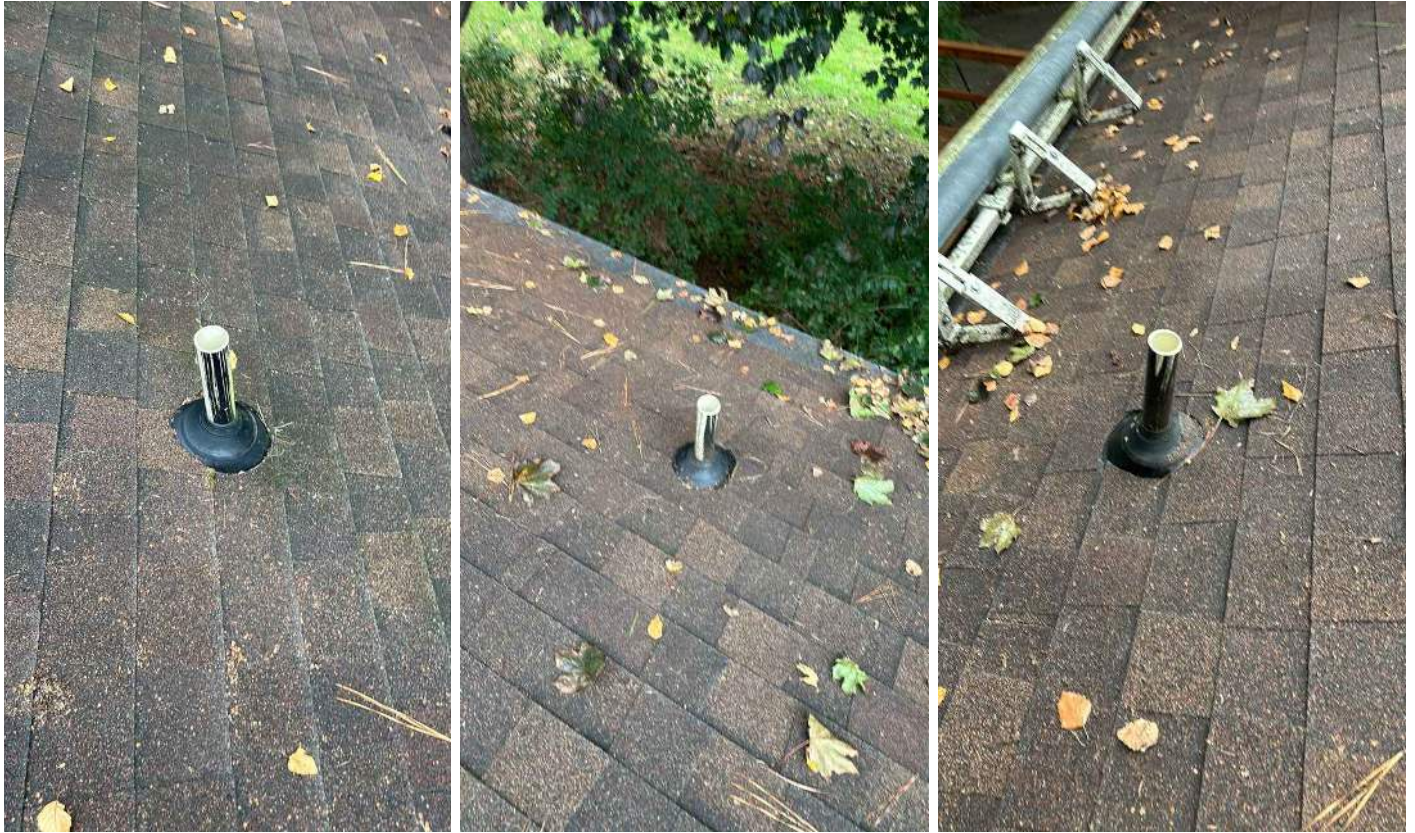
Solar panels, See Imitations, Plumbing vent PVC

Rubber boots systems have a limited life expectancy and can fail without warning. I recommend a qualified professional to evaluate these connections yearly to check for deterioration and to replace before a roof leak develops.

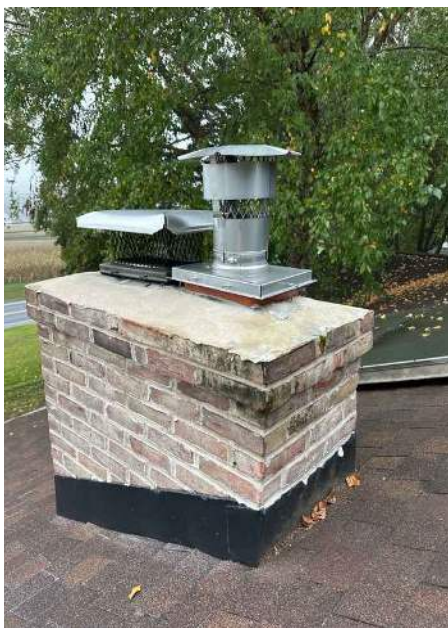
Brick chimney

Masonry products, including stucco and adhered masonry, tend to absorb and hold moisture. This moisture will then dry inwards and can carry that moisture into the interior structure. I recommend periodic examination of the structure on the inside in order to verify that moisture intrusion is not occurring.

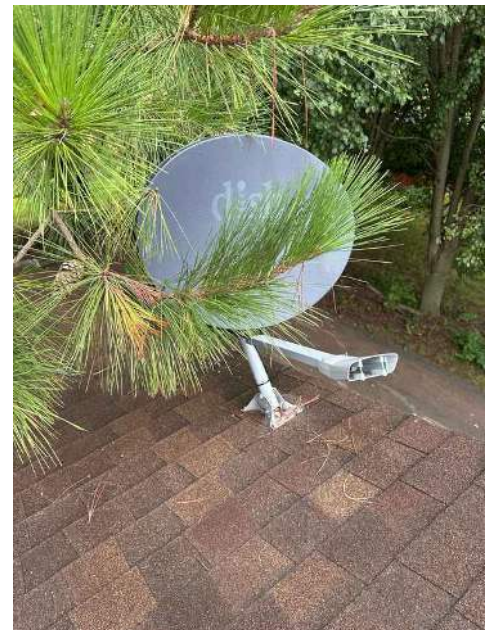
Rear Roof

At the time of inspection a satellite dish was installed on the roof. The inspection of satellite dishes is beyond the scope of an ASHI home inspection. These systems have been known to develop leaks where they are fastened to the roof. A licensed roofer is recommended to evaluate the system.

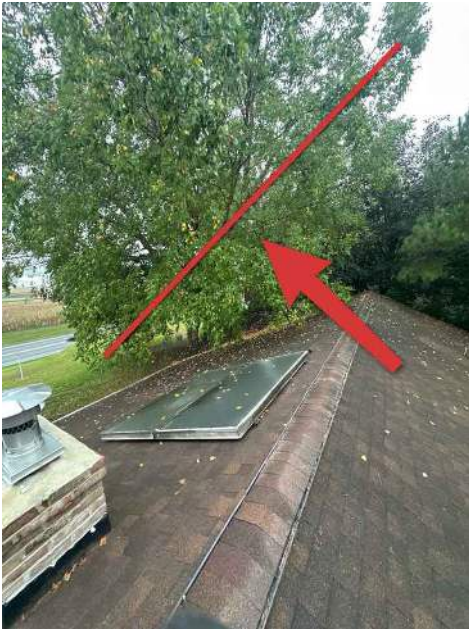
Front

I observed a tree(s) whose branches were overhanging the roof. This condition is not healthy for roof life. Moisture, insects and biological growth are encouraged to remain on and around the roof surface. I recommend this growth be cut back.

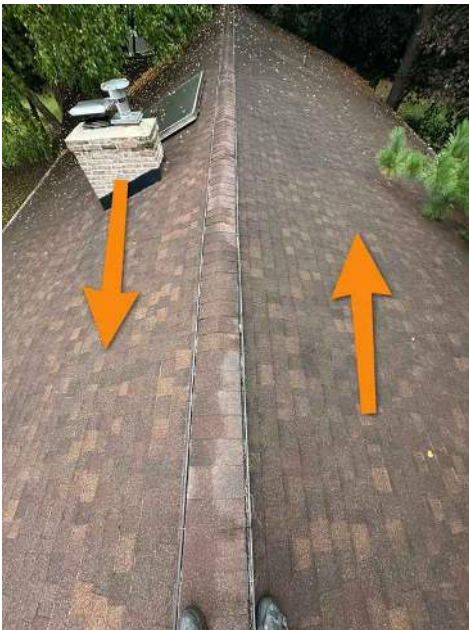
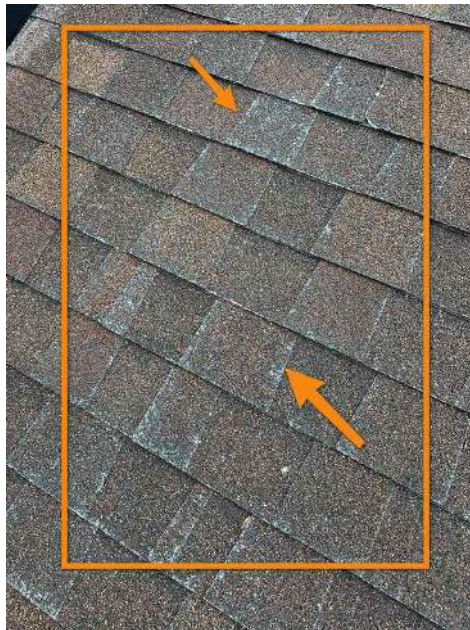
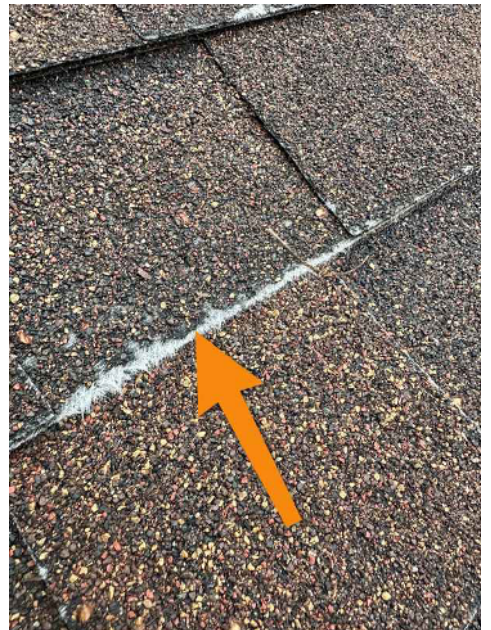
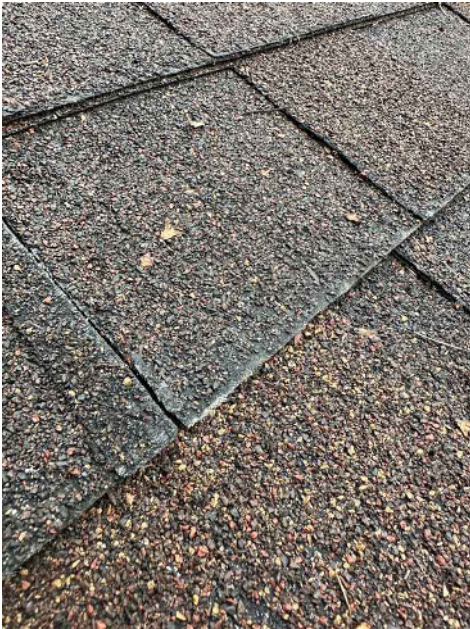
SHINGLE WEAR

At the time of the inspection the shingles showed signs of wear. This may include cupping, splitting, erosion and surface wear. See photo descriptions. The roof was not leaking at the time of inspection, however, it is difficult to project the exact life expectancy. **I recommend a thorough roof evaluation be by a qualified contractor in order to advise on timing for an eventual replacement.**

Shingle wear

Edge wearing thin

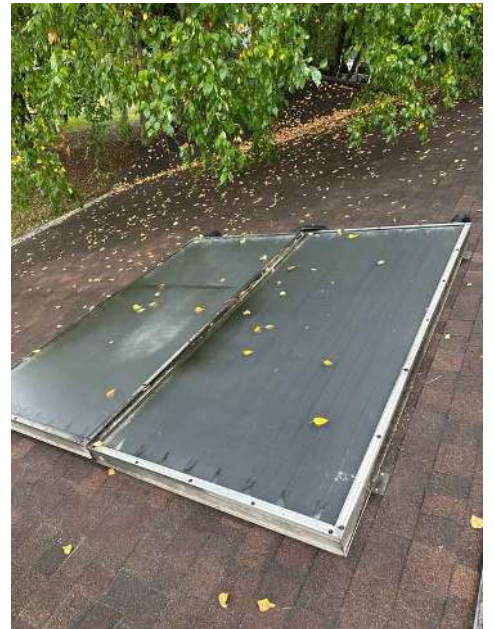
SOLAR ROOF PANELS

I observed a solar panel system with associated panels and disconnects. ASHI standards of practice do not include inspecting these systems, however, I recommend having a qualified specialist evaluate this energy system to confirm that it is functional and to regularly check the roof covering, to identify leaks before they begin.

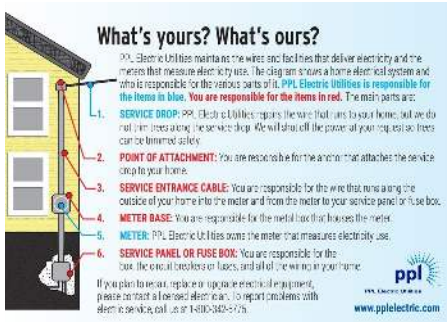
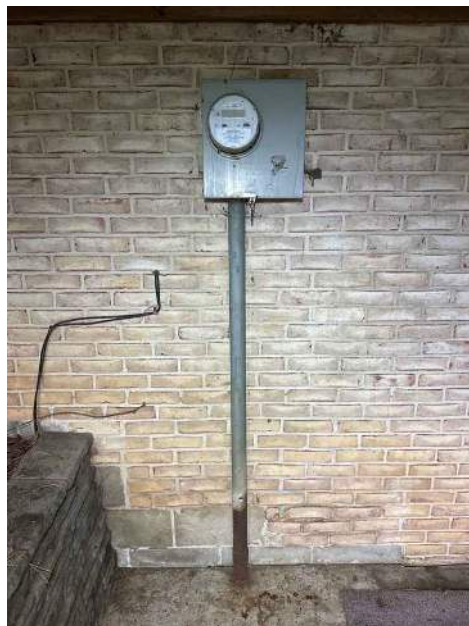
At the time of the inspection the service conductors appeared to be in good condition. Any defects will be listed separately in the report.

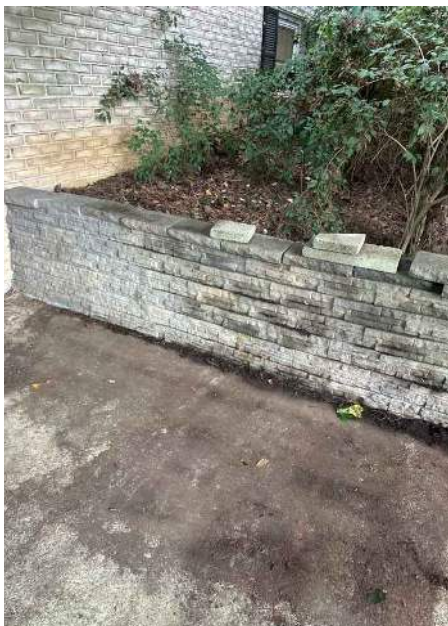
Concrete masonry units

At the time of inspection the retaining wall appeared to be in good condition. Any recommendations will be listed separately in the report.

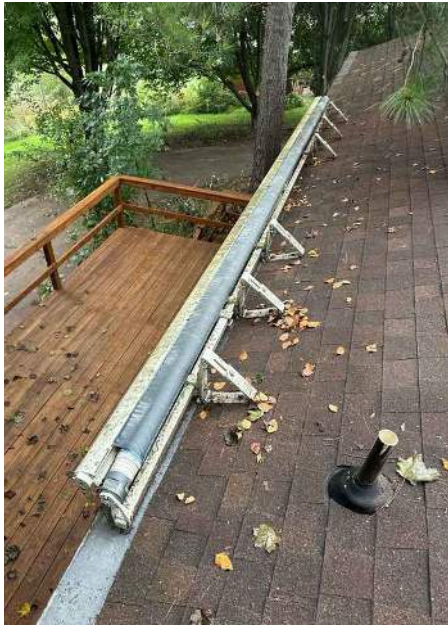
Rear Roof

Other items present: Fabric awning

At the time of the inspection, the property there was a fabric awning present. Inspection of this item falls outside the scope of a home inspection performed by Precise Inspecting. I recommend hiring a qualified awning professional to inspect the unit prior to settlement.

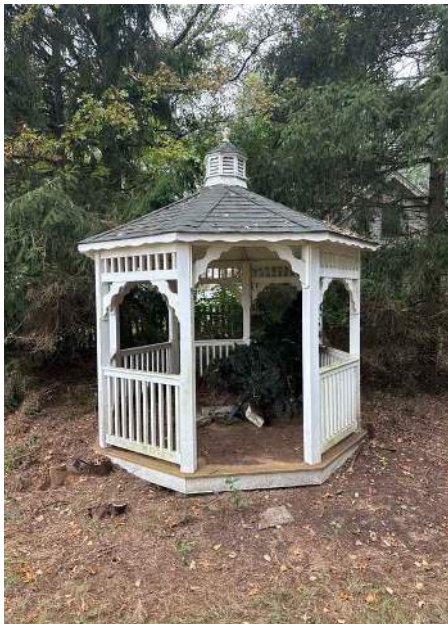
**Other items present: Gazebo**

There was a gazebo present on the property. These structures do not fall within the scope of an ASHI home inspection and was not inspected.

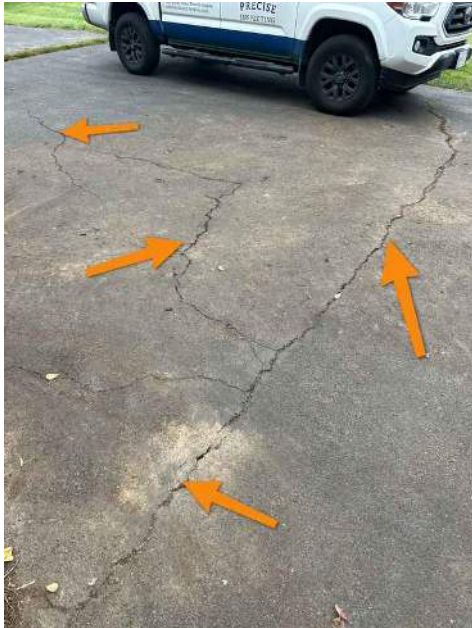
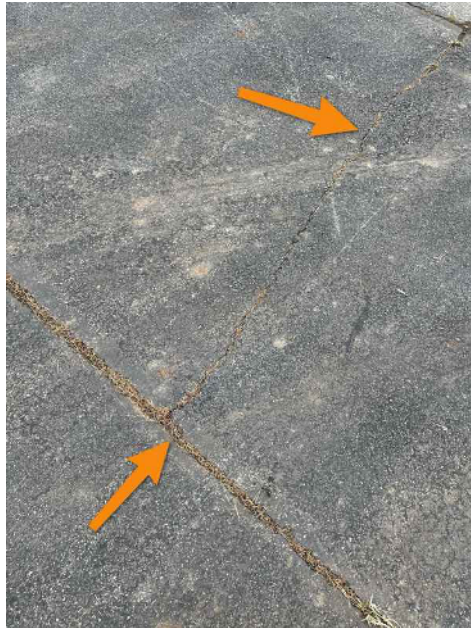
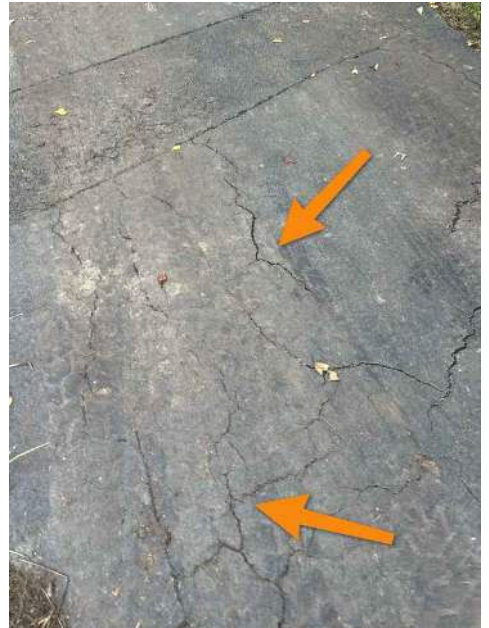
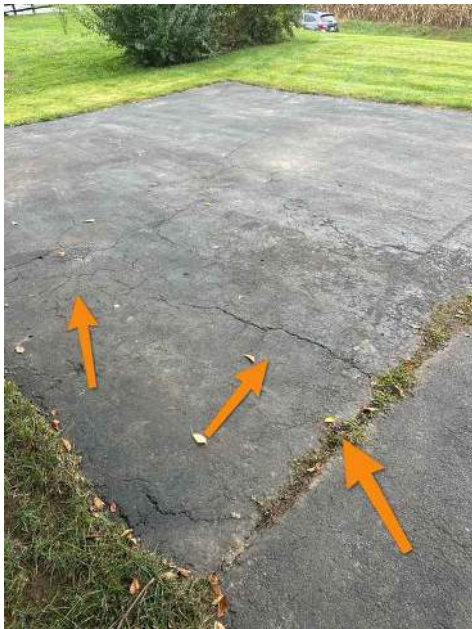
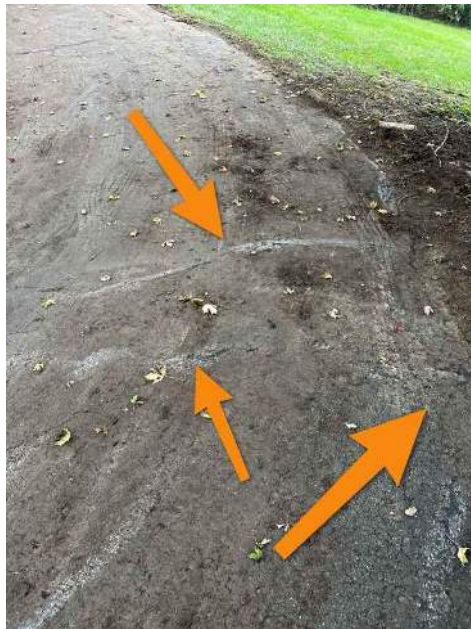
DRIVEWAY - ASPHALT CRACKING - MODERATE

At the time of the inspection the driveway showed signs of moderate cracking. In order to maintain a serviceable surface, the driveway should be free from cracking and maintained with appropriate caulking. Because these photos may be representative of more than one crack, I recommend a qualified professional to evaluate the entire driveway and make recommendations for ongoing maintenance.

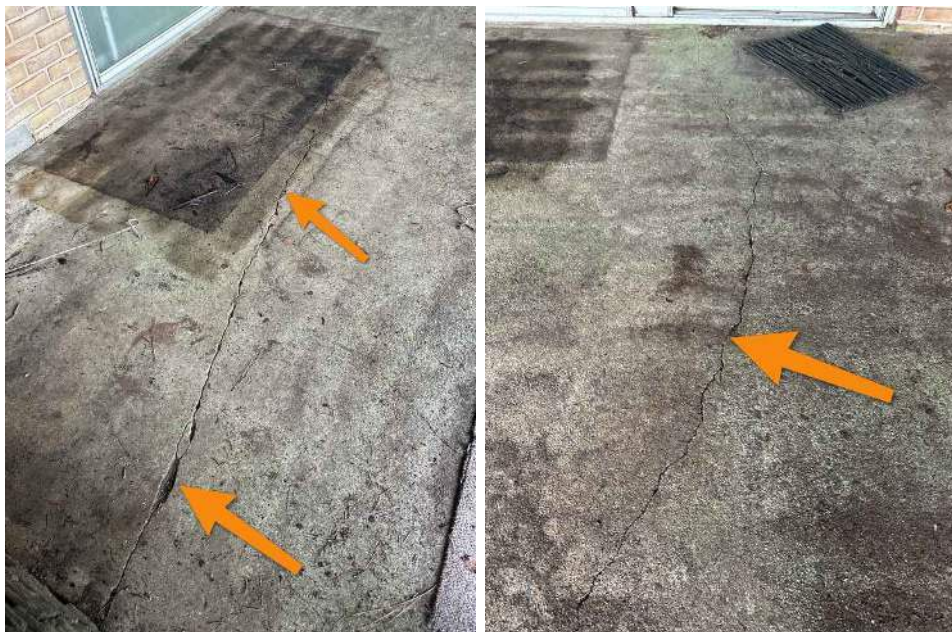
REAR PATIO

CONCRETE CRACKING - MODERATE

At the time of the inspection I observed an area(s) where the concrete surface was cracking. The size of this particular crack is small. There does not appear to be any underlying structural problems, however this area should be evaluated by a professional to determine if the problem will continue to degrade so that repairs can be made.

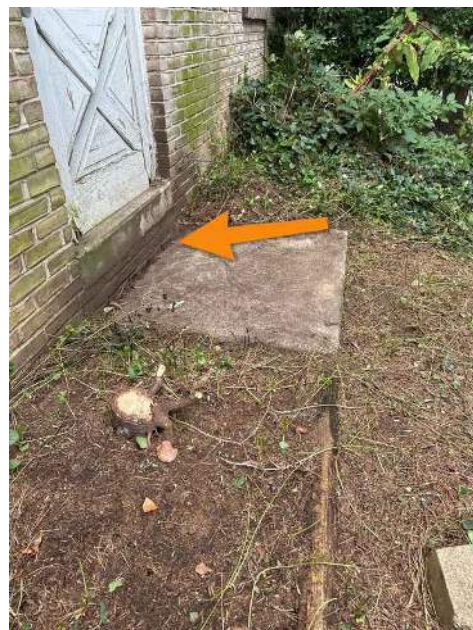
CONCRETE STOOP SETTLING

Settling back towards garage

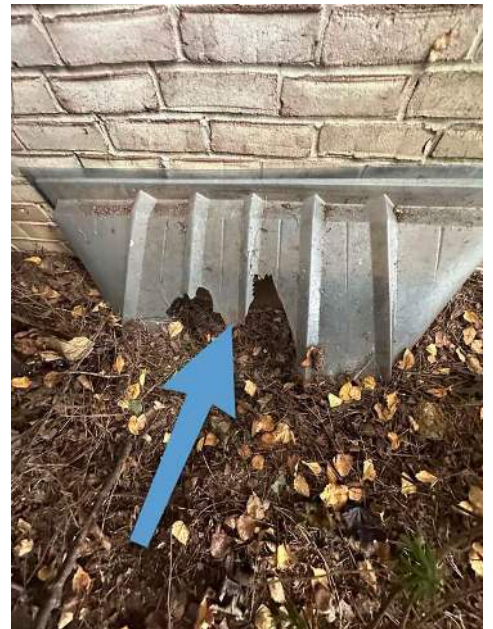
Left Side Representative

At the time of the inspection one or more window wells were full of debris and/or vegetation. This encourages moisture and insects to remain close to the foundation which can lead to potential damage. I recommend cleaning out the window well(s) and installing a cover(s).

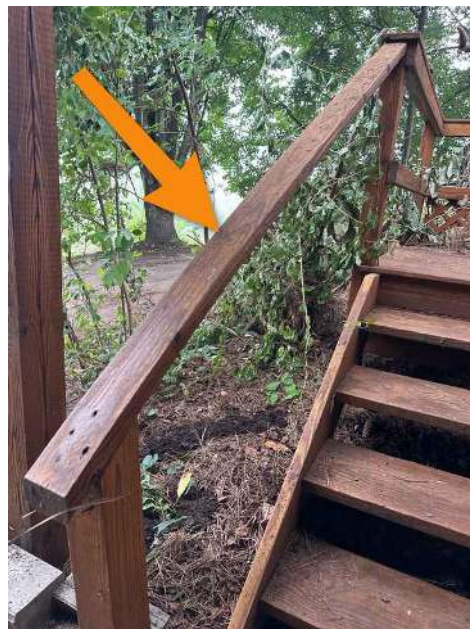
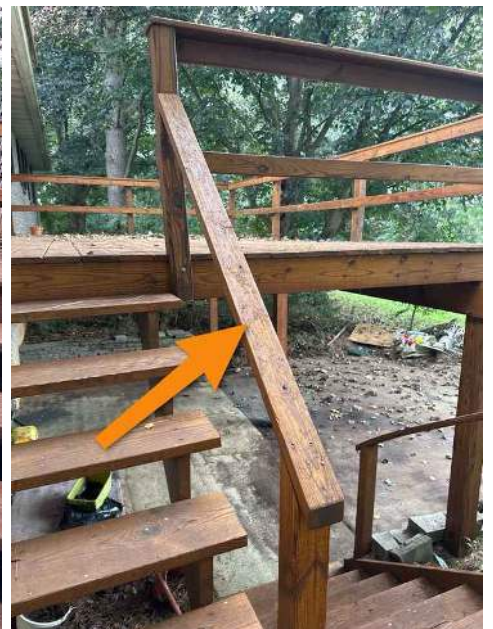
REAR DECK STEPS

At the time of the inspection I observed a handrail that was not graspable. This presents a fall risk. I recommend a safe graspable handrail be installed.

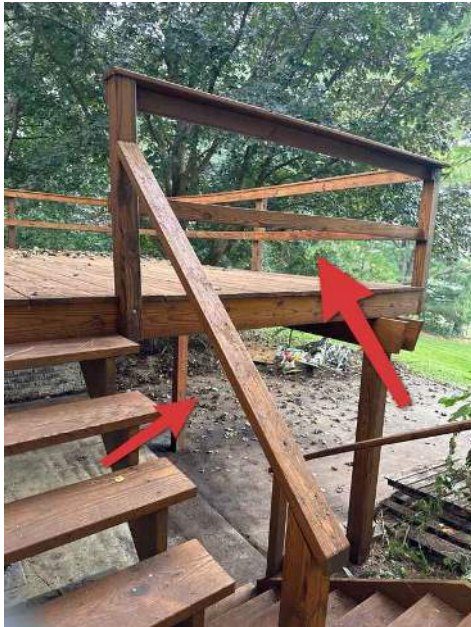
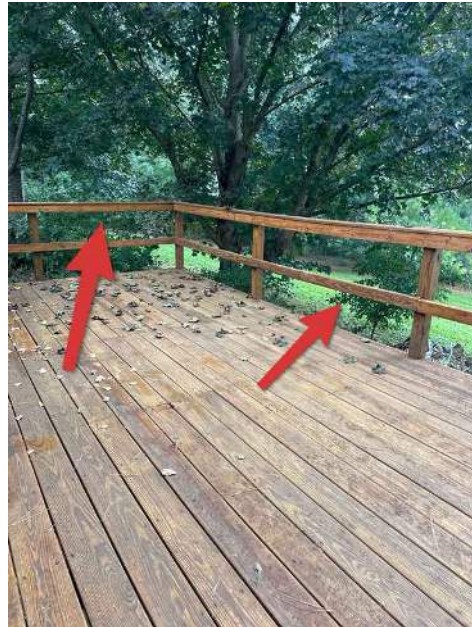
REAR DECK

At the time of the inspection, the deck stairway and railing were open in places that should have railings or balusters for safety. Spacing for safety should be 4" or less in these locations. These portions of the stairway should be evaluated and modified by a qualified professional.

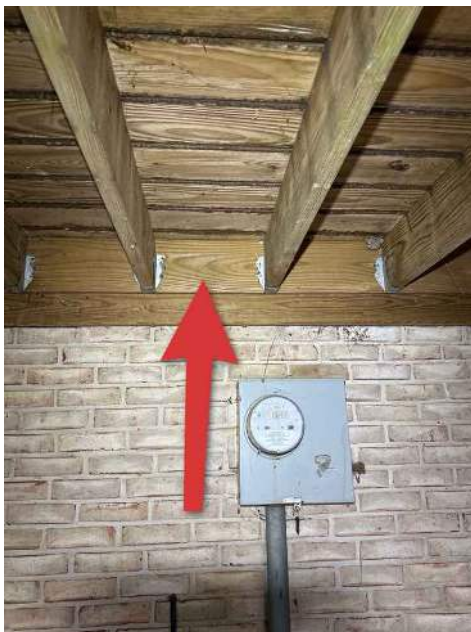
Close up

****Safety issue**** - At the time of the inspection the deck ledger did not appear to be attached to the house with enough fasteners. Deck ledgers should be designed to resist vertical load (force pushing down on ledger) **and** lateral load (force pulling away from ledger) in order to prevent collapse. The ledgers current attachment presents a potential safety hazard. I recommend a qualified professional to confirm that the deck is properly and safely attached to the house. Because this could be an expensive repair I suggest having this done prior to settlement.

We further recommend that the chosen professional be familiar with code compliances in a nationally recognized standard such as the [DAC6](#).

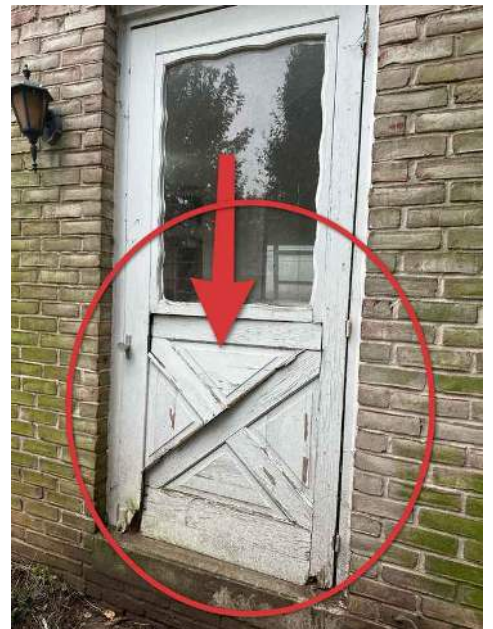
DAMAGED STORM DOOR

I observed a storm door that was damaged or in disrepair. I recommend a qualified professional to evaluate in order to determine if replacement or repair should take place.

Broken panels

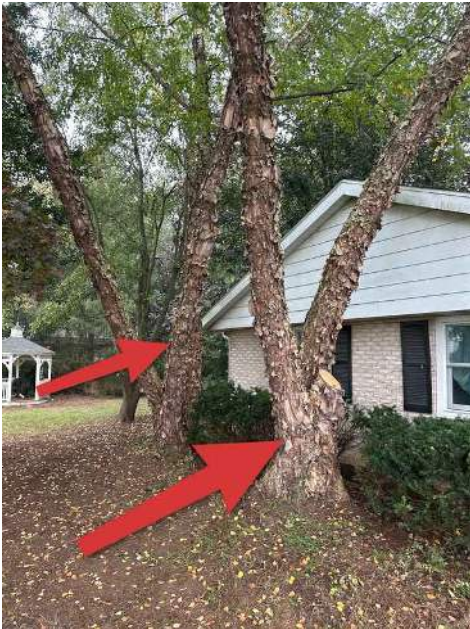
Front Exterior

At the time of the inspection there was at least 1 tree(s) that was growing too close to the house. Potential damage to the structure may result from high winds or root damage. I recommend a qualified professional to make recommendations for trimming or removal.

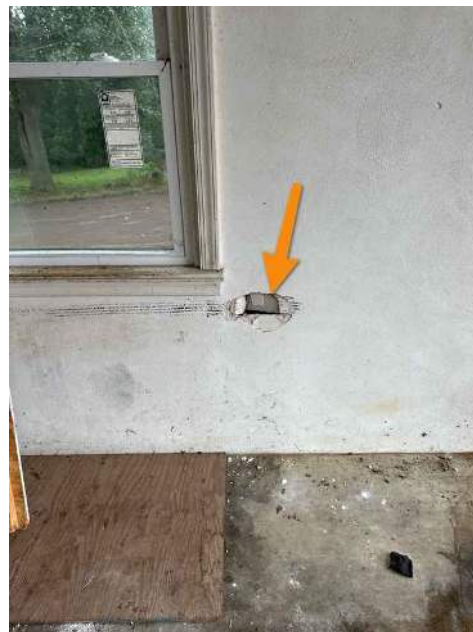
Garage

At the time of the inspection I observed one or more hole(s) in the wall. This area should be repaired by a qualified professional.

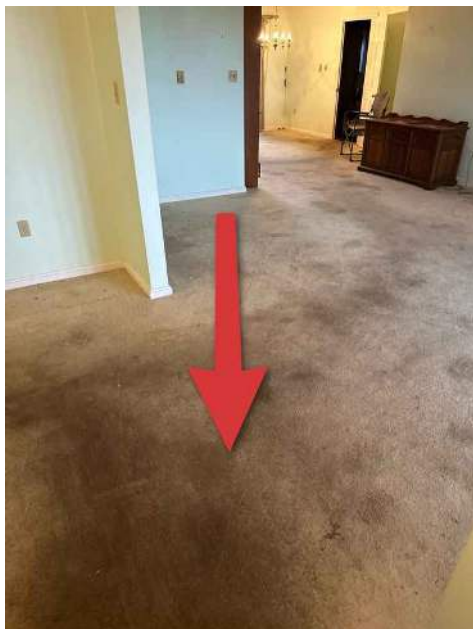
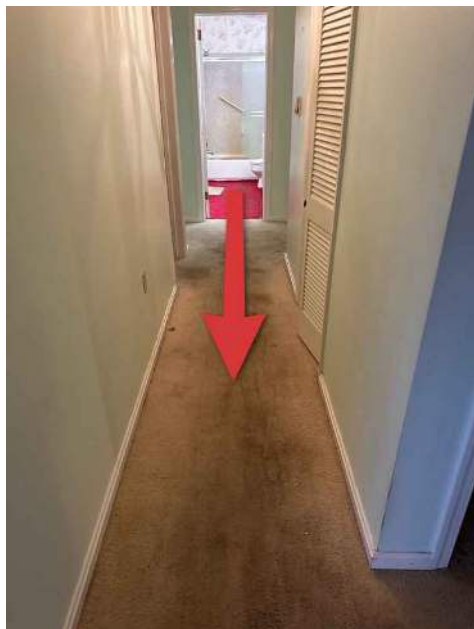
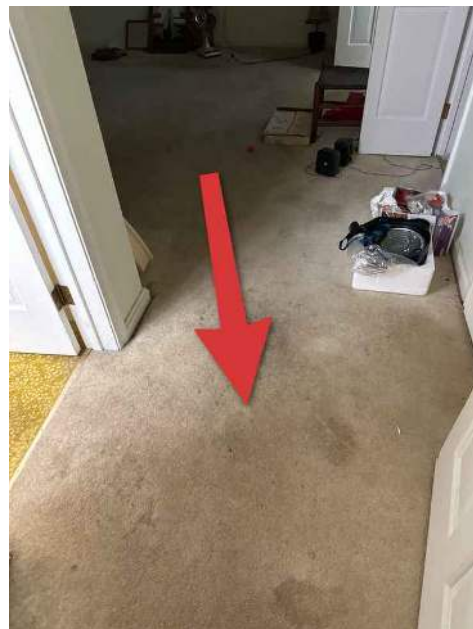
I observed carpet that was past it's useful life. See photo descriptions. I recommend a qualified professional to evaluate and replace.

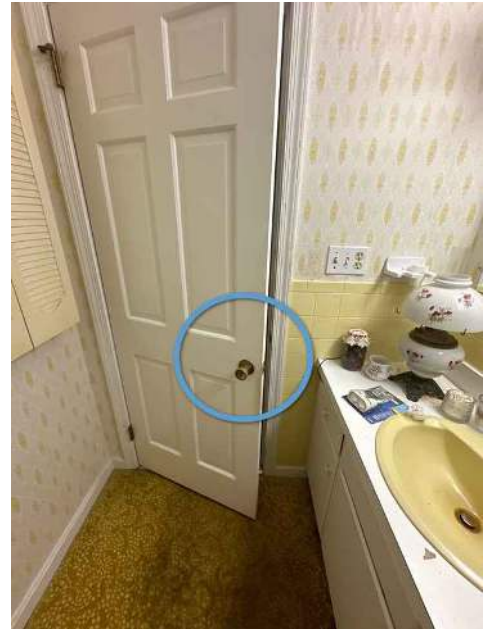
DOOR(S) - DOESN'T LATCH

At the time of the inspection one (or more) interior door was not latching properly. It appears to be a hardware or fitting defect. I recommend this be adjusted.

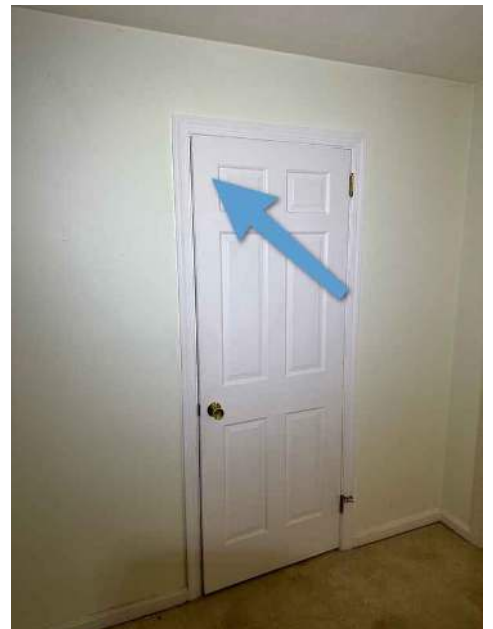
I observed a door(s) that was sticking. It was difficult to open and close. I recommend a professional to make adjustments so that it operates smoothly.

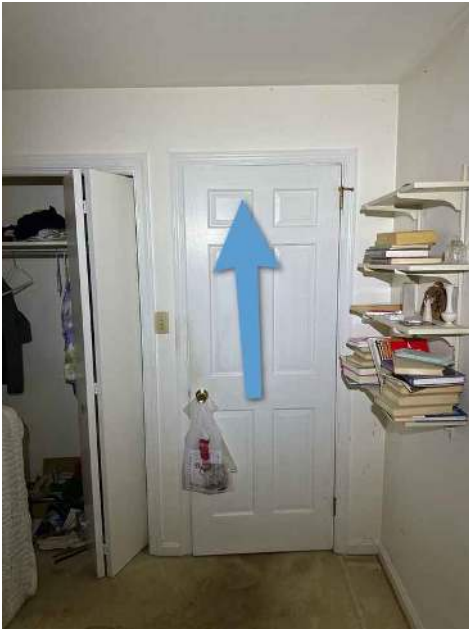
I observed that a door(s) would not close. A door should fit into its opening easily and close without effort in order to be considered effective. I recommend repair by a qualified professional.

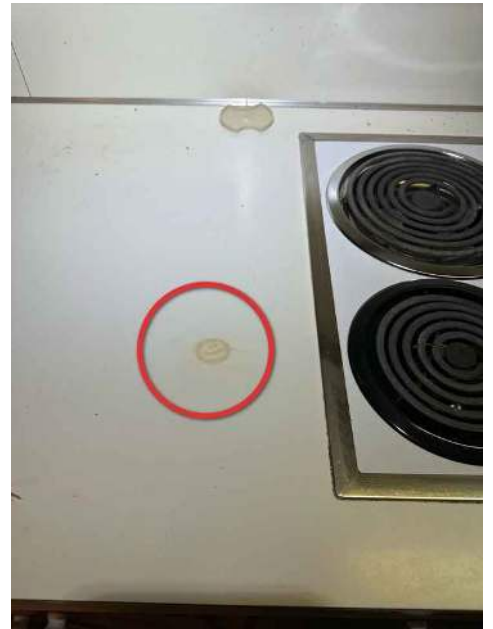
COUNTERTOP BURN

At the time of the inspection I observed one or more areas of the laminate counter that was chipped, cracked, delaminating or missing. See photos. I recommend a qualified professional to repair.

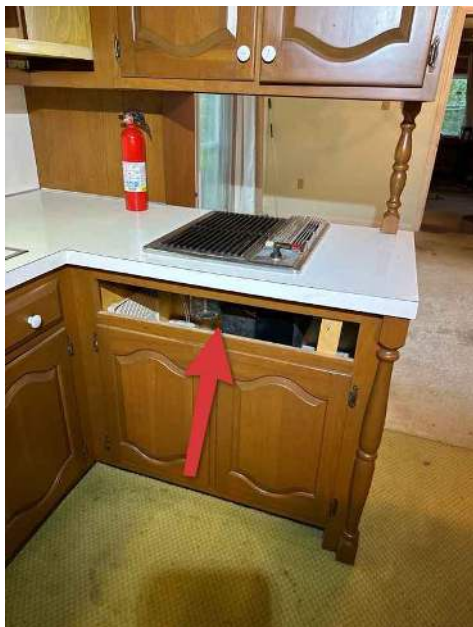
Kitchen at griddle

MISSING DRAWER FRONT

I observed a missing drawer front I recommend a qualified professional to replace.

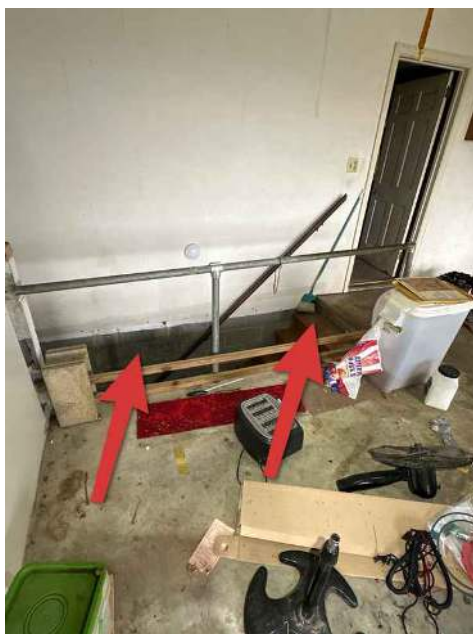
Garage railing

****Safety issue**** - There was an open stairway in which safety railing was either temporary, insufficient or missing altogether. This is a safety hazard, especially for children or the elderly. Any open staircase with 4 or more steps should have proper railing and balusters installed. I recommend a licensed professional install handrail and balusters for safety.

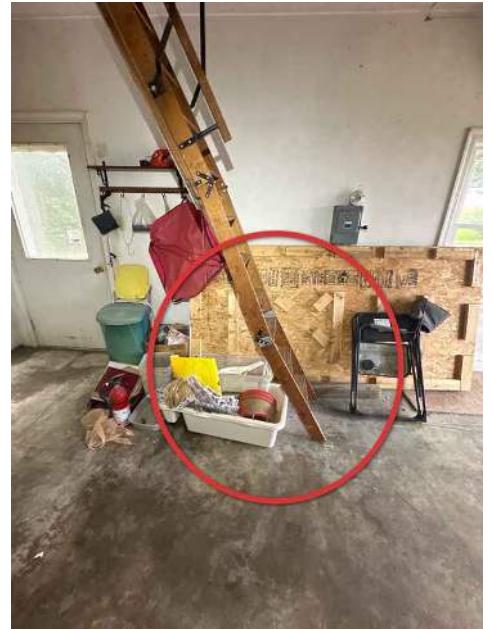
GARAGE ATTIC

I found the collapsible attic pulldown stairs to be too long. These stairs must be the right length to be safe. The present condition makes it difficult to use the stairs because there is not a firm footing for the steps. I recommend these be repaired to enable safe operation.

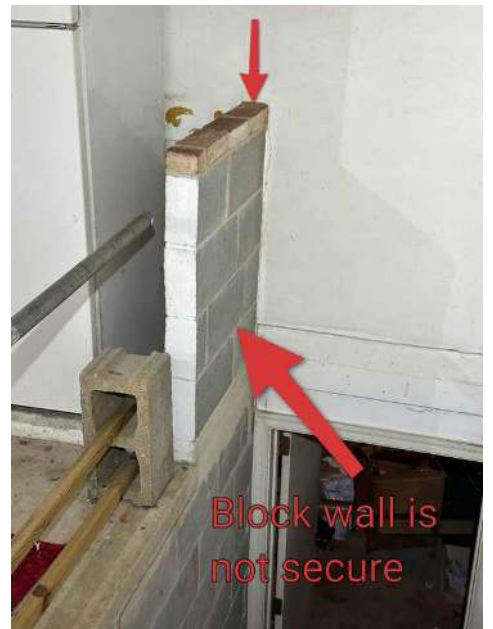
Block wall

UNSTABLE WALL AT STAIRWAY

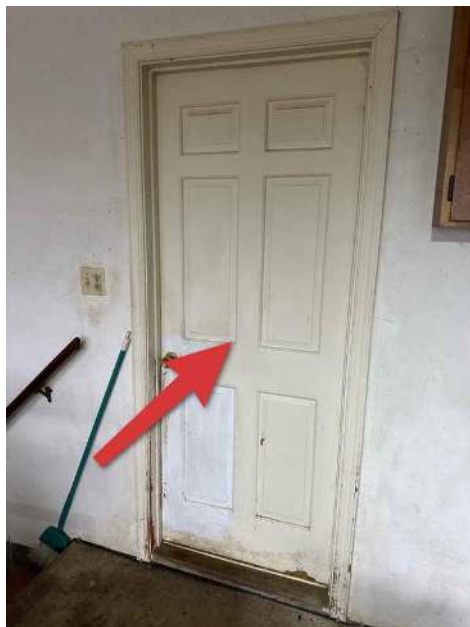
A door that meets municipal fire separation code between the garage and living space was not present at the time of the inspection. I recommend a qualified professional to evaluate and install a door that meets proper fire separation.

Hollow wood door

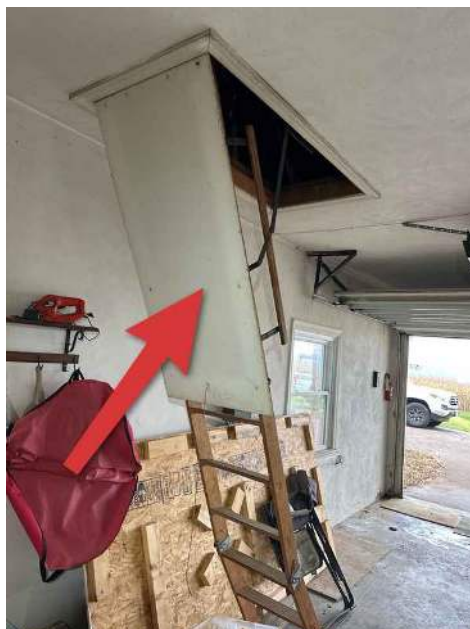
At the time of the inspection, the fire separation material at the ceiling pull down stairs or hatch was not adequate. Municipal code normally requires that garage pul-down stairs or ceiling hatches be separated from the dwelling unit/attic with a 20 minutes fire rated material. I recommend a qualified professional to evaluate and upgrade the separation in order to comply with local municipal code.

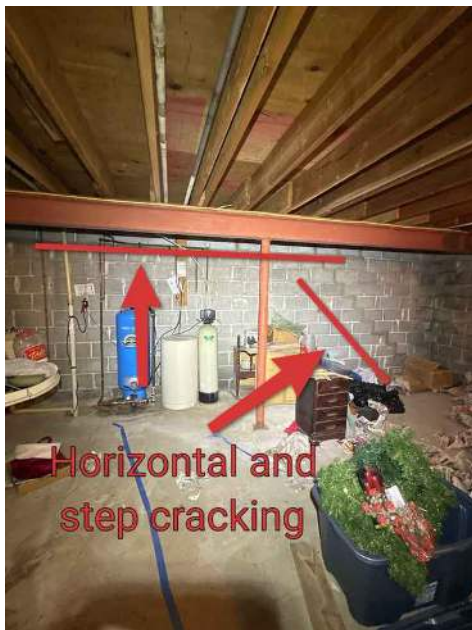
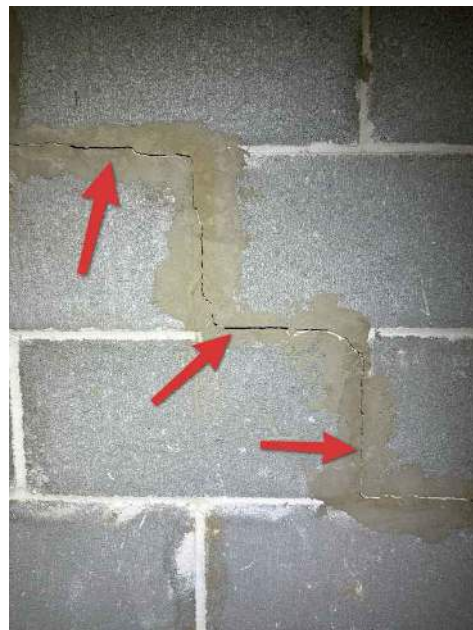
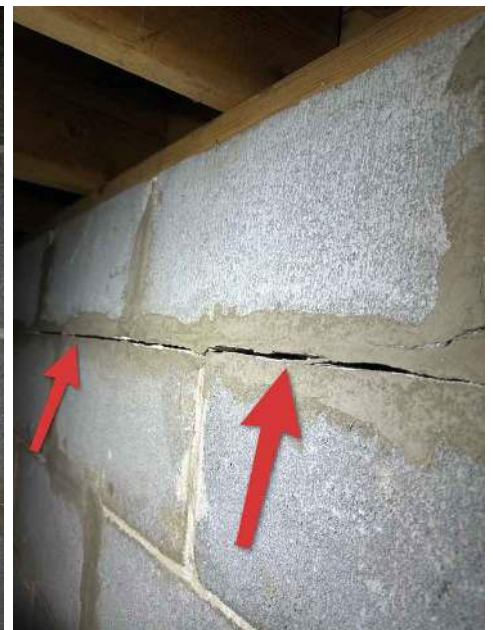
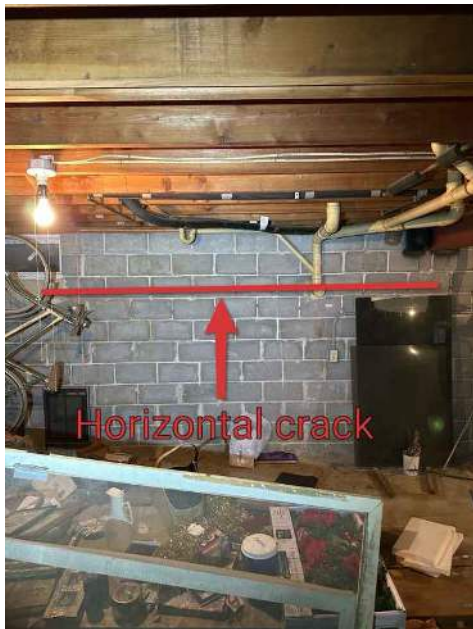
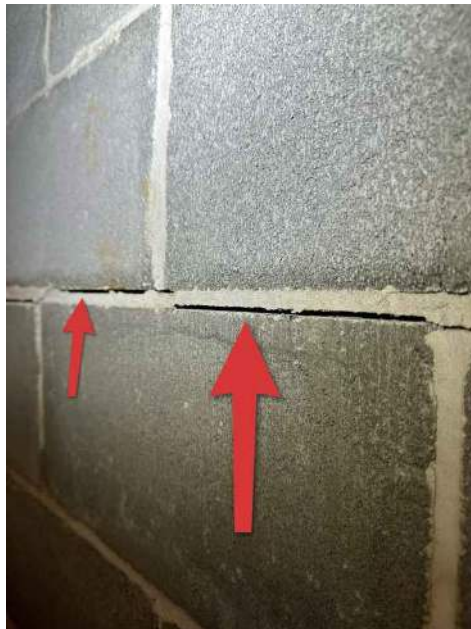
Step cracks, stair-step cracks or stepping cracks all refer to cracks that follow the mortar joints in a block wall. The cracks step up or down along the mortar. In many cases, this type of crack is caused by minor movement of the footing, shrinkage or wall movement, and by itself is not a major cause for concern.

Front Foundation Wall Perspective view

Front Foundation Wall Step Crack

Foundation Wall Horizontal Crack

Left Side Foundation Wall Perspective view

Left side horizontal crack

I recommend a qualified professional to evaluate and give recommendations for repair.

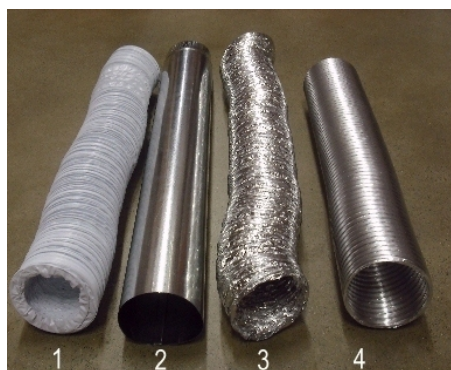
Types of exhaust ducting

Ducting material is a key component in moving harmful moisture from the home to the outside. The quality of the material used for this ductwork is important. See more info on [Ducting Material](#) as referenced in the picture below.

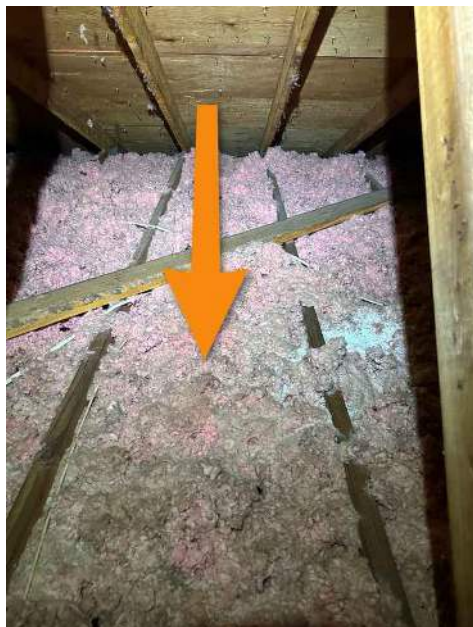
Overall Attic

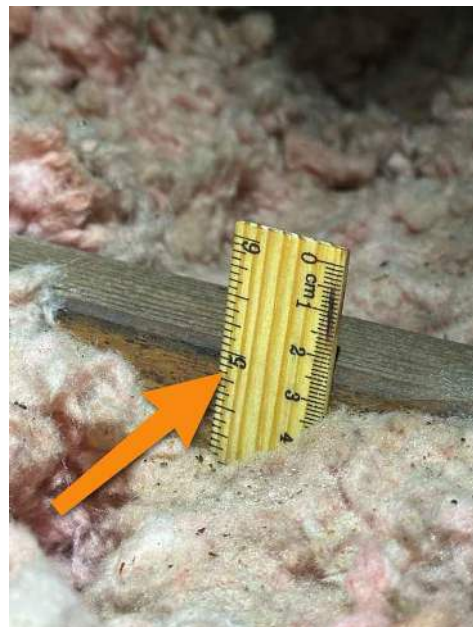
Close up @5"

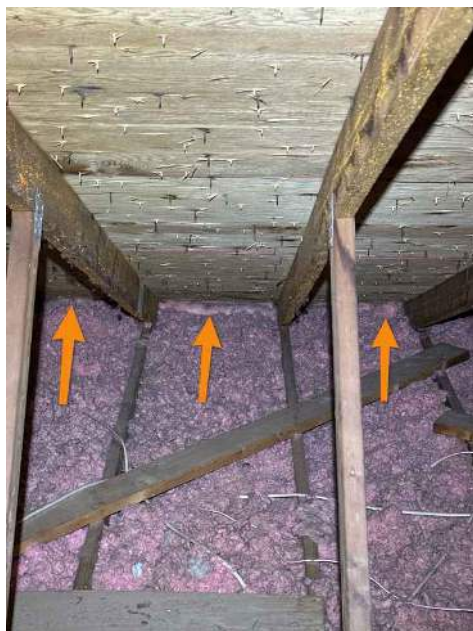
All along rear soffit

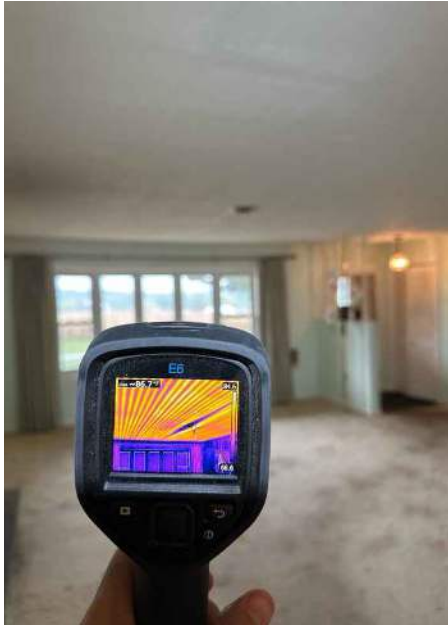
Radiant ceiling heat, Wall heater

Representative of all rooms

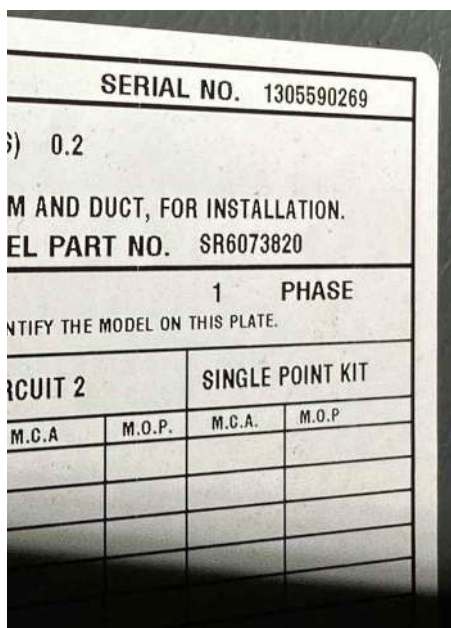
Cooling Equipment: Regular maintenance recommended

At interior AC unit

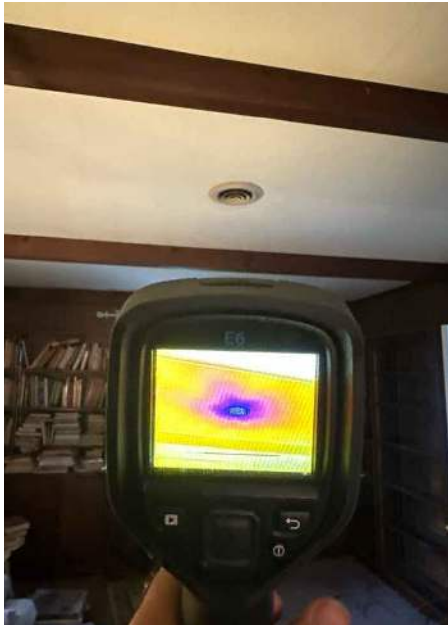
At the time of the inspection, the ducting system appeared to be in good condition. All accessible supply ducts were checked for flow. Representative photos are show below. Any defects will be listed separately in the report.

1st Floor Representative

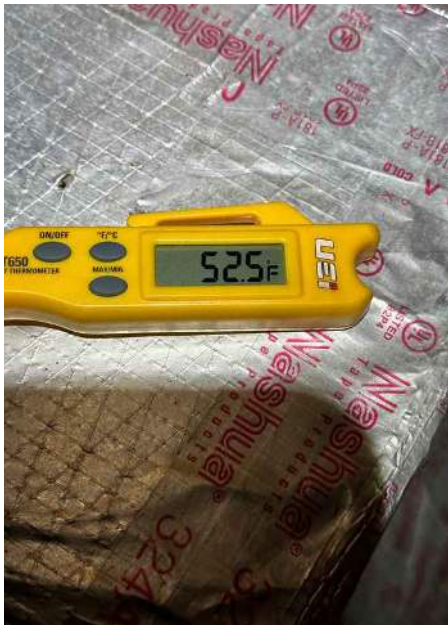
AC Differential: Return temp

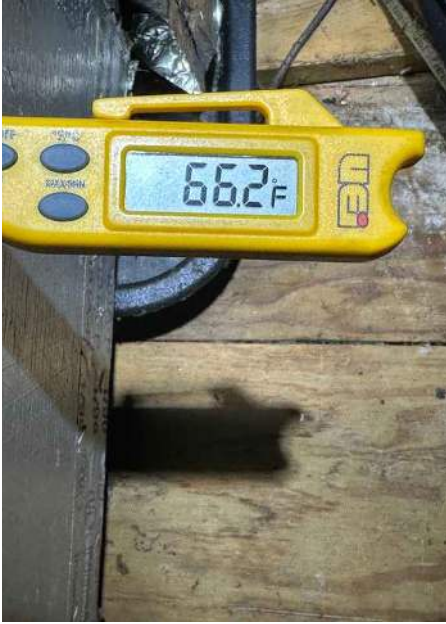
Return temp refers to the temperature of the warmer air as it returns to the AC unit to be cooled again.

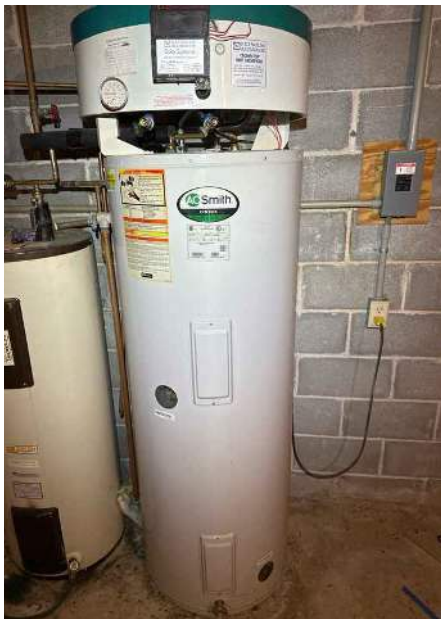
Basement

Water Heater: Water Heater

Water Heater: Capacity

80 gal

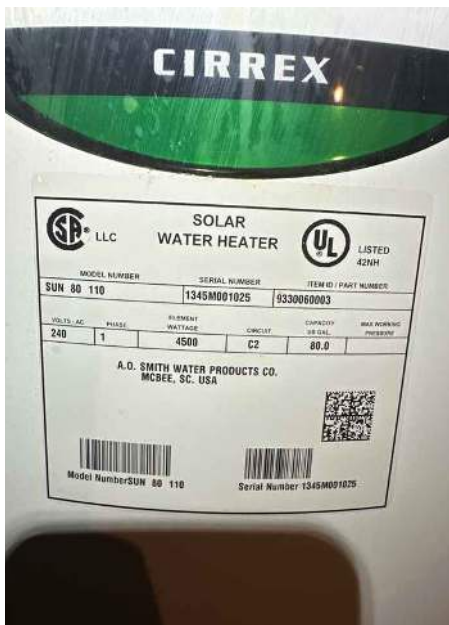
Water Heater: Age

2013

Based on the manufacturer's suggested service life, the life expectancy of a gas water heater is about 8 to 14 years and an electric water heater is 10-18 years. I recommend having a qualified professional evaluate the condition of the water heater to best determine its life expectancy.

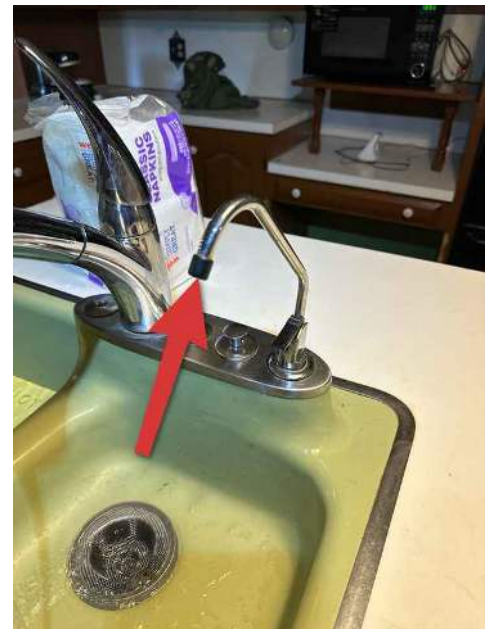
I observed a water faucet that was not working. This should be repaired or replaced by a licensed plumber.

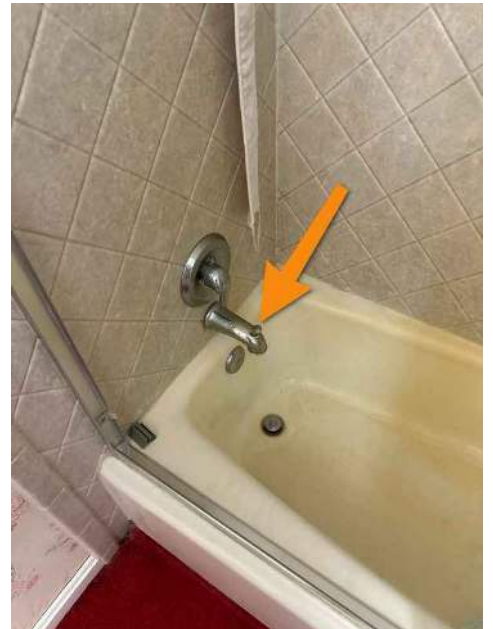
FAUCET WORN OUT

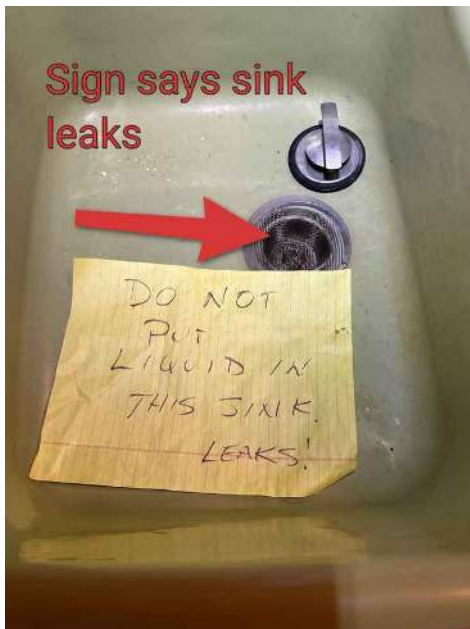
ACTIVE LEAK(S)

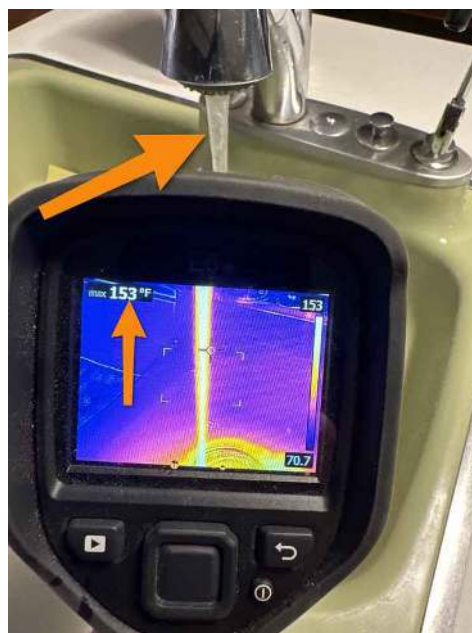
153°

**** Safety issue**** I observed that the hot water supply temperature was too high. This can lead to scalding and burns. I recommend reducing the hot water temperature.

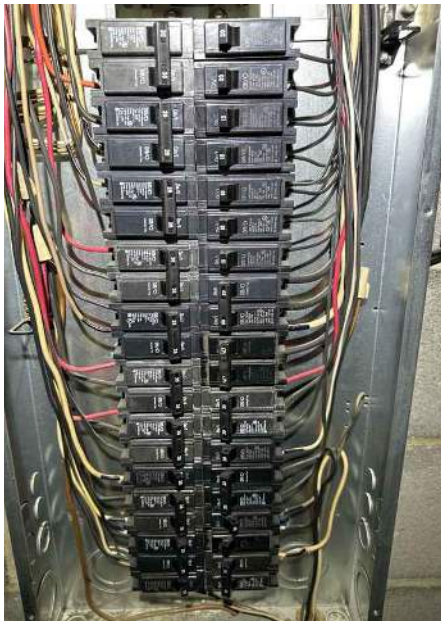
Main Distribution Panel: Over-current Protection

Breakers

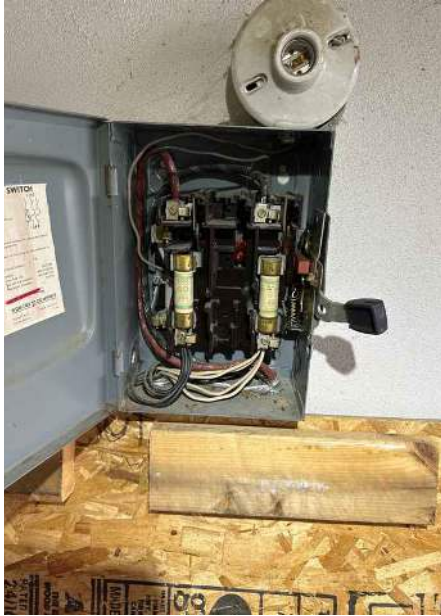
60 amp barrel disconnect AC

Branch Wiring: Branch disconnect

Garage
