INSPECTION REPORT

755 Long Ln
Lancaster, PA 17603

Chris Payton
10/04/2024

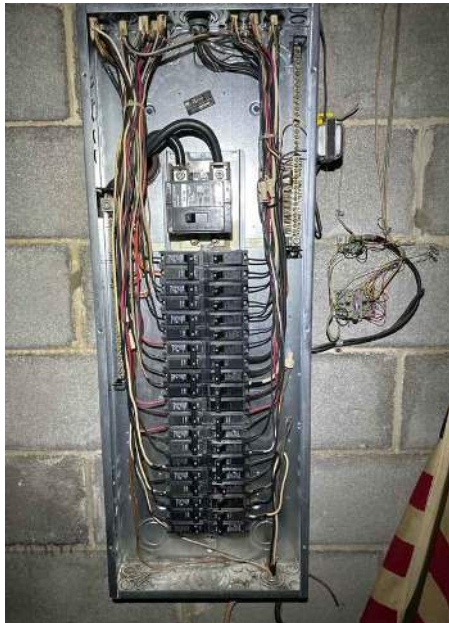
Basement

Electrical panels are considered continuous-use appliances because they are always on. They experience daily heating and cooling of their components. As such, they should be replaced periodically. The average life of a panel is 30-50 years depending upon many factors. I recommend a qualified professional to evaluate this panel to determine if this panel should be updated to a newer panel.

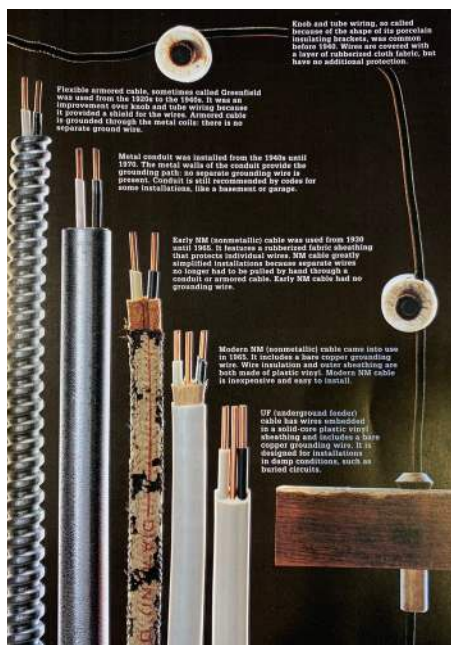
Copper, Non-metallic sheathed (Romex)

At the time of the inspection, the predominant, visible branch wiring appeared to be in good condition. Any visible defects will be listed separately in the report.

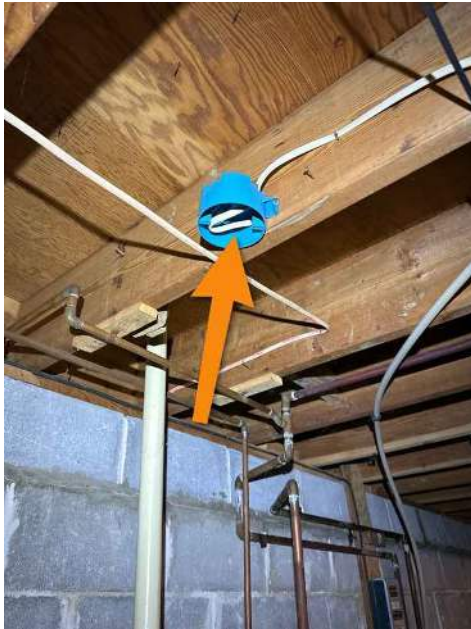
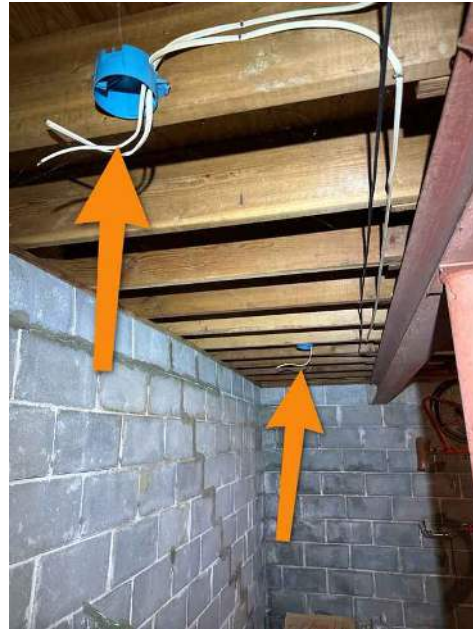
At the time of the inspection one or more junction boxes were without covers. This presents a potential shock hazard. I recommend a qualified professional evaluate and install cover plates where absent.

Above laundry sink

Front Foundation Wall Ceiling

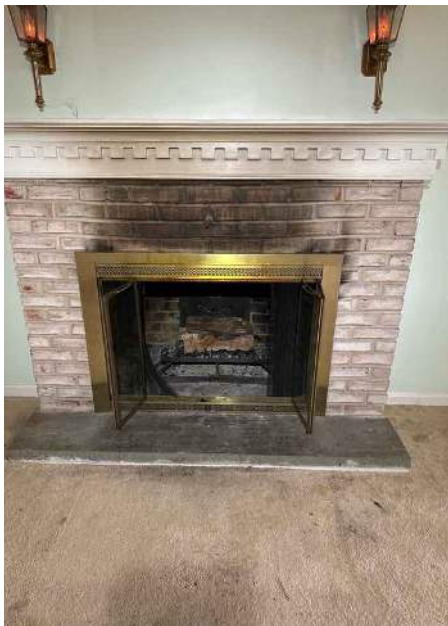
Living Room

Fireplaces, Stoves & Inserts: Type

Masonry fireplace, Woodstove

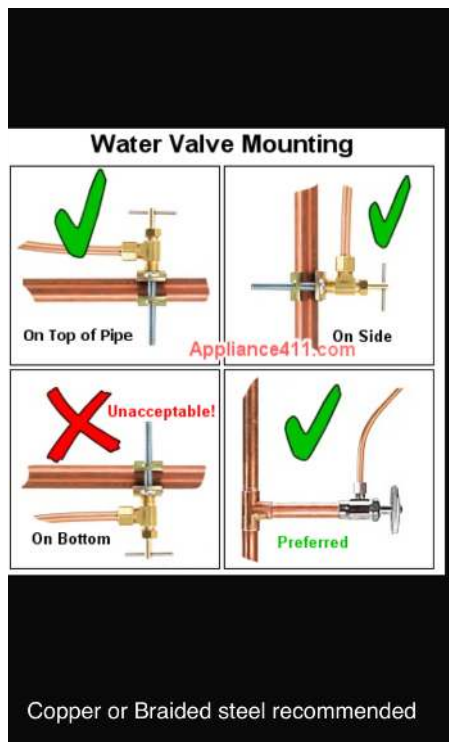
Refrigerator: Water/Ice Supply Line

Copper

Certain material (i.e. plastic) is subject to early failure which could result in significant water damage.

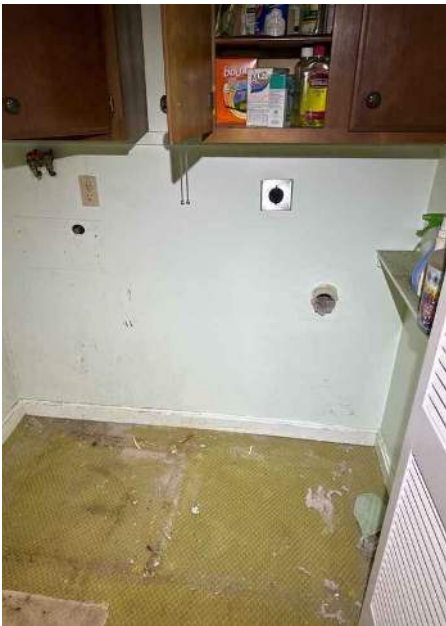
Washer/Dryer: W/D not present, not inspected

At the time of inspection, a washer and dryer was not present. Inspecting washer and dryer operation is not within the scope of a home inspection.

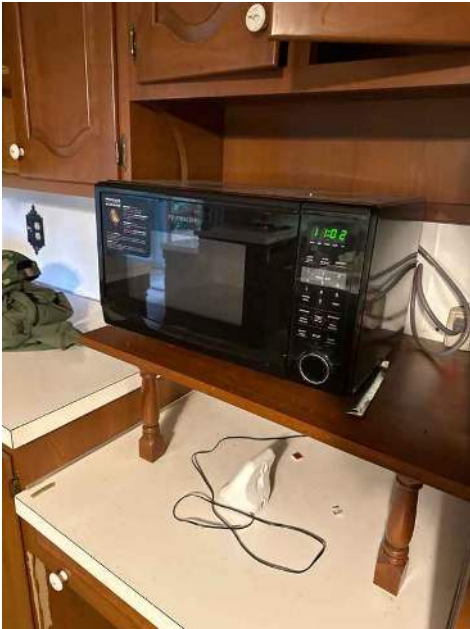
FREE STANDING MICRO-WAVE

Freestanding microwave ovens are not within the scope of a home inspection. Only built in microwaves are inspected for operation.

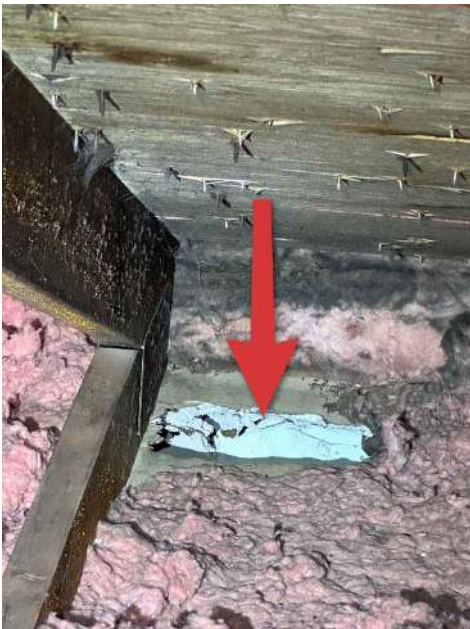
Close up

Exhaust from range hood terminates into the attic. This can result in moisture damage and mold in the attic. I recommend a qualified contractor re-route this duct to terminate to the exterior.

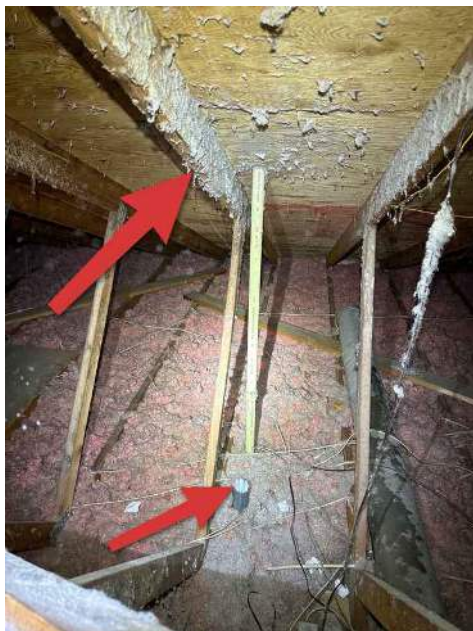
Perspective view

DRYER VENTING TO INTERIOR

At the time of inspection the dryer was venting to the inside of the home. This will discharge large amounts of moisture laden air into a confined space. A potential for mold and damage exists. I recommend a professional redirects the dryer vent to the outside.
