INSPECTION REPORT

4905 Colonial Dr
Mechanicsburg, PA 17055

11/08/2024

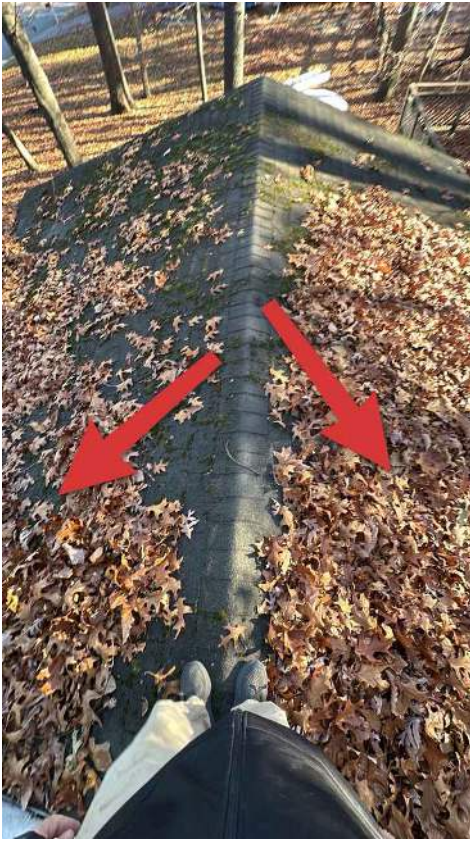
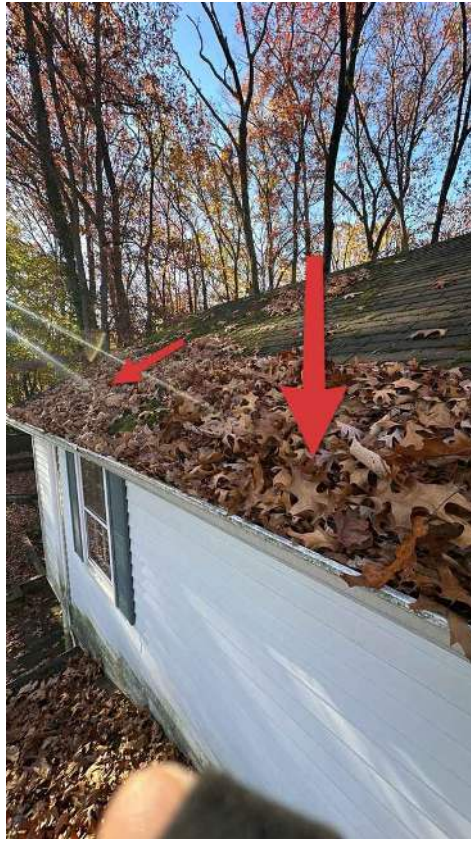
2.1.2 Coverings

NEW ROOF NEEDED

At the time of the inspection I observed that the asphalt roof material was worn/damaged to the point that it was no longer serviceable. See photo descriptions. A qualified roofer should evaluate the roof before settlement.

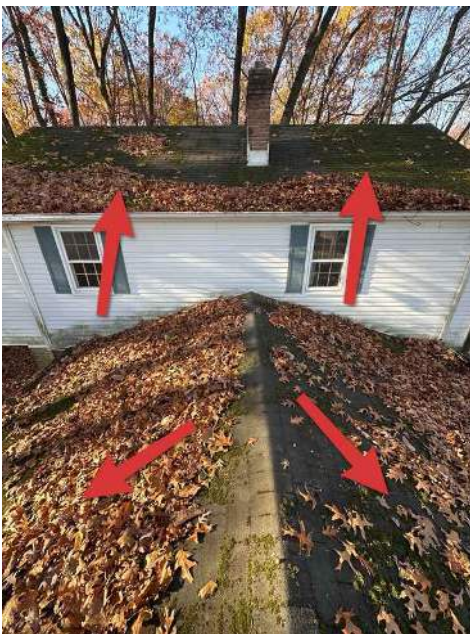
Overall Roof

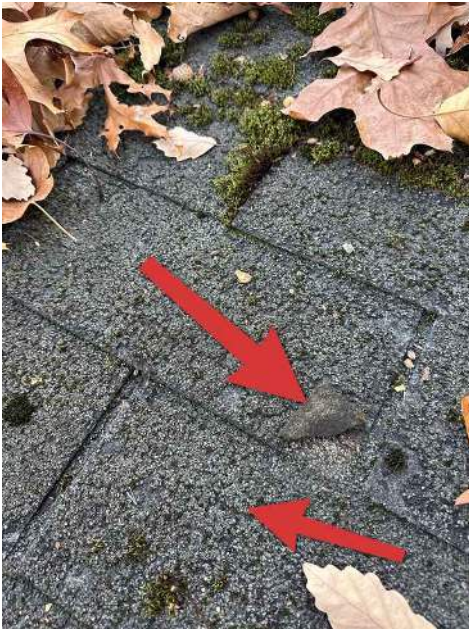
Brittle and cracked shingles

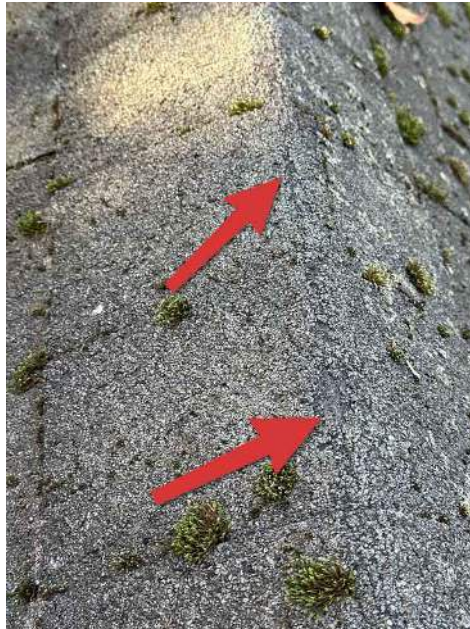
Worn shingles

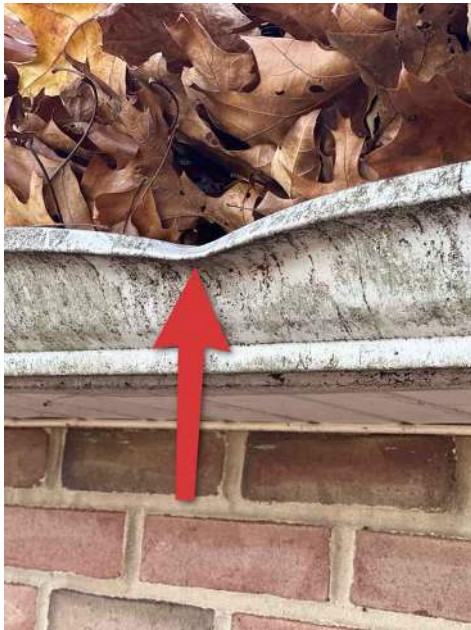
I observed a gutter section that was dented. I recommend this be repaired or replaced.

Close up

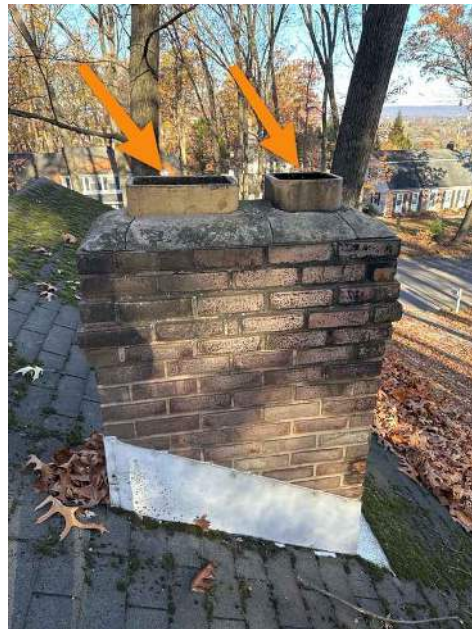
2.5.1 Skylights, Chimneys & Roof Penetrations

CHIMNEY CAP MISSING

The chimney vent did not have a cap. The absence of a cap can lead to potential damage to the flue through moisture penetrating into the home. I recommend installing a properly sized cap.

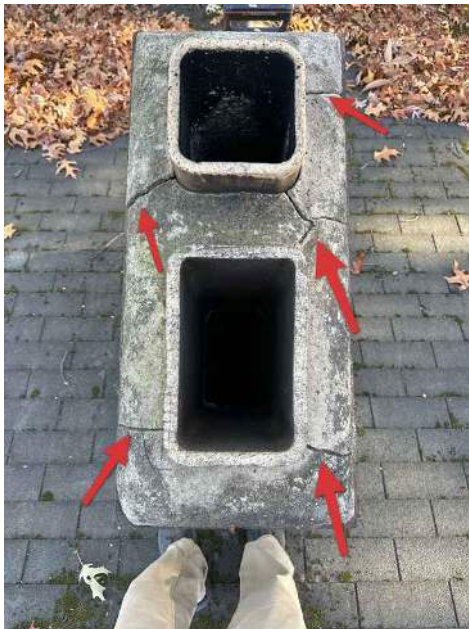
2.5.2 Skylights, Chimneys & Roof Penetrations

CHIMNEY CROWN DETERIORATION

I observed the chimney crown to be damaged. Cracking was visible in the chimney cap and/or masonry. The damaged areas should be repaired immediately to prevent further moisture penetration. A qualified professional should evaluate and repair.

Overview

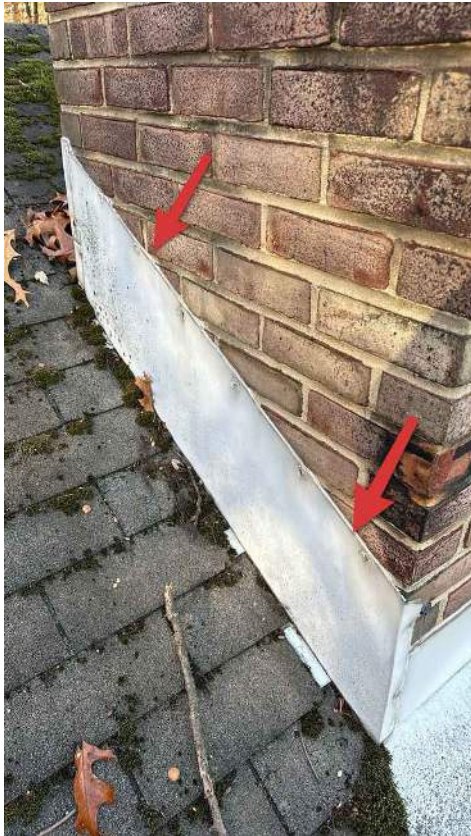
The flashing around the chimney was not properly cut into the masonry. The chimney will leak in this location. I recommend it be evaluated and repaired by a professional.

Perspective view

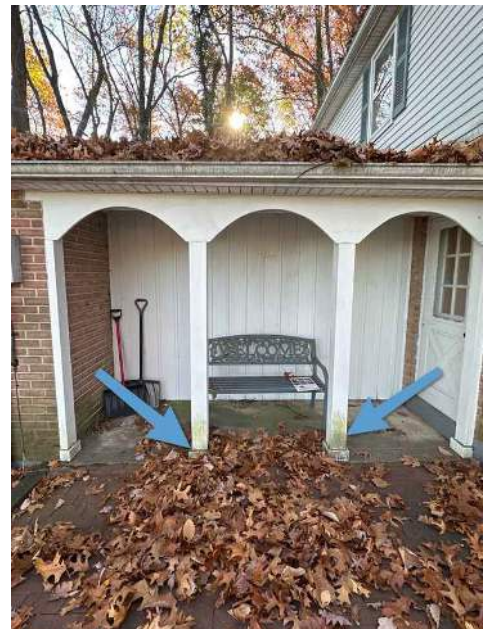
3.8.1 Porches, Balconies, Steps and Railings

LOOSE PORCH POSTS

Loose at base

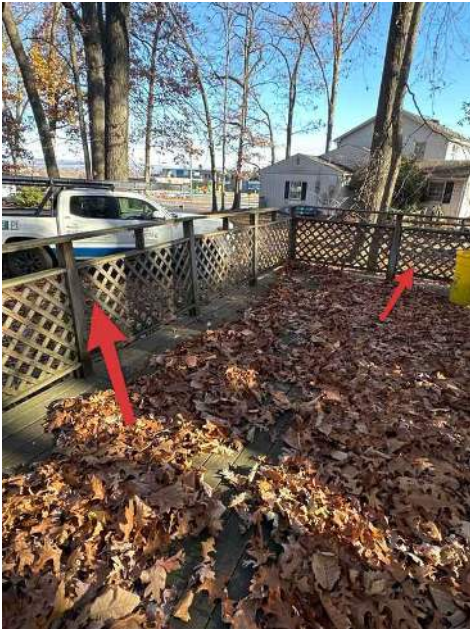
Loose railing

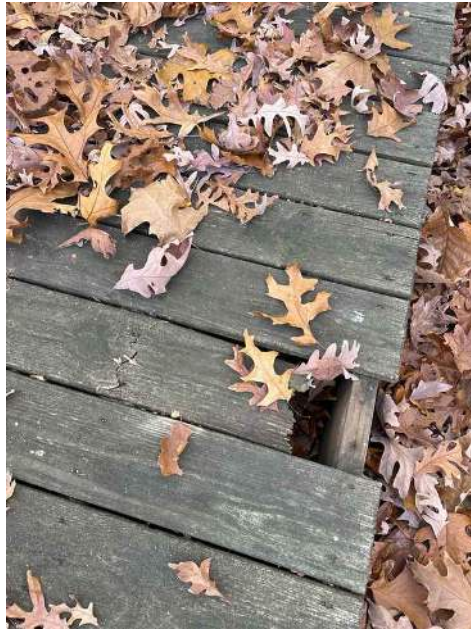
Damaged decking

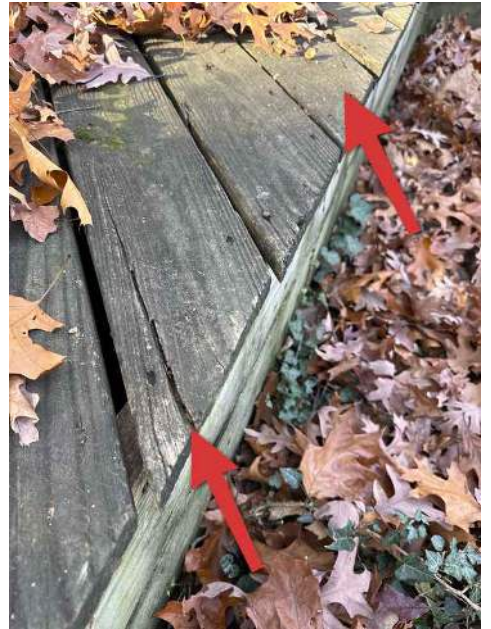
Weathered decking

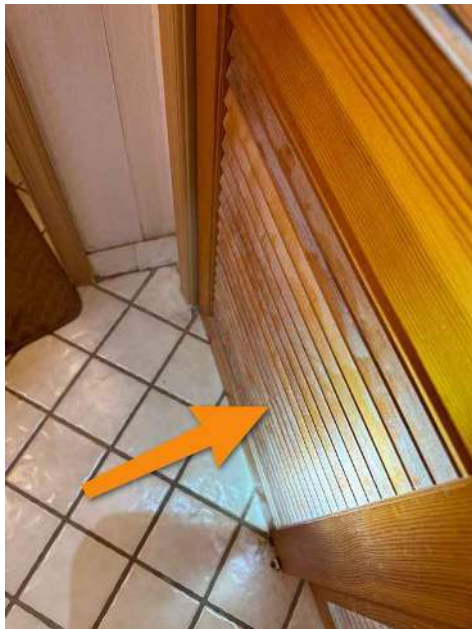
Master Bath Door

At the time of the inspection, I observed a mold like substance. Mold has the potential to cause health problems. Molds produce allergens and irritants. Inhaling or touching mold or mold spores may cause allergic reactions in sensitive individuals. I recommend an evaluation by a qualified professional to evaluate and recommend a treatment plan.

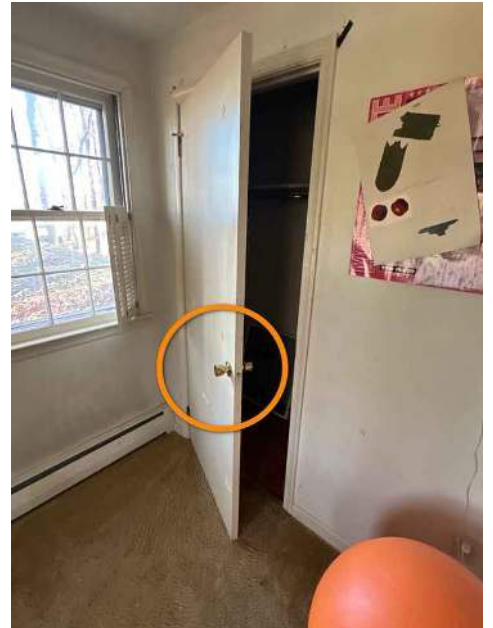
2nd Floor Front Corner Bedroom

I observed one or more doors where the operating hardware was loose or missing. I recommend that a handyman or DIY repair so that the door operates properly.

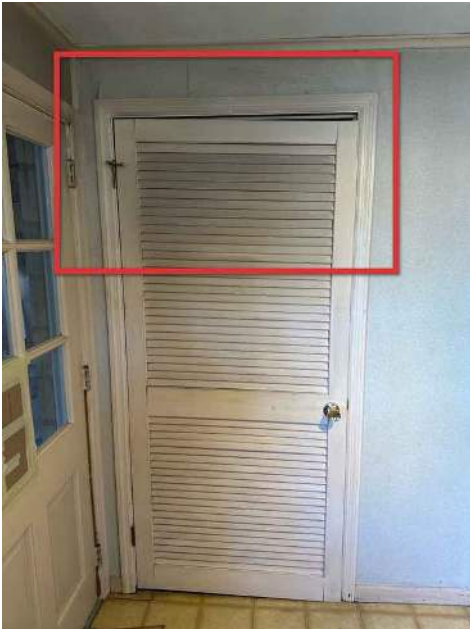
4.6.3 Doors

At the time of the inspection I observed an interior door(s) that was damaged to the point where it should be replaced. See photo description. I recommend repair by a qualified professional.

Door racked

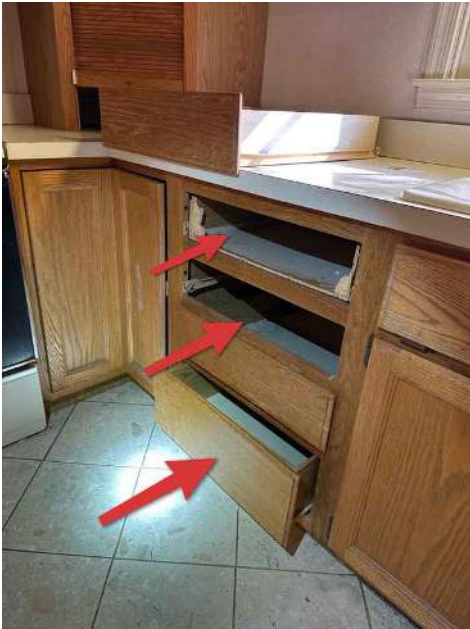
4.7.2 Countertops & Cabinets

DRAWER DAMAGED

3 drawers

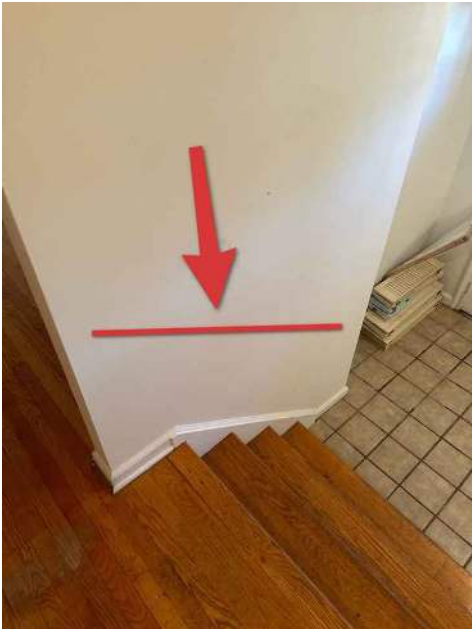
Foyer Steps

****Safety issue**** - At the time of inspection, the staircase was missing a handrail as depicted in the photo. This presents a safety hazard. I recommend a qualified professional install an additional handrail.

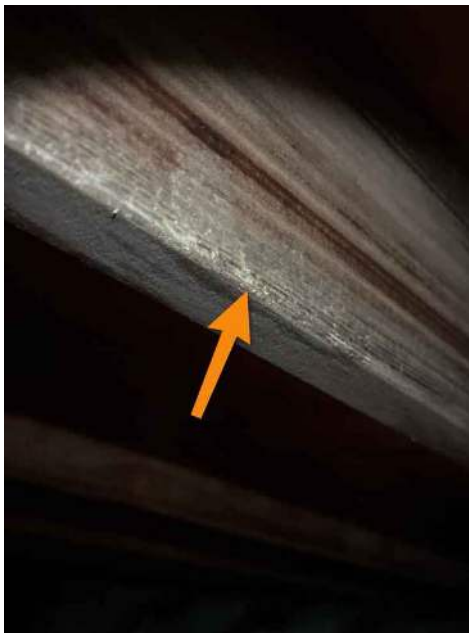
At the time of the inspection, I observed a mold like substance. Mold has the potential to cause health problems. Molds produce allergens and irritants. Inhaling or touching mold or mold spores may cause allergic reactions in sensitive individuals. I recommend an evaluation by a qualified professional to evaluate and recommend a treatment plan.

Rafter

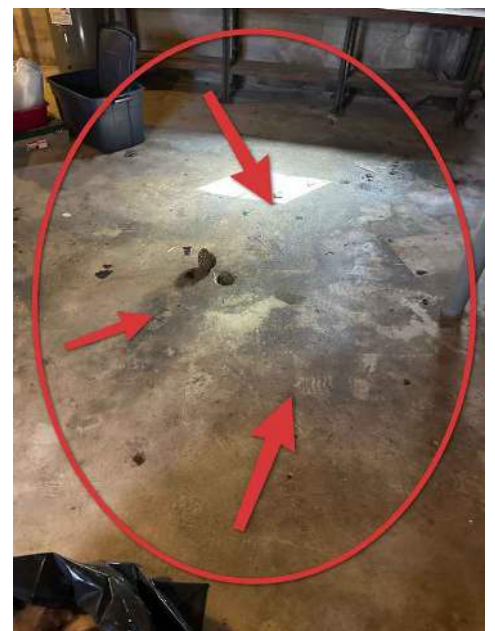
Appears to be coming from drain

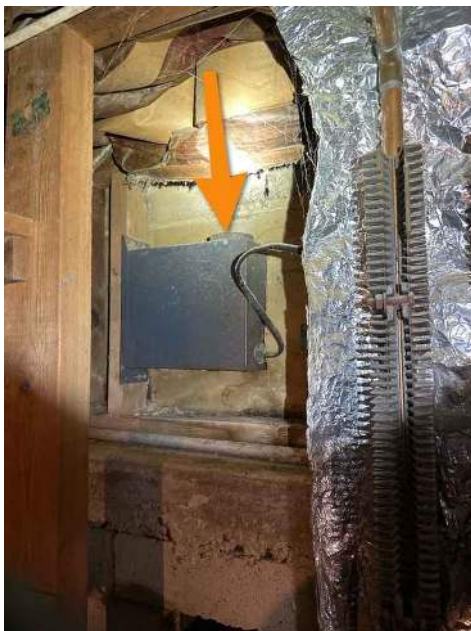
****Potential Mold issue**** - At the time of the inspection, I found one or more interior exhaust fan(s) venting into inside space. When an interior fan discharges into a basement, crawlspace, attic, or another building cavity, the potential for moisture-related damage is significant. I recommend a qualified professional evaluate and re-direct the exhaust venting to the exterior.

Perspective view Basement

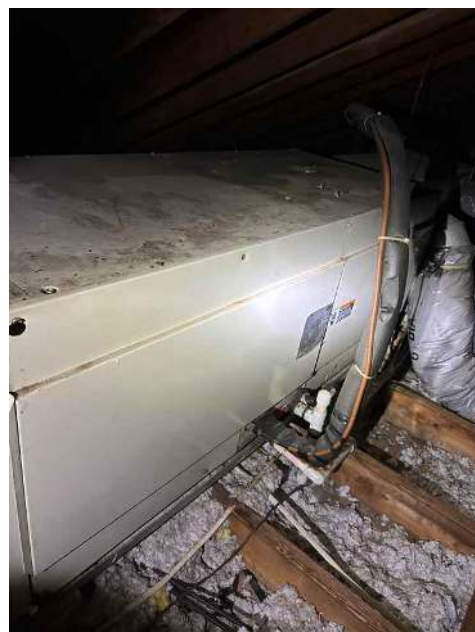
INTERIOR AC UNIT NOT WORKING

At the time of the inspection the air conditioning system was not working. A good faith effort was made to operate the system. The thermostat, breakers, disconnects, fuses and switches were all checked. As a result I recommend a qualified professional be consulted to inspect the system in order to determine the problem prior to settlement.

AC System

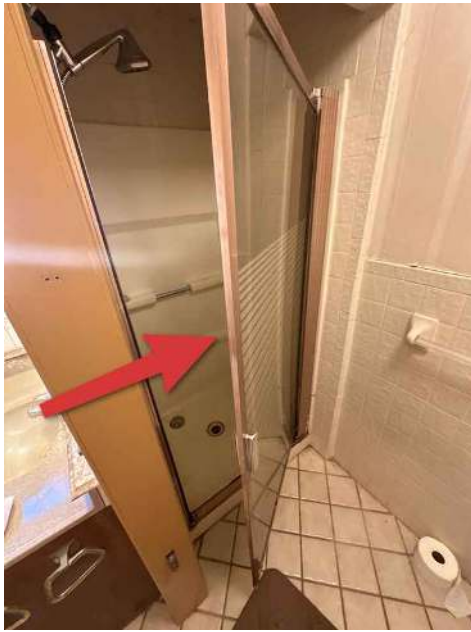
At the time of the inspection the shower door pictured here was beyond its useful life and needed to be replaced. I recommend a qualified professional to evaluate and replace.

Corroded metal

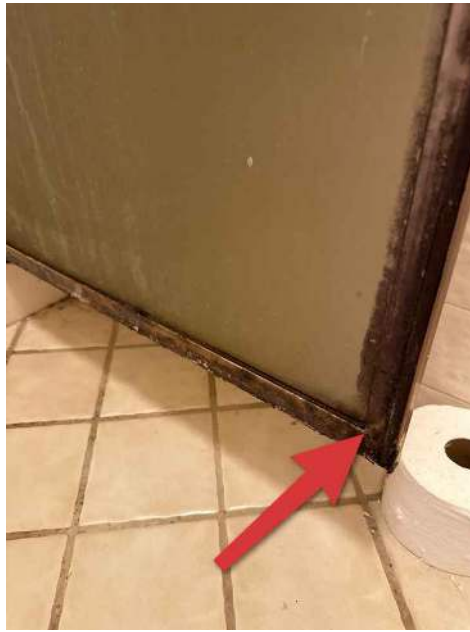
Corrosion

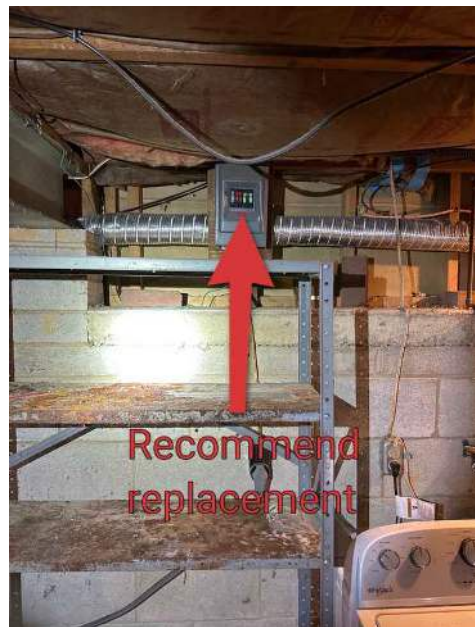
10.4.1 Sub Panel Basement

ZINSCO PANEL POTENTIALLY UNSAFE
