INSPECTION REPORT

1626 Lampeter Rd
Lancaster, PA 17602

Renee Weaver
04/08/2025

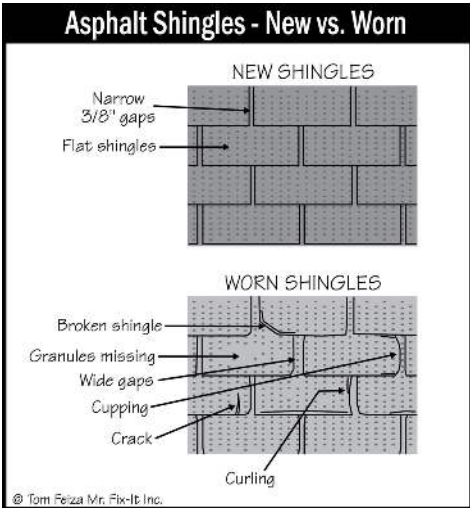
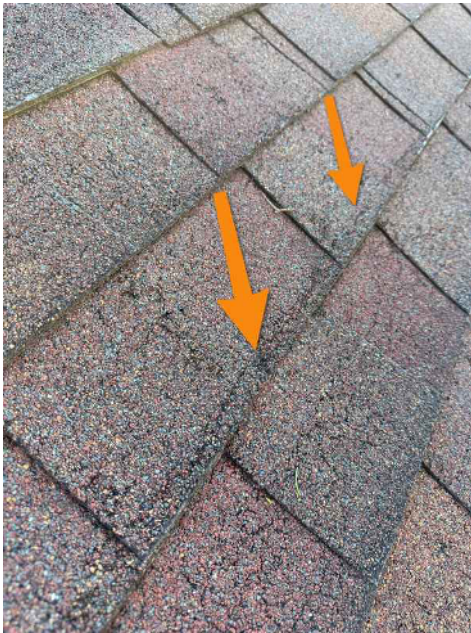
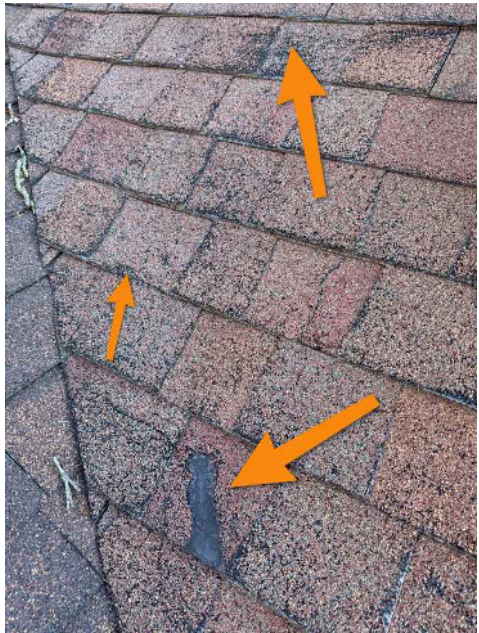
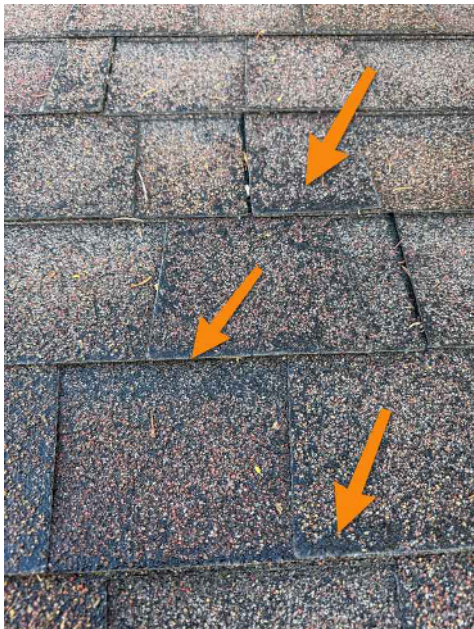
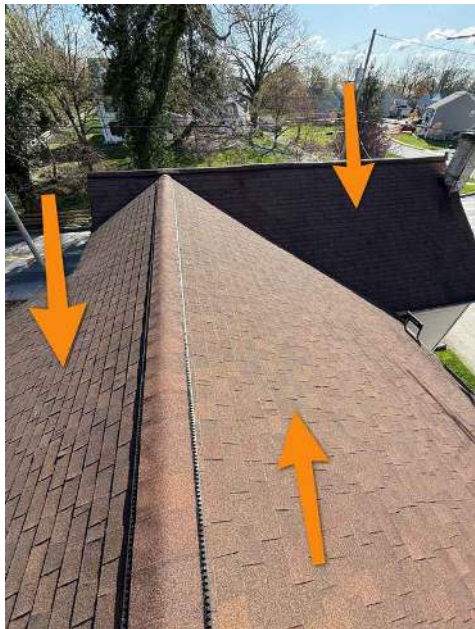
2.1.1 Coverings

SHINGLES - GRANULE WEAR AND DAMAGE

OVERALL ROOF

The roofing shingles were beginning to show signs of granule wear and damage in numerous areas. This wear indicates a thinning of the shingle wear surface. I recommend a qualified professional to evaluate this roof in order to more accurately determine the roof's life expectancy.

Shingle cracking

Shingle damage and wear

Shingle wear

Overall roof

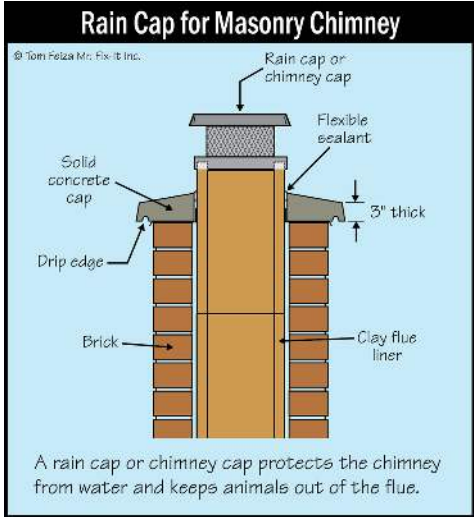
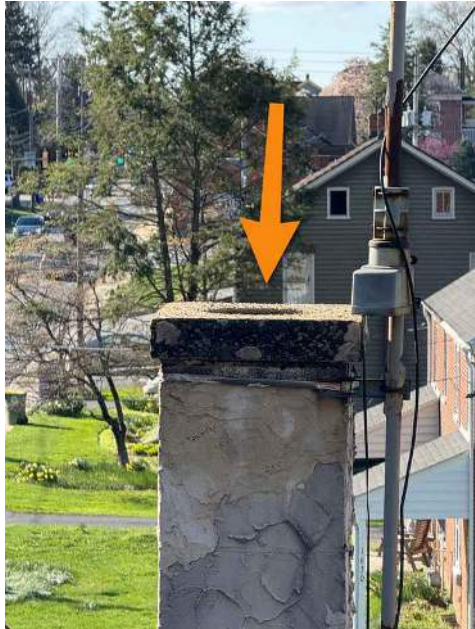
2.5.1 Skylights, Chimneys & Roof Penetrations

CHIMNEY CAPS MISSING

The chimney vent did not have a cap. The absence of a cap can lead to potential damage to the flue through moisture penetrating into the home. I recommend installing a properly sized cap. If a chimney flue is in disuse you may want to consider sealing it permanently.

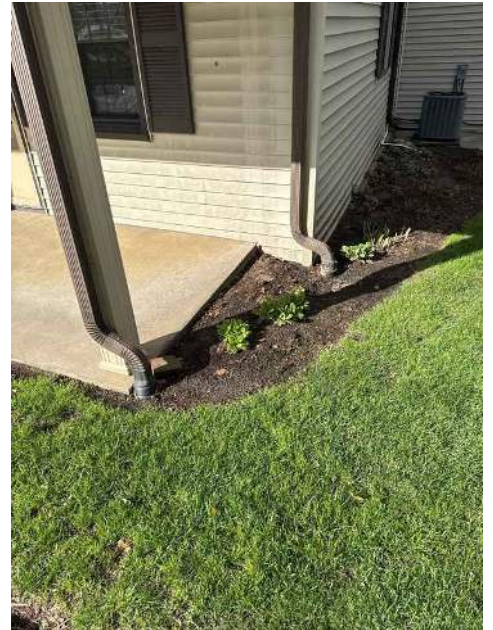
UNDERGROUND DRAINAGE

At the time of inspection I observed downspout drainage that entered underground piping in one or more places. In certain municipalities storm drains are connected to the public sewer system. It is not always possible to determine where these underground pipes deposit their water. I recommend a qualified professional to investigate with a video scope where these underground pipes empty and to confirm that adequate drainage is taking place away from the house.

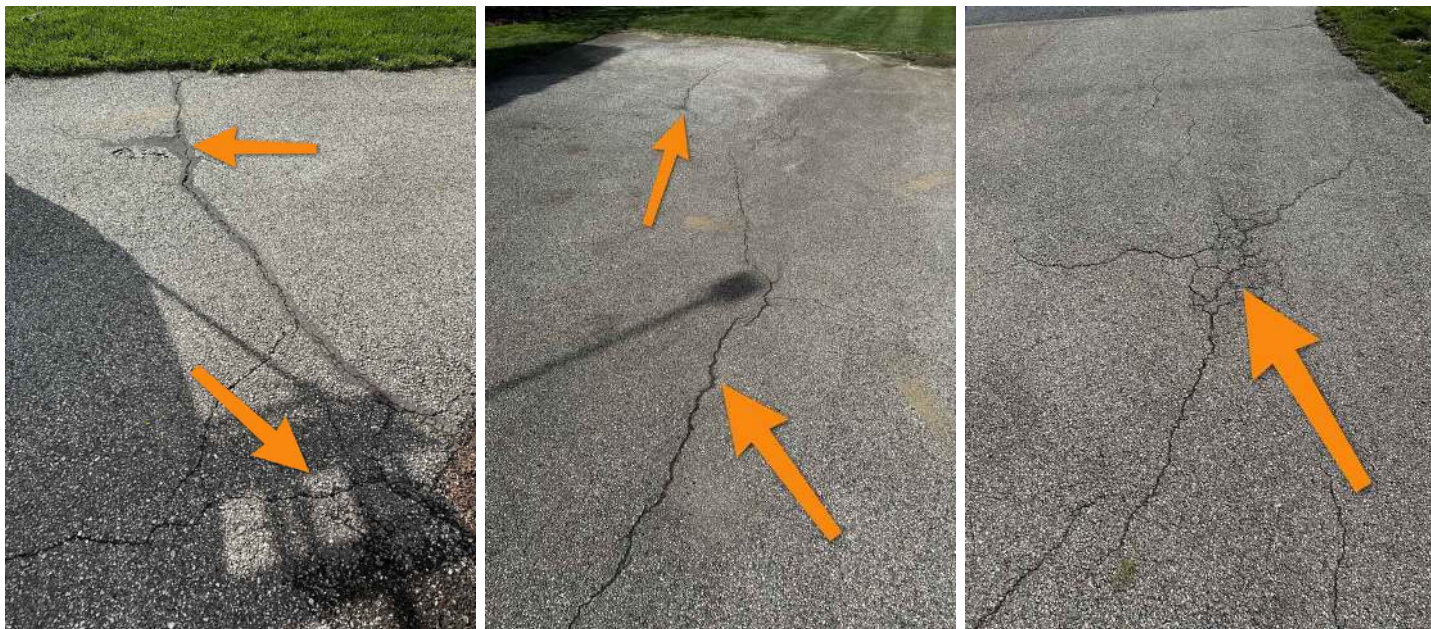
DRIVEWAY - ASPHALT CRACKING -MODERATE

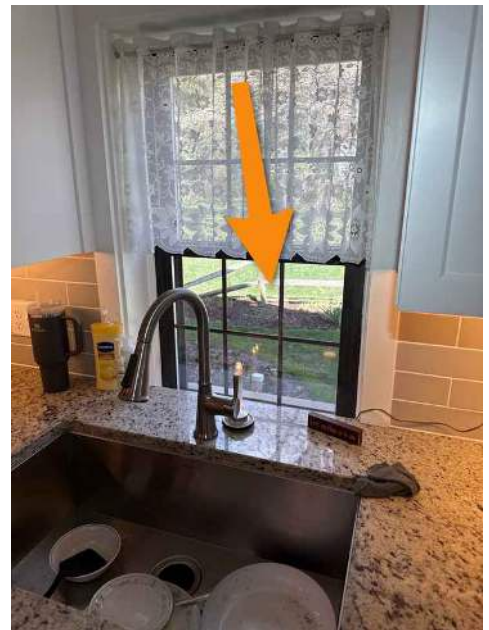
Lower sash

SASH MECHANISM WORN

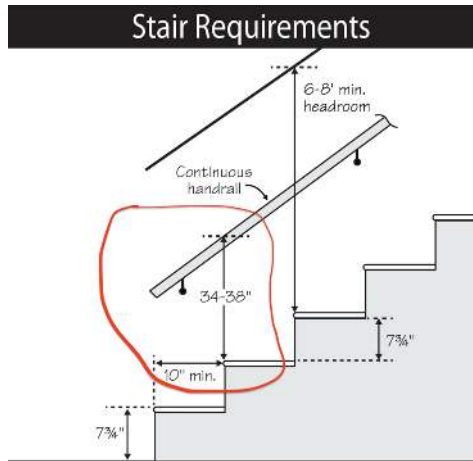
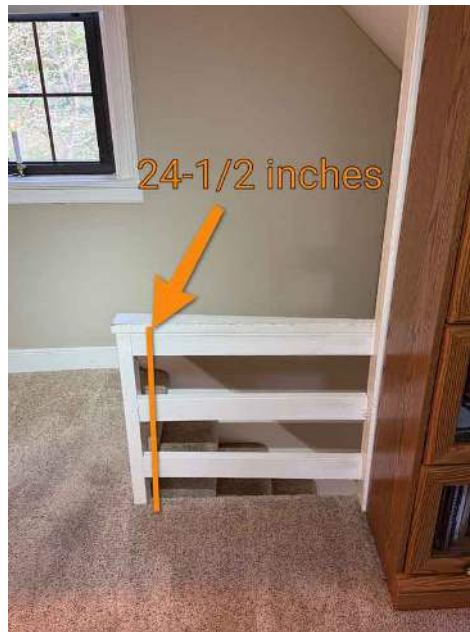
****Safety issue**** - I found a stairway railing that was too low. This railing presents a fall risk. The height of a handrail at a stairway should be 34-38 inches off the leading edge of the tread. I recommend a professional to repair this.

Handrails are required with 3 or more risers.
Stairway minimum width is 36 inches. Check with
local code authorities for specifics.

Illustration

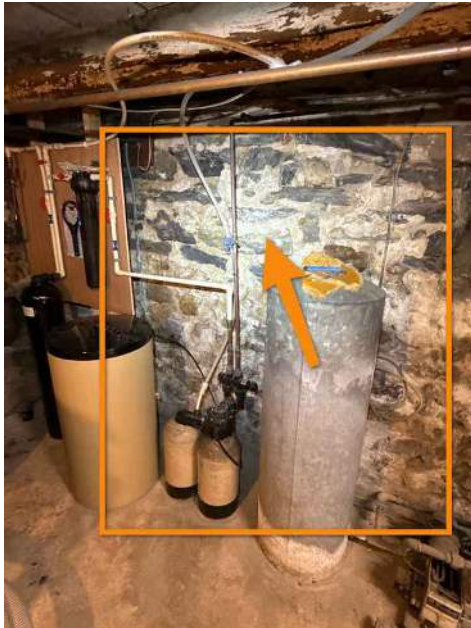
Perspective view

At the time of the inspection the mortar in the foundation wall was soft and crumbling. This condition is common in older homes with stone or brick foundation walls. This softer mix is vulnerable to moisture penetration from exterior ground water which causes the mortar (and brick) to soften and crumble. I recommend a qualified professional to evaluate and repair these areas. Often a parge coat (concrete mortar mix) spread over the area will stop the crumbling.

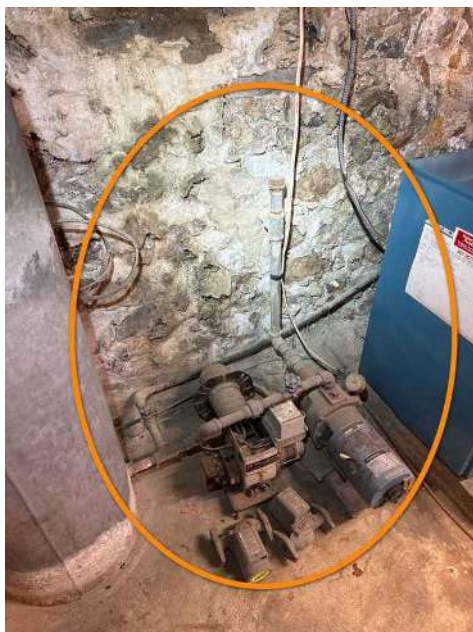
Inside well pump

The house had a secondary well with a pump that was not working. This plumbing system does not supply the main water source for the home and is therefore not critical for occupancy. However, if the well and its pump system would need to be activated, I recommend the qualified professional to evaluate the entire well and it's system.

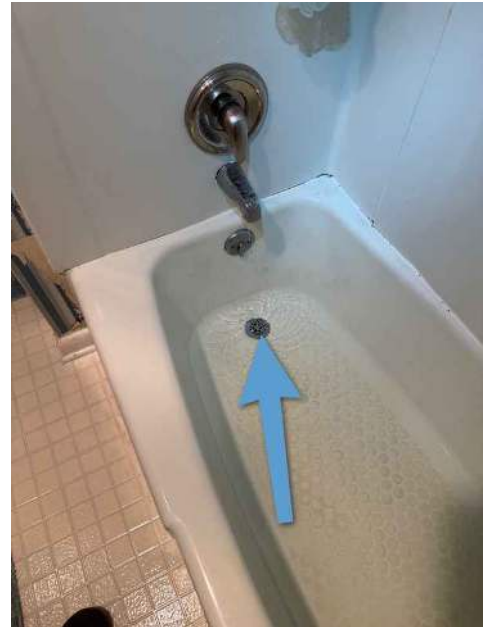
At the time of the inspection, I observed a drain that was slow. It may be clogged, in need of repair or the stopper is ineffective. I recommend a qualified plumber evaluate and repair as necessary.

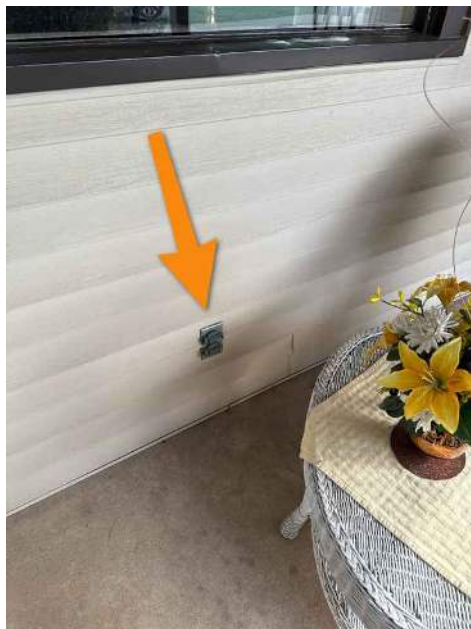
Left Side Porch

GFCI OUTLET(S) PROTECTION MISSING

*It is not recommended that a refrigerator outlet in a garage be on a GFCI outlet
