INSPECTION REPORT

466 E Main St
Leola, PA 17540

05/09/2025

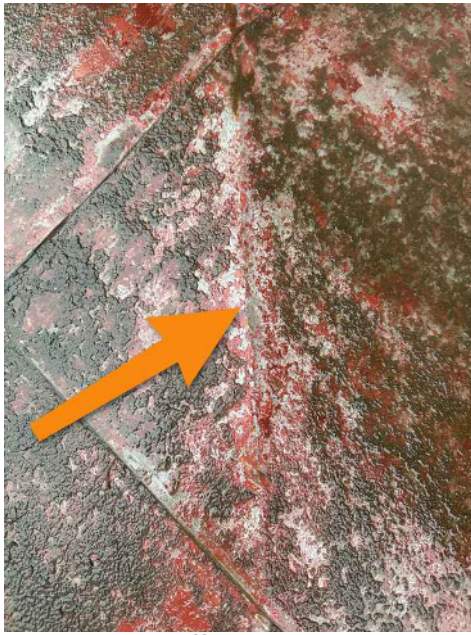
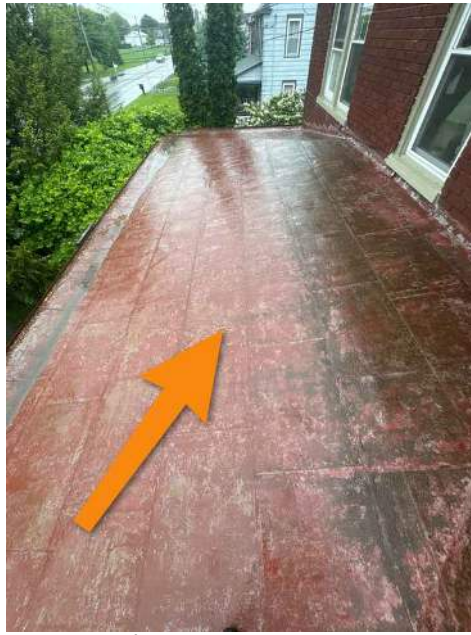
The home had a tin roof (along with other tin surfaces). Tin needs regular maintenance in order to maintain its usefulness. In most circumstances painting is the best option. I recommend regular maintenance of these surfaces by a qualified professional.

Paint wearing off

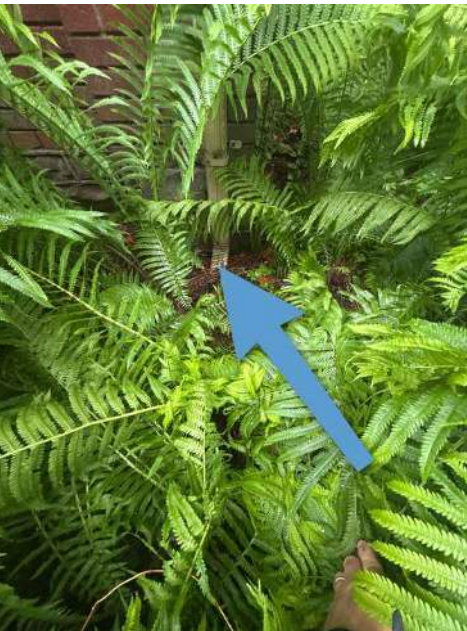
Front Right Side

At the time of the inspection one or more downspouts were discharging close to the structure. This can result in erosion and damage to the foundation structure because the soil remains constantly wet in this area. The recommended distance for a surface extension of a downspout is 4-6 feet from the structure. I recommend these downspouts be extended.

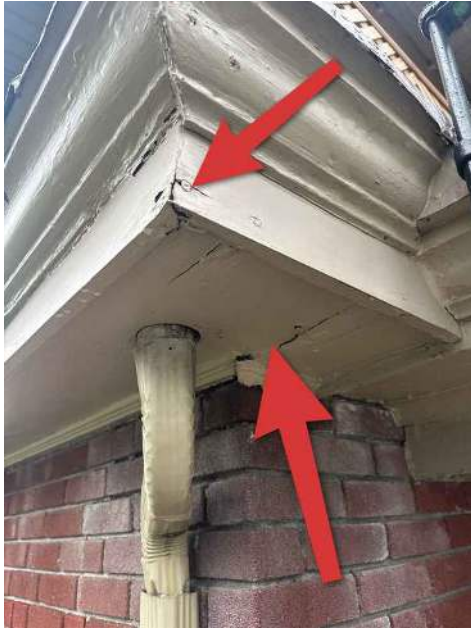
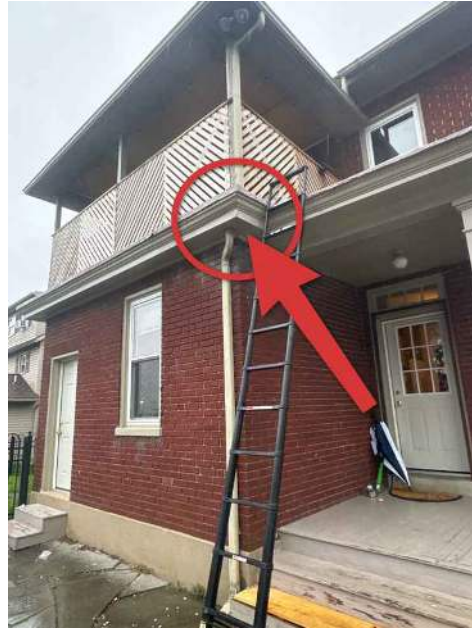
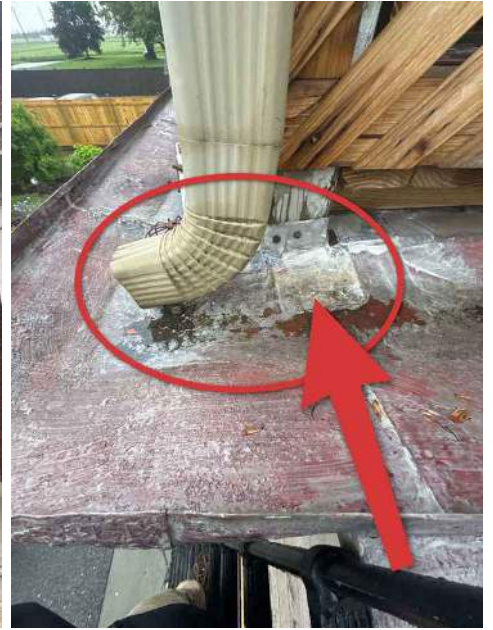
One or more sections of the and soffit are rotted. I recommend a qualified professional to evaluate and repair. The source of moisture penetration should be included in the evaluation.

Close up of wood rot

Wood soffit rotted

Flashing above may be allowing water to leak into soffit

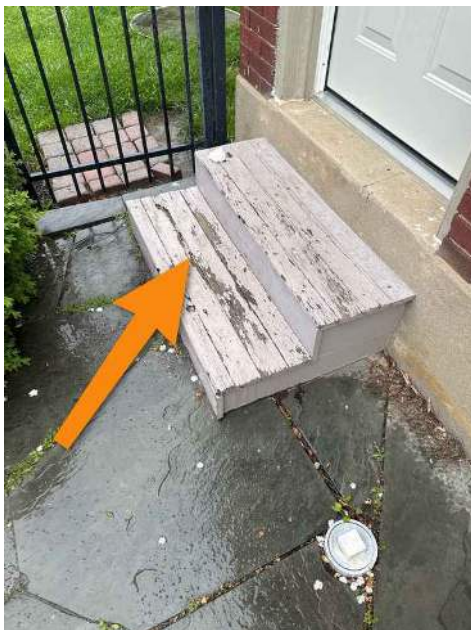
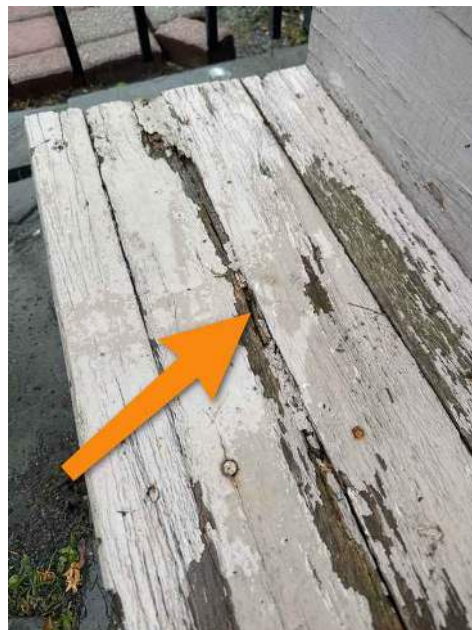
I observed rotten sections of the exterior steps in one or more locations. There is no structural concern at this time. However, I recommend a qualified contractor evaluate & repair.

Step boards beginning to rot

Close up

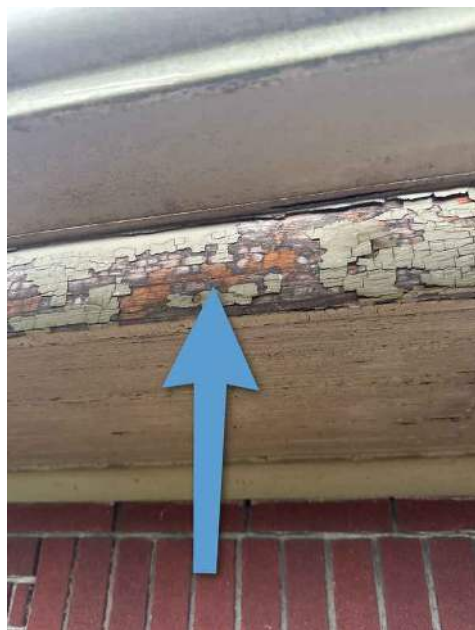
At the time of the inspection the painted exterior surfaces showed signs of peeling/blistering and exposure to weather in numerous locations. I recommend all the exposed surfaces be evaluated and maintained on a regular basis.

Close up

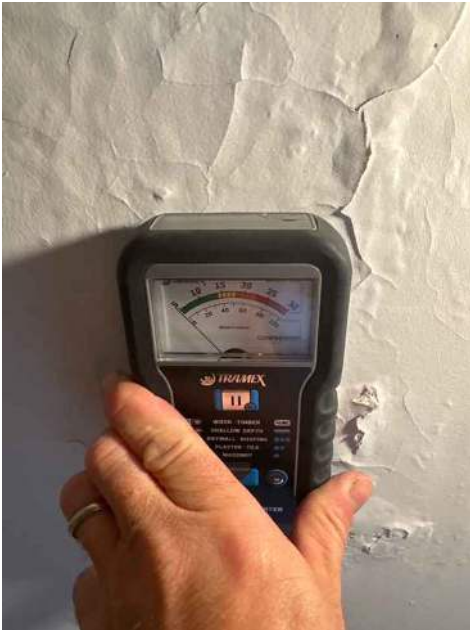
CEILING - DAMAGE FROM PAST LEAK

Currently dry on moisture meter

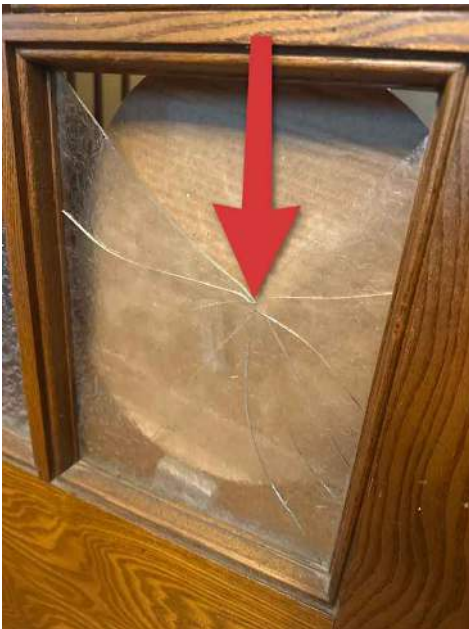
DOOR - BROKEN GLASS

Close up

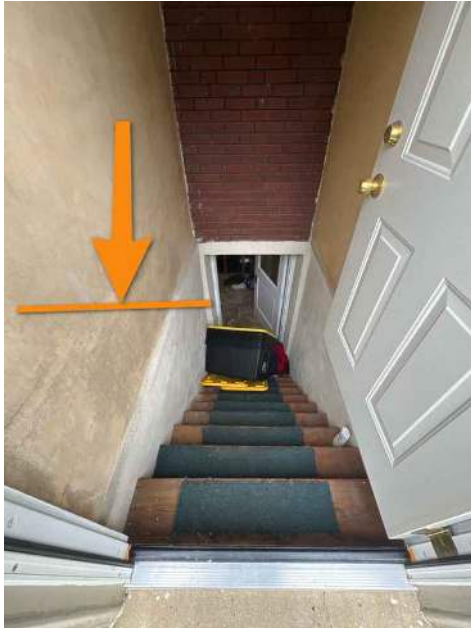
Rear Basement

****Safety issue**** - At the time of inspection, the staircase was missing a handrail as depicted in the photo. A handrail is required for safety when a stairway has more that four risers. This presents a safety hazard. I recommend a qualified professional install an additional handrail.

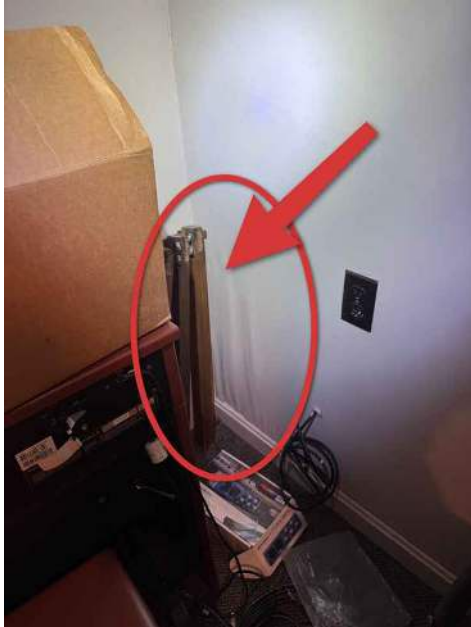
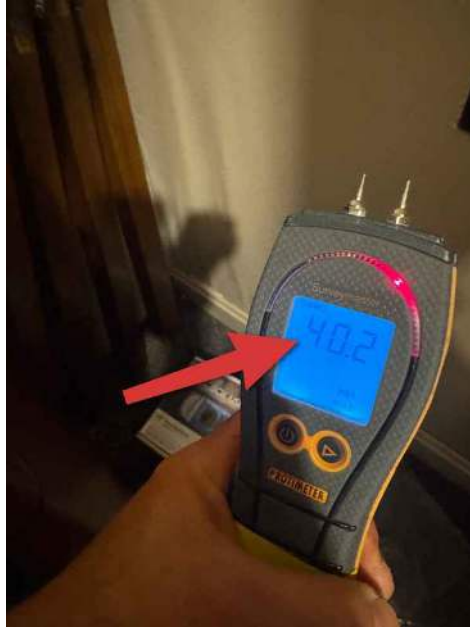
MOISTURE PENETRATION

Moisture appeared to be entering the foundation. See photos. Most moisture problems originate on the exterior. If the source is not identified, this moisture can cause significant damage. I recommend the exterior be evaluated in order to determine where the water is coming from and so repairs can be made to stop future water penetration.

Drywall is wet

Wet reading on moisture meter

Backside of wall wet

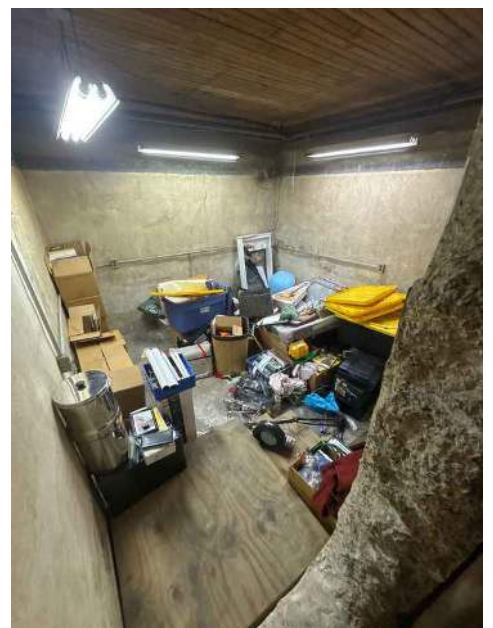
At the time of inspection I observed what appeared to be an abandoned cistern. This falls outside the scope of a home inspection. I recommend contacting a plumber for further evaluation.

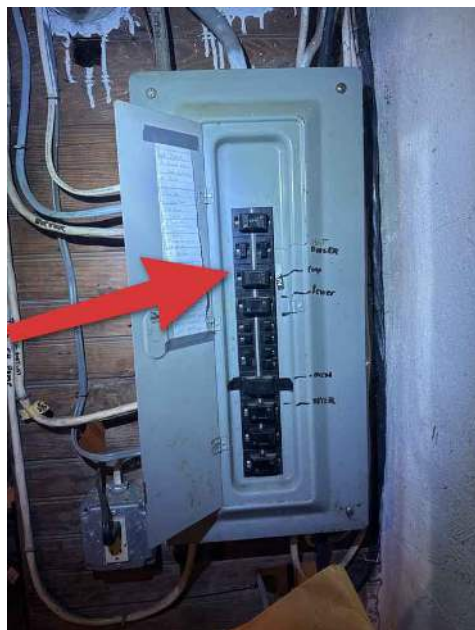
While the Pushmatic panels are not a huge fire hazard, they are a very old panel that is obsolete after the company went out of business. Finding parts is expensive and difficult and adding new circuits to your home electrical panel is impossible. Due to potential safety risks and an outdated design, upgrading to a modern panel is highly recommended for safety and reliability.

Pushmatic panel
