INSPECTION REPORT

328 Walnut St
Columbia, PA 17512

Renee Weaver
06/25/2025

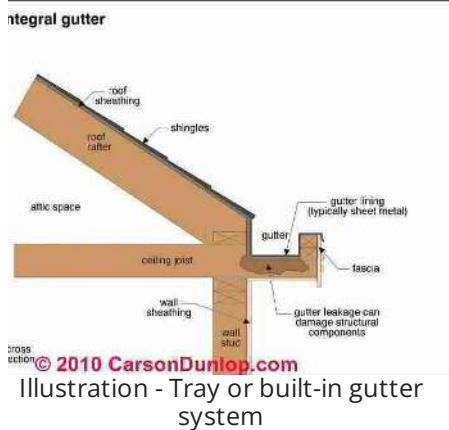
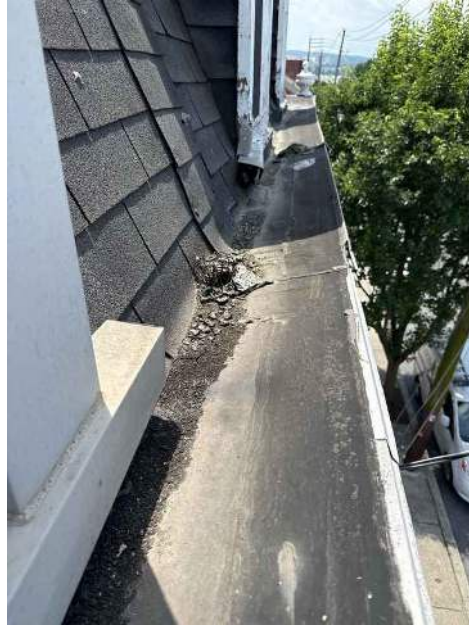
3rd Floor, Rubber

The drainage system made use of "tray gutters" (aka box gutters) in one or more places. These drainage gutters are "built in" systems that combine practical water drainage with architectural design. Often they are used in conjunction with built up soffits. These systems depend upon a thin layer of tin, copper, aluminum or rubber to divert water to the downspout. It is important to maintain these system with periodic cleaning and examination of all the joints. If not leakage can occur unnoticed causing damage. Because these systems are usually located on parts of the home that are not easily accessible and their joints are covered with debris, I highly recommend regular maintenance by a roofing professional.

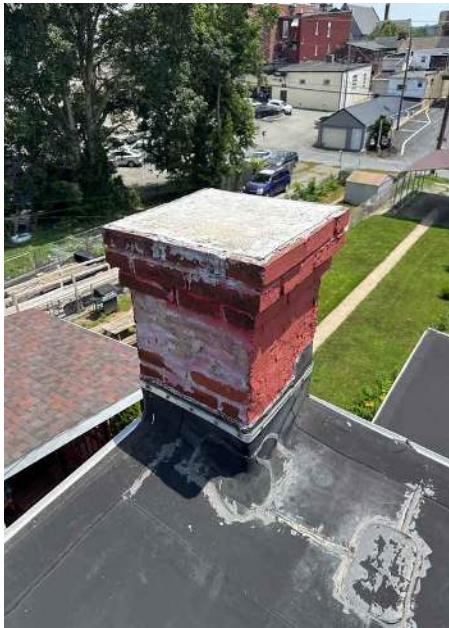
Abandoned rear chimney

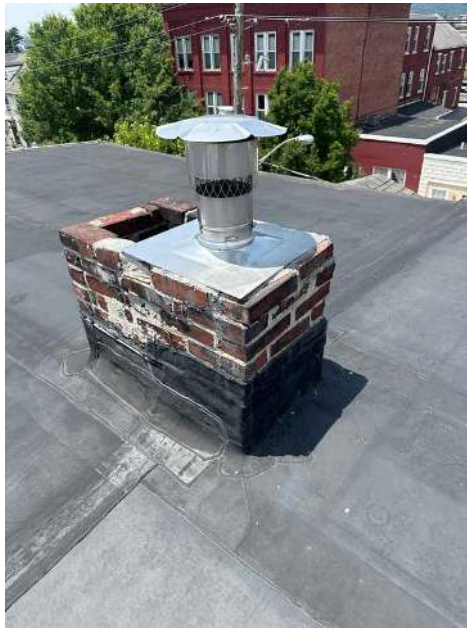
Main chimney

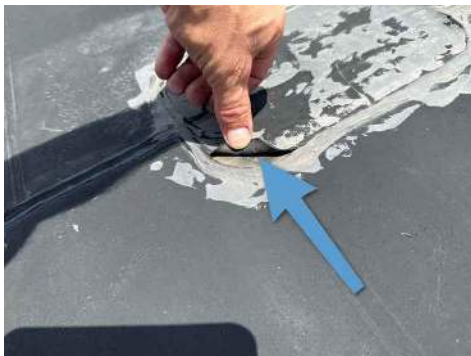
REAR 2ND FLOOR ROOF

At the time of inspection I observed rubber roof seams that need to be caulked. Seams like this need to be maintained with manufacture's recommended caulk to keep water and ice from penetrating the roof. I recommend a qualified rubber roofing professional to evaluate all the seams and repair.

Close up

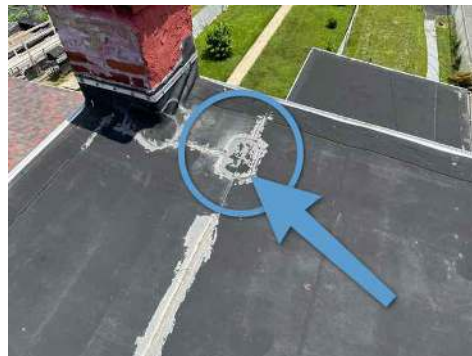
Caulk needed around patch

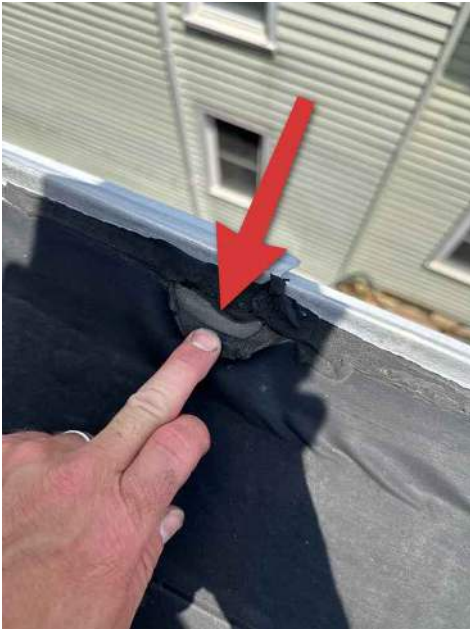
Close up

At the time of the inspection I observed a hole(s) in the roof. The roof is subject to leakage at this point. I recommend an evaluation and patching by a licensed professional.

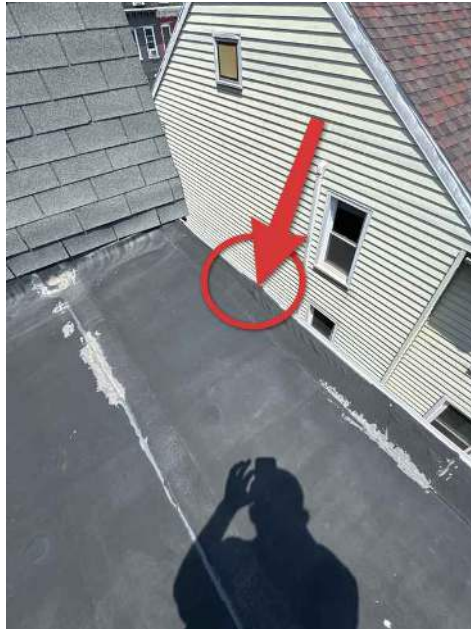
Hole in rubber edge seam

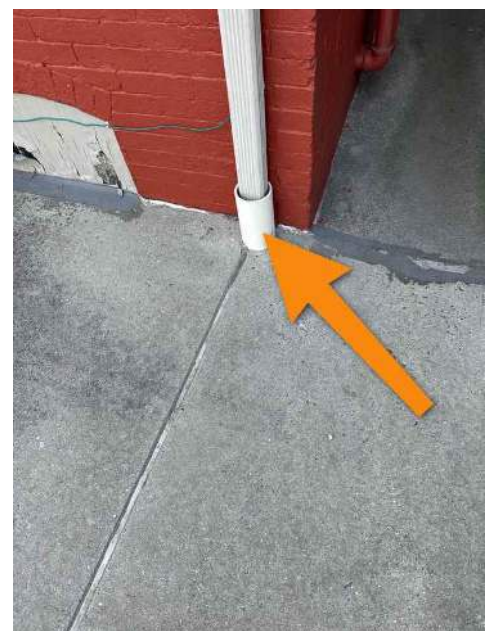
REPRESENTATIVE LOCATIONS

At the time of inspection I observed downspout drainage that entered underground piping in one or more places. In certain municipalities storm drains are connected to the public sewer system. It is not always possible to determine where these underground pipes deposit their water. I recommend a qualified professional to investigate with a video scope where these underground pipes empty and to confirm that adequate drainage is taking place away from the house.

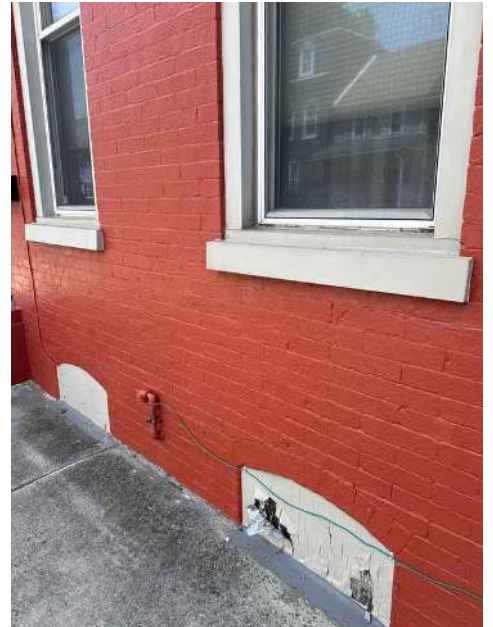
FRONT / RIGHT SIDE

PAINTED BRICK

All or portions of the brick was painted. This can provide an effective sealer to porous brick. It can also hide defects in the brick. Inspection of these hidden areas is outside the scope of this home inspection. An in-depth professional evaluation is recommended.

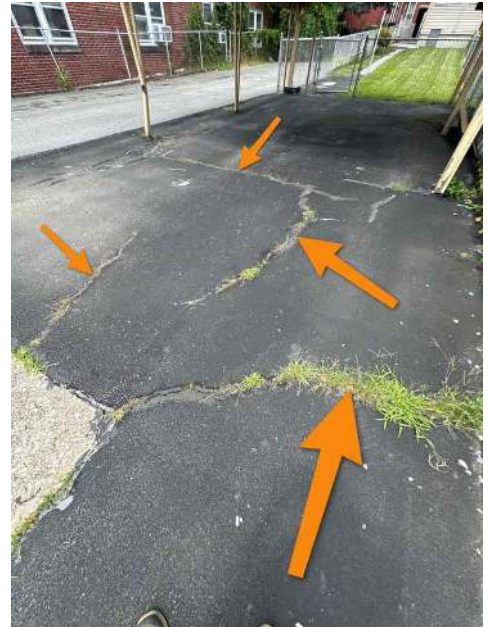
At the time of the inspection the driveway showed signs of moderate cracking. In order to maintain a serviceable surface, the driveway should be free from cracking and maintained with appropriate caulking. Because these photos may be representative of more than one crack, I recommend a qualified professional to evaluate the entire driveway and make recommendations for ongoing maintenance.

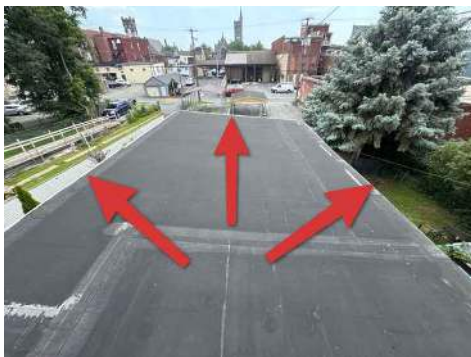
No railings around roof edge

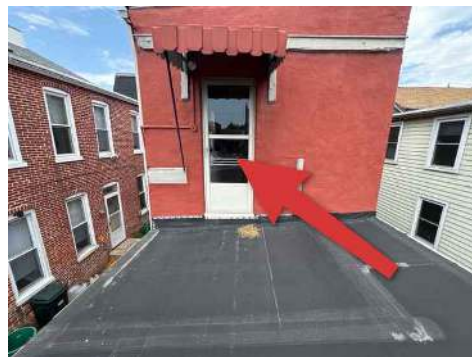
Door to open roof

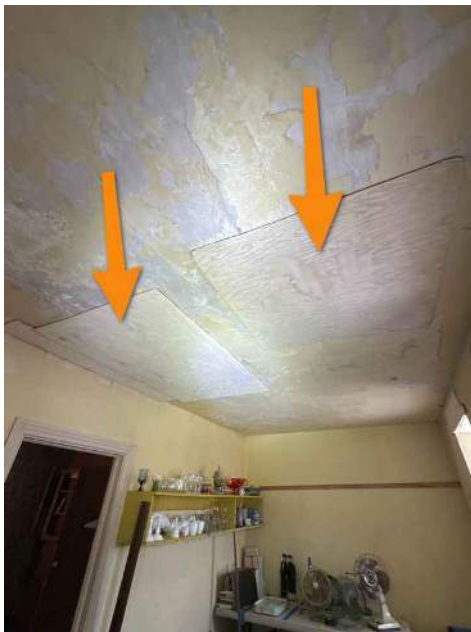
Front 3rd Floor Bedroom

I observed ceiling damage that appears to be the result of a past leak above. There was no moisture evident at the time of the inspection. I recommend a qualified professional confirm there will not be any further issues and to repair the area.

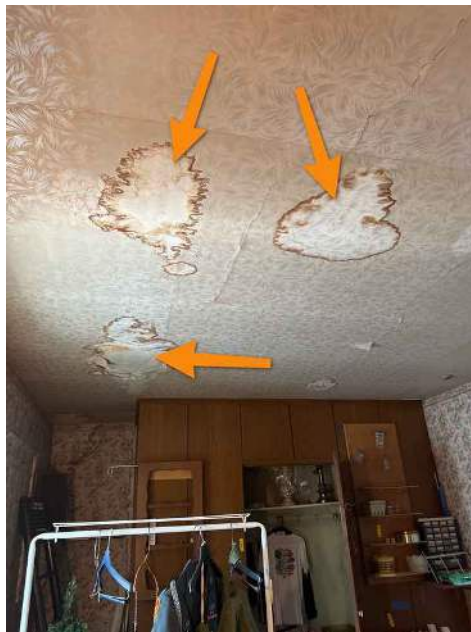
CEILING - DAMAGE/STAIN FROM PAST LEAK

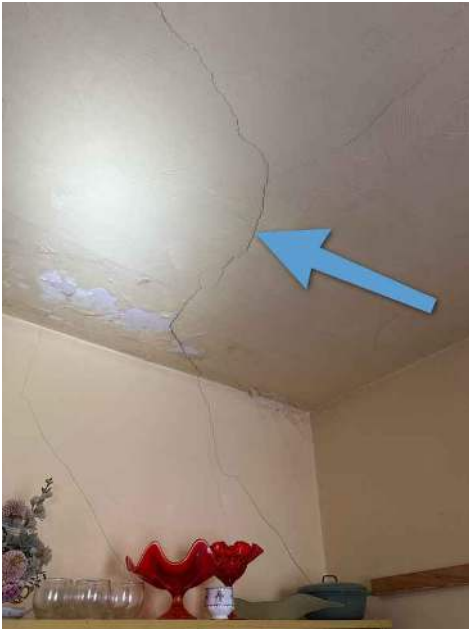
1st Floor Rear room

CRACKED CEILING - HAIRLINE

Ceiling plaster/drywall was cracked in one or more places. I did not observe any moisture at the time. I recommend cosmetic repair by a qualified professional.

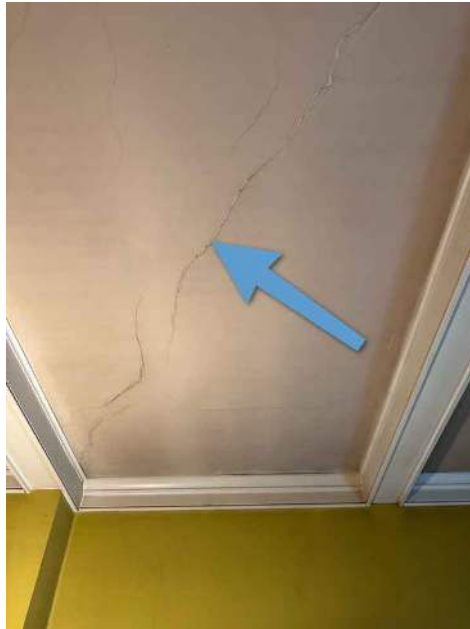
Front 1st Floor

I observed ceiling damage due to moisture penetration from above. There was a high level of moisture present at the time of the inspection. I recommend a qualified professional to locate the source of the moisture, eliminate it and repair the ceiling.

Ceiling damaged by moisture

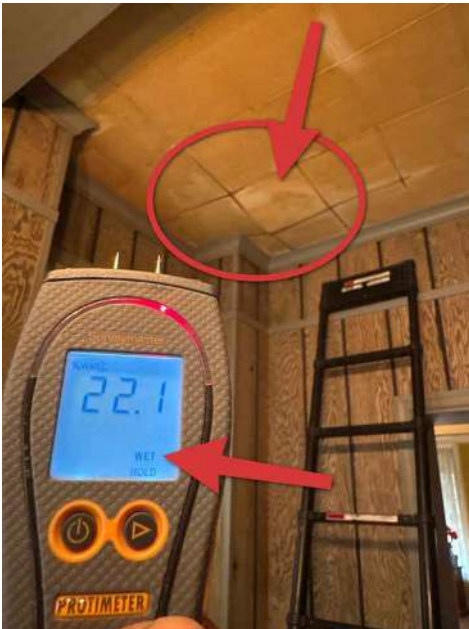
Wet Meter reading

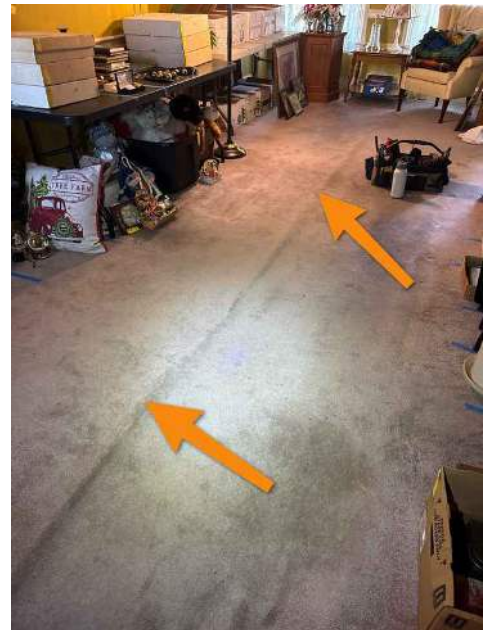
I observed rooms where the carpet needed re-stretching due to looseness, buckling or bulging. I recommend a qualified professional to evaluate and repair.

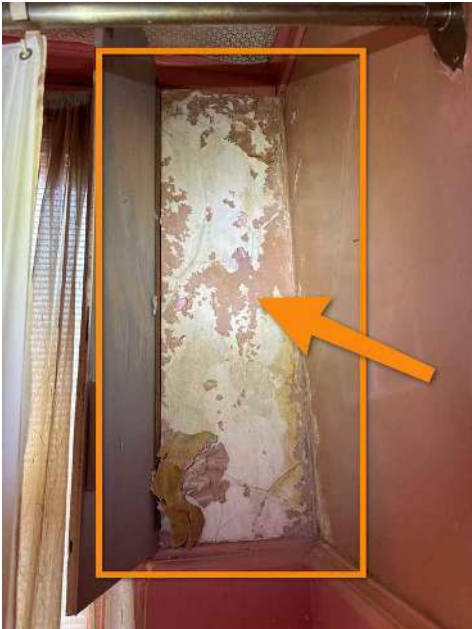
Open stairs

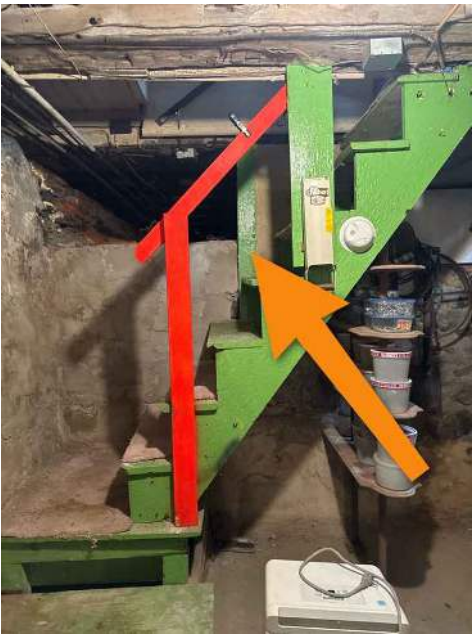
****Safety Issue**** - At the time of the inspection I found a stairway that was open at the railing and at the stair risers. It did not have adequate balusters or railings and was missing stair risers. These protect against falls (think children and elderly). I recommend a qualified professional to add necessary railings and/or balusters.

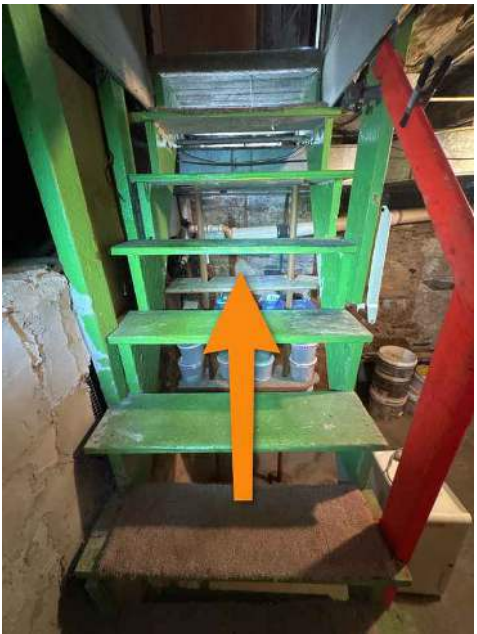
Open risers

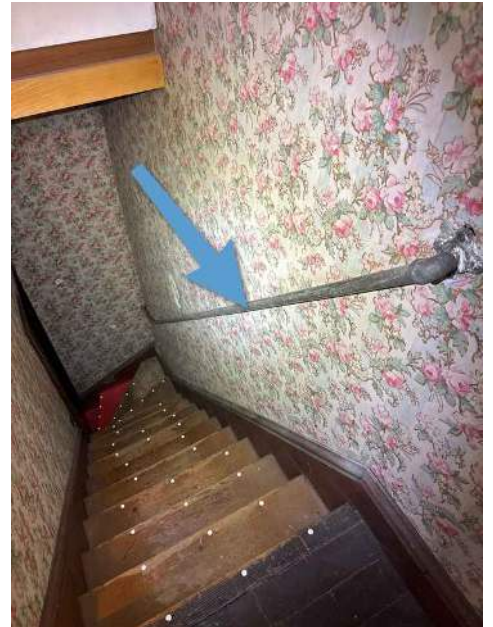
At the time of the inspection a portion of the hand railing was loose. Consult with a qualified professional to discuss repair.

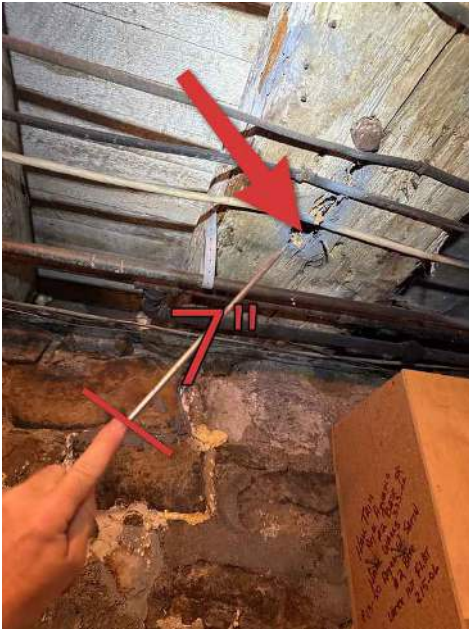
Screwdriver plunged all the way through beam

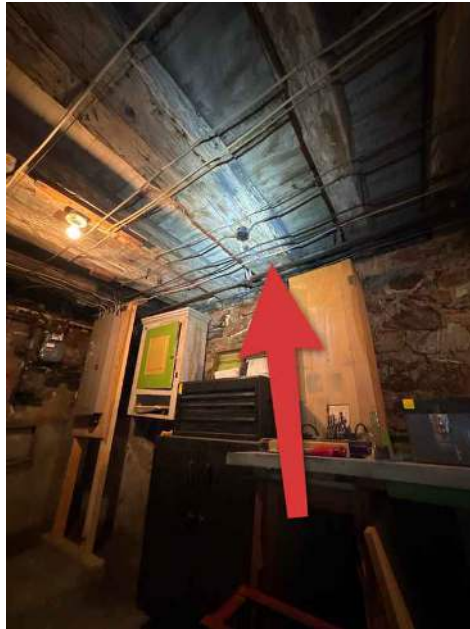
Front Left Side beam

Floor beams or joist were damage in several locations. This may present a structural issue. A qualified professional should evaluate and repair.

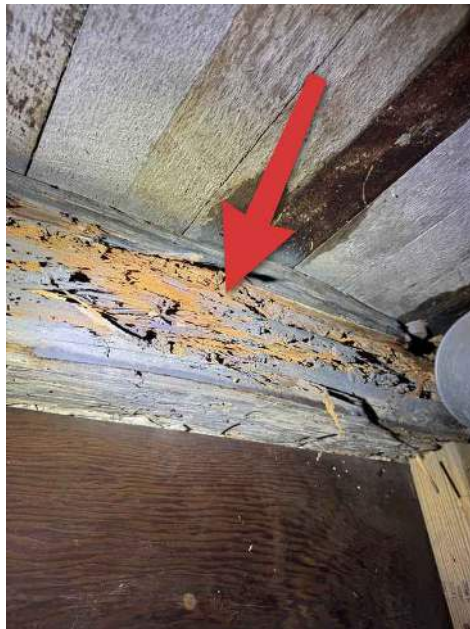
Wood damaged by termites

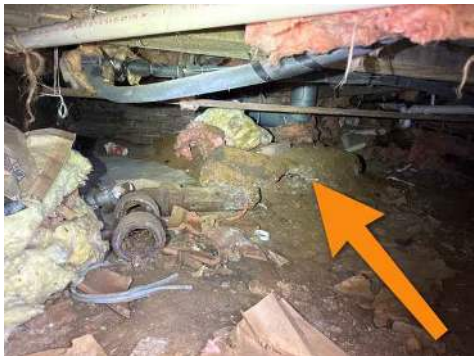
Rear Crawlspace

At the time of the inspection I observed that all or part of the crawlspace was dirt. This condition allows for increased moisture and pest intrusion resulting in increased damage to the home. Consider installing an effective vapor barrier. I recommend this space be cleaned and upgraded to a conditioned space.

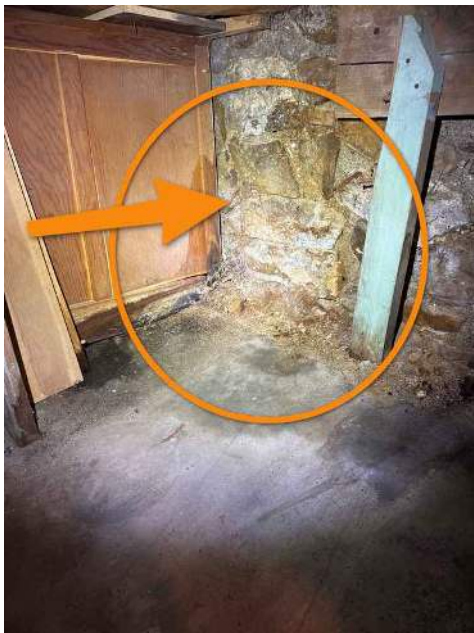
Close up - moisture appears to be seeping through foundation wall

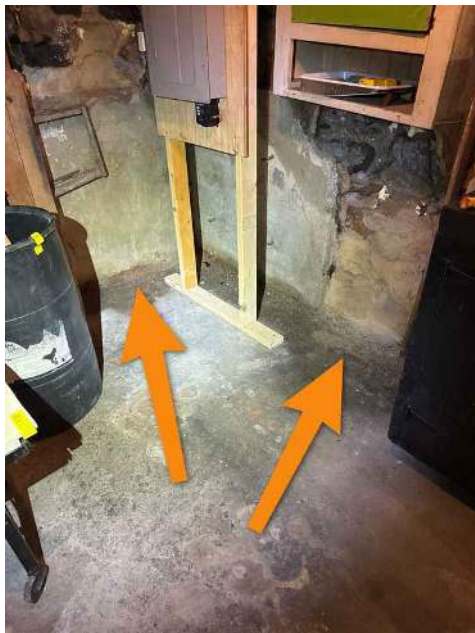
Front Left Side

Moisture appeared to be entering the foundation. See photos. Most moisture problems originate on the exterior. If the source is not identified, this moisture can cause significant damage. I recommend the exterior be evaluated in order to determine where the water is coming from and so repairs can be made to stop future water penetration.

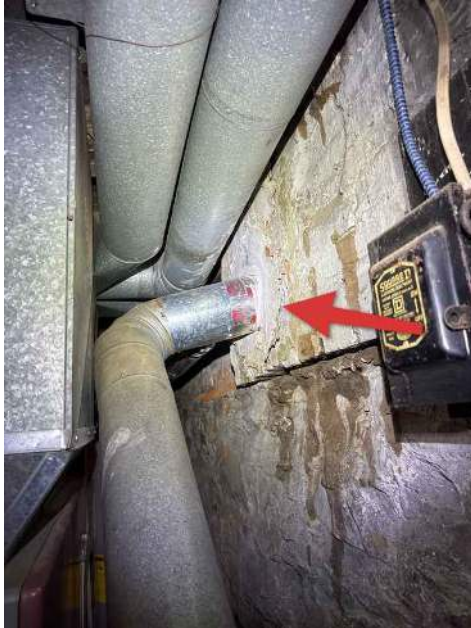
****Health Hazard**** At the time of the inspection I observed cracking or an open gap where the flue pipe enters the chimney. This joint should be sealed so that the products of combustion don't leak. This presents a health hazard. I recommend a qualified professional to evaluate and seal the joint.

Seal around vent delaminating

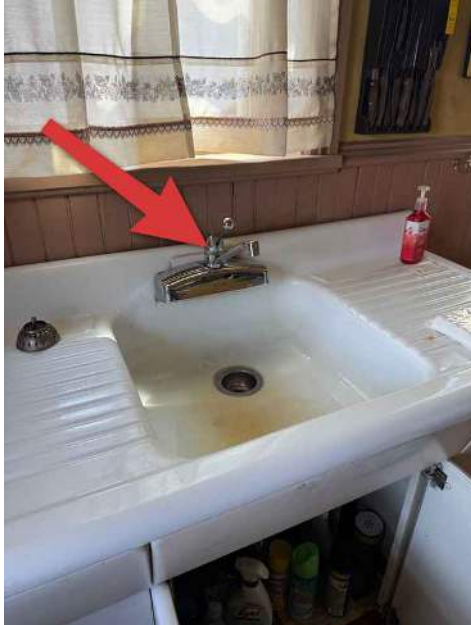
2nd Floor Kitchen

FAUCET LEAK

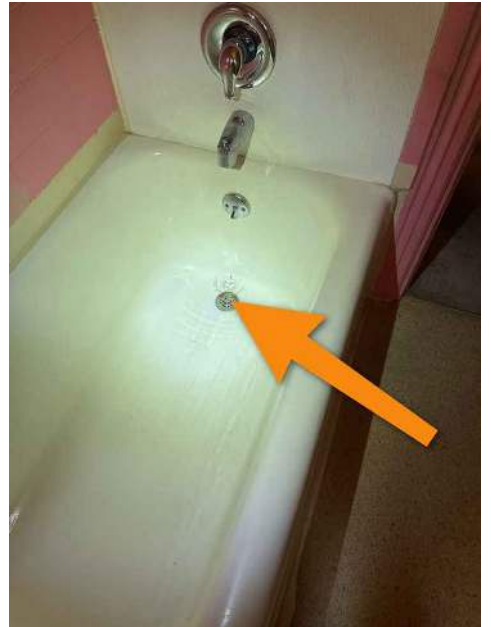
At the time of the inspection, I observed a drain that was slow. It may be clogged, in need of repair or the stopper is ineffective. I recommend a qualified plumber evaluate and repair as necessary.

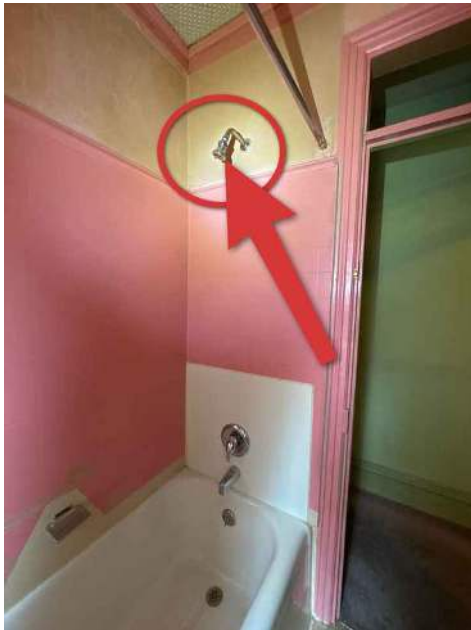
At the time of the inspection the bath shower diverter was not working. I recommend a qualified professional to repair or replace this valve so that the shower head functions.

Shower not working

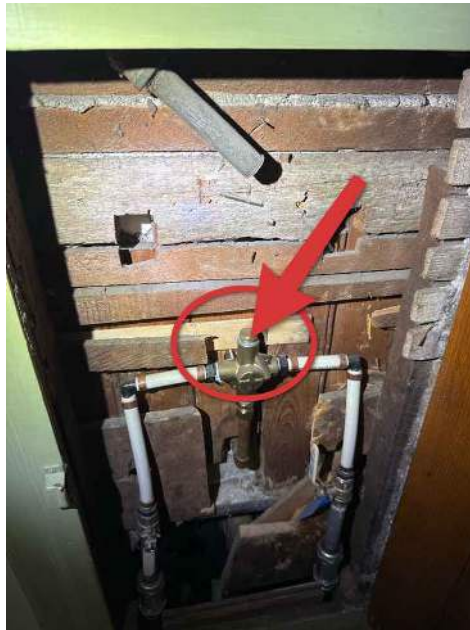
Shower disconnected

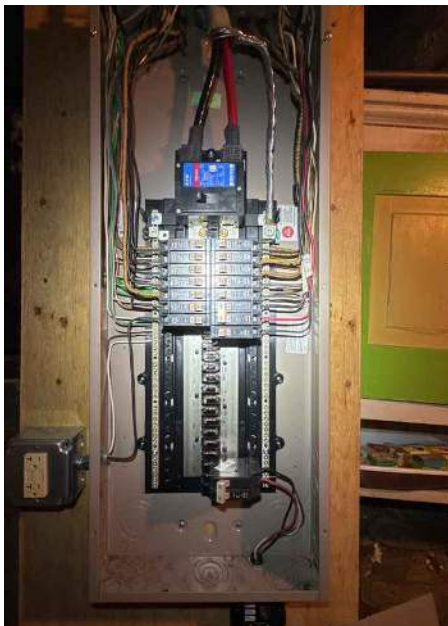
Basement

Electrical panels are considered continuous-use appliances because they are always on. They experience daily heating and cooling of their components. As such, they should be replaced periodically. The average life of a panel is 30-50 years depending upon many factors. I recommend a qualified professional to evaluate this panel to determine if this panel should be updated to a newer panel.

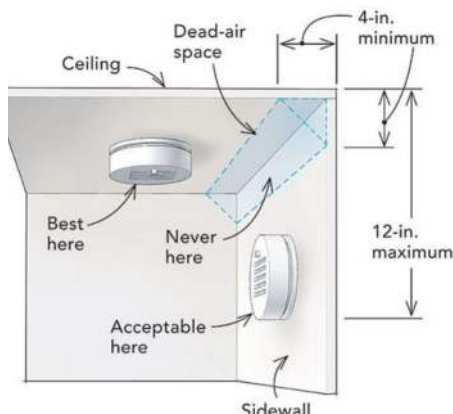
Outside bedrooms, Missing smoke alarms, in 3 bedrooms

Safety -- The inspector shall comment on the presence or absence of smoke detectors in all required areas. To be effective, these detectors should be permanently mounted according to local codes and with appropriately operational batteries or hard wiring. I recommend the whole house be equipped with smoke detectors in the areas that are required by local municipality codes. A home inspection does not include testing the functionality of smoke or carbon monoxide detectors. Smoke Alarms

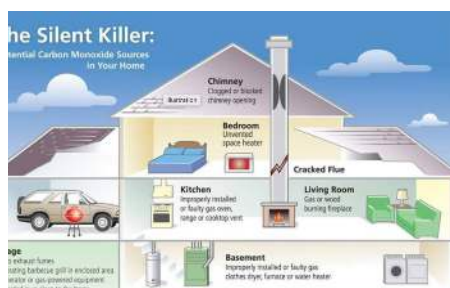
Missing CO detector, Outside bedrooms, 3rd Floor, Basement, 1st floor

Suggested locations

Safety -- At the time of the inspection, carbon monoxide detectors were missing in areas most often recommended by municipalities. To be effective, these detectors should be permanently mounted according to local codes with appropriately operational batteries, or, hard wired. I recommend the local municipalities be consulted and carbon monoxide detectors be installed the recommended areas. CO Detectors

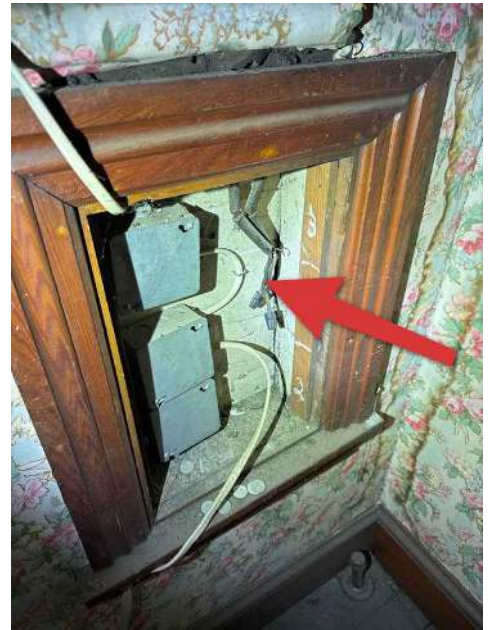
At the time of inspection I observed an abandoned wire that was not terminated in a receptacle or junction box. The wire was hot. This presents a potential fire/shock hazard. I recommend a qualified electrician to terminate the wire in a junction box or eliminate.

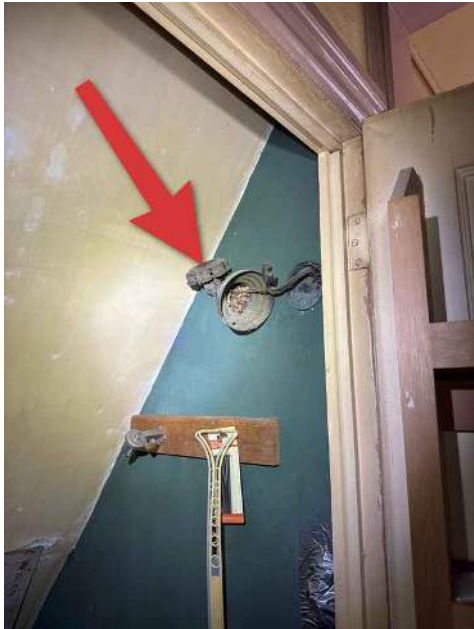
2nd Floor Kitchen Closet

FIXTURES NOT WORKING

I observed one or more light fixture(s) and/or switch(es) that did not appear to be working. They did not respond to normal switching. The bulb may need to be replaced. There may also be a photocell connected to the light (if exterior). If that does not work, I recommend a qualified professional to evaluate.

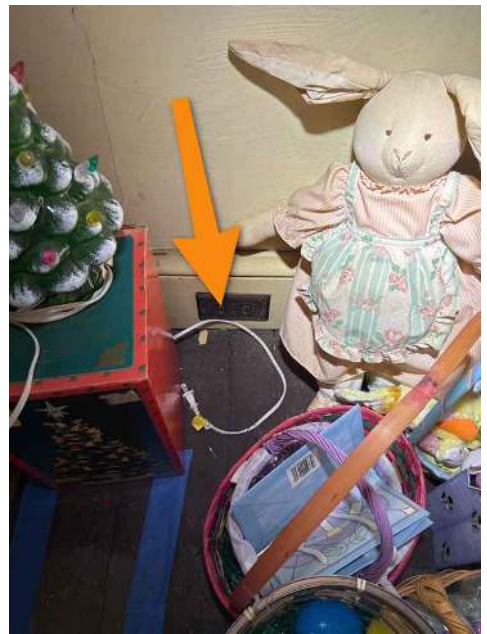
3rd Floor

2-SLOT RECEPTACLES

2-slot receptacles (outlets) were installed in one or more areas. This is considered old wiring and does not have an equipment ground and is considered unsafe by today's standards. In some cases Knob and Tube wiring is behind the wall. In which case it should be evaluated by an electrician. Appliances that require a ground should not be used with 2-slot receptacles. Examples of such appliances include computers and related hardware, refrigerators, freezers, portable air conditioners, clothes washers, aquarium pumps, and electrically operated gardening tools. The client should be aware of this limitation when planning use for various rooms, such as an office. Upgrading to grounded receptacles typically requires installing new wiring from the main service panel or sub-panel to the receptacle(s), in addition to replacing the receptacle(s). The NEC (National Electric Code) also allows these outlets to be replaced with GFCI protection as a repair to use grounded appliances with them. Consult with a qualified electrician about upgrading to 3-wire, grounded circuits or installing GFCI protection.

I recommend a professional be consulted who can offer an opinion on the current condition of these outlets and their circuits.

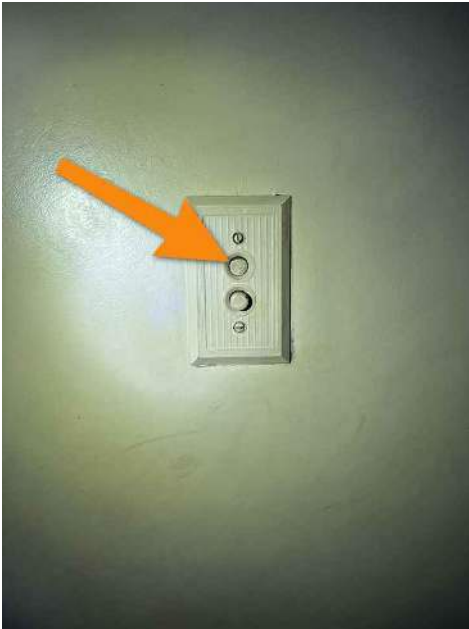
At the time of the inspection I observed electrical switches that were old and outdated. This may be an indicator that knob and tube wiring is present and active in the home. These switches should be evaluated by a licensed electrician.

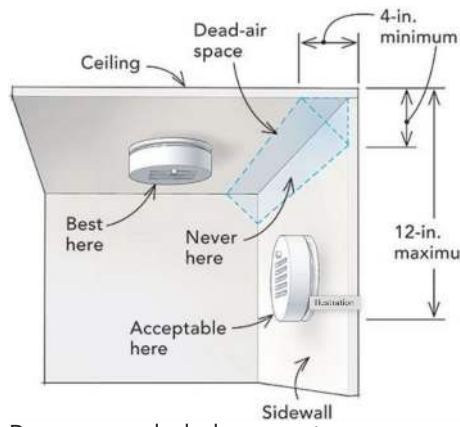
Recommended placement

Your home inspector will report on the presence or absence of smoke alarms and carbon monoxide alarms in their proper places throughout the home. We recommend upgrading to the recommended house map included below.

Because actual testing of smoke and CO alarms will not be performed I recommend that all smoke alarms and CO alarms present or absent **be professionally replaced or evaluated upon taking possession of the home.**

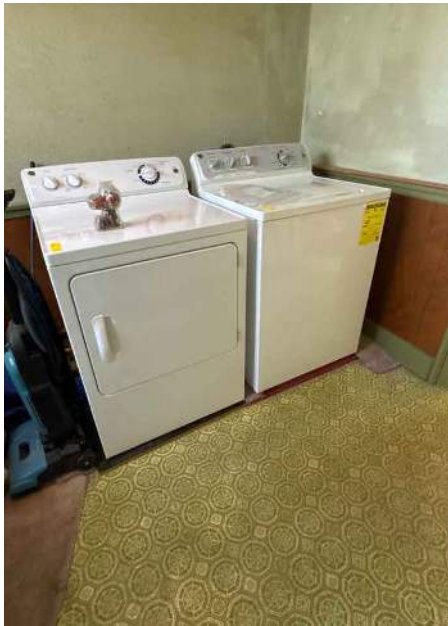
Rear 1st Floor

At the time of the inspection there was a washer and dryer present. Inspecting washer and dryer operation is not within the scope of a home inspection.

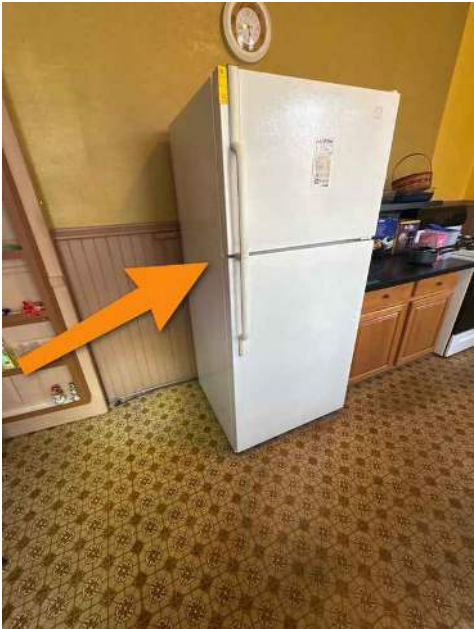
At the time of inspection, I could not determine the condition of the refrigerator because it was not plugged in or was off. Without complete knowledge of why the unit was unplugged, I could not ensure that plugging it in would not damage it or cause a plumbing leak in the event of an icemaker/water line. I recommend evaluation by a licensed professional prior to settlement.

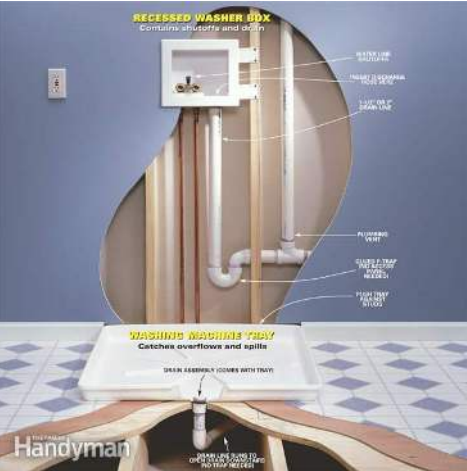
Illustration

At the time of inspection there was no drain pan under the washing machine. The absence of a drain pan can result in significant damage to walls and floors in the event of a water leak at the washer. I recommend a qualified professional install a drain pan waste line for the pan.

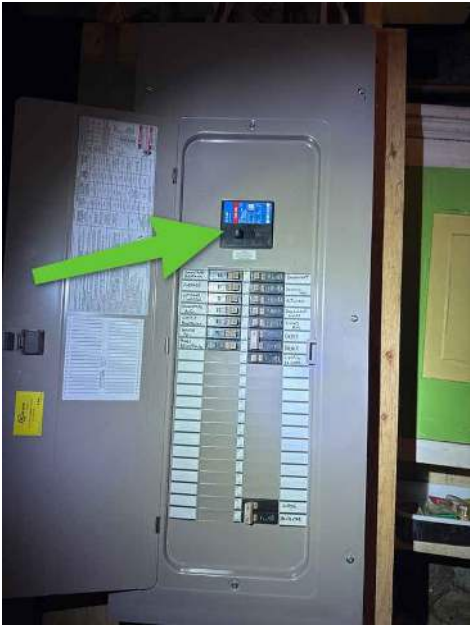
Basement

Electric: Electric shut off

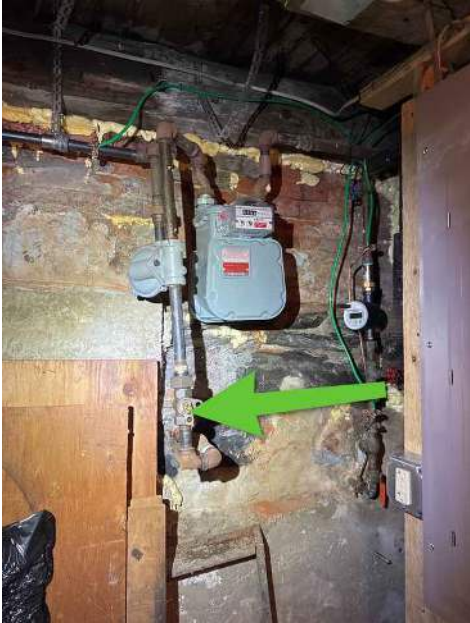
Basement

Gas: Gas

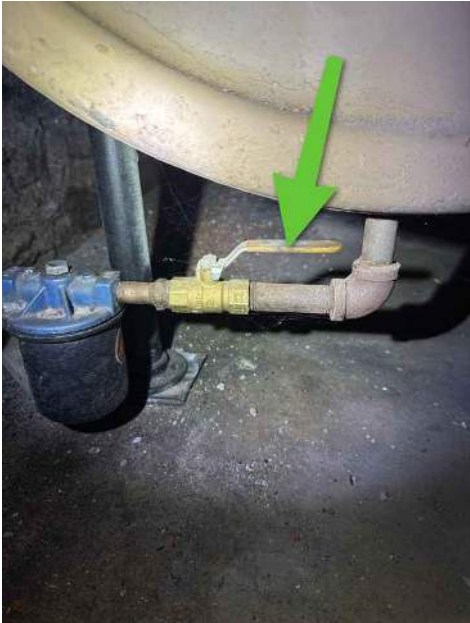
Basement

Oil: Oil shut-off

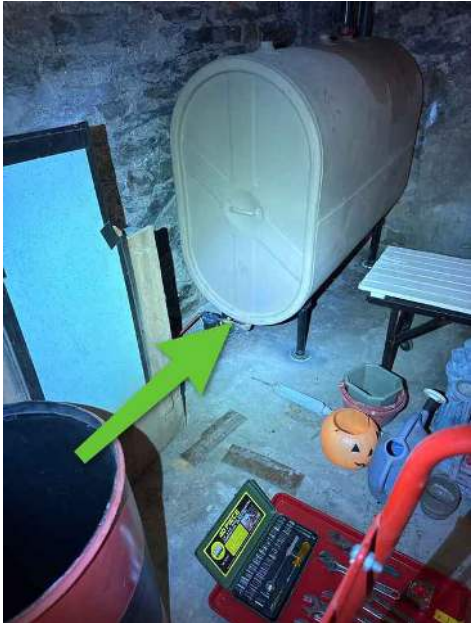
Oil shut off valve
