Residential Property Inspection|PA Report

Report No. 2503131

Property Address:
461 Shelleys Lane, Etters, PA 17319

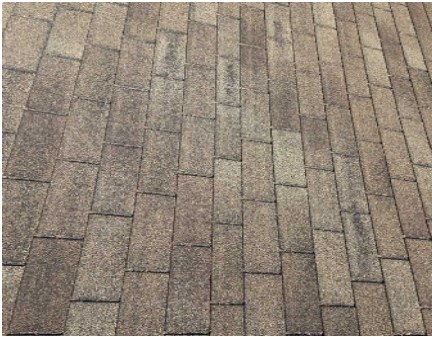
Roof & Chimney**Roof****Asphalt Composition Shingles****• Major Weathering Observed**

Weathering is a general term used to describe the effects on shingles of long-term exposure to the elements. Weathering is a natural process that causes shingles to deteriorate over time. The rate at which shingles weather can be affected by a number of factors to include: shingle quality; structure orientation; degree of roof slope, climate, thermal cycling; roof color; elevation, roof structure ventilation and quality of maintenance. When major weathering occurs to a roof's covering, this usually indicates that the roof covering has been compromised. It is suggested that a qualified specialist be contacted to determine replacement procedures and costs.

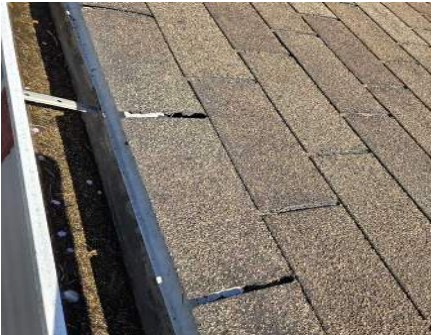
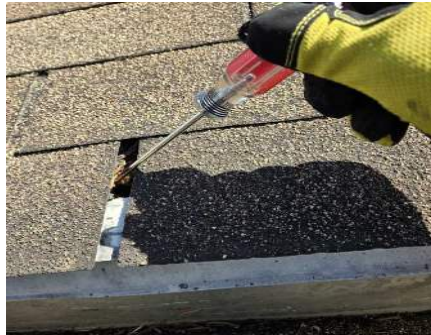
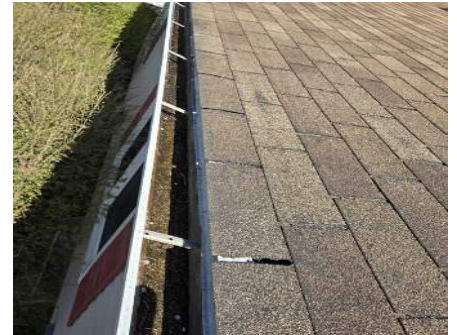
Location: Front and rear along gutters over eaves

**• Underlayment and/or Substrate Damage Observed**

It is suggested to have a qualified specialist further evaluate and make corrections as needed.

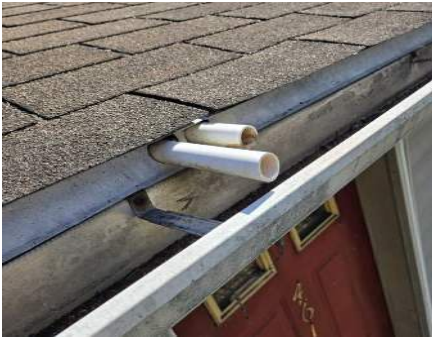
• Air conditioning condensation lines improperly drilled and run through drip edge and fascia, subject to water infiltration, suggest relocation

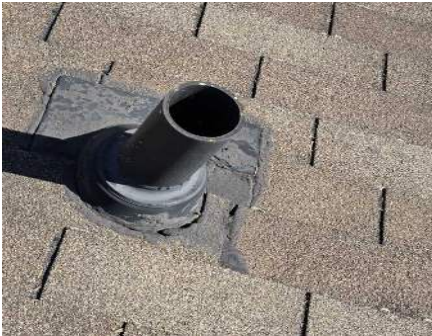
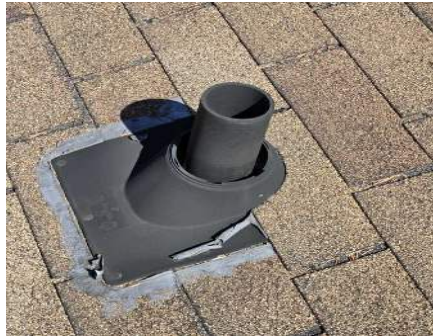
• Roof Pipe Flashing Damaged

Pipe flashing, sometimes referred to as a roof boot, is manufactured to seal tightly around small ventilation pipes, plumbing, and other vents and equipment that protrude from the roof of a home or commercial building. The flashing is necessary to prevent leaks. The base is typically a flexible metal so that it is compatible with virtually any roofing material. It is suggested to have a qualified specialist make corrections as needed.

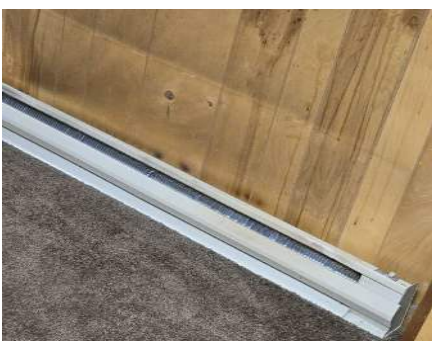
- Basement units all mounted up side down, suggest corrections by qualified specialist

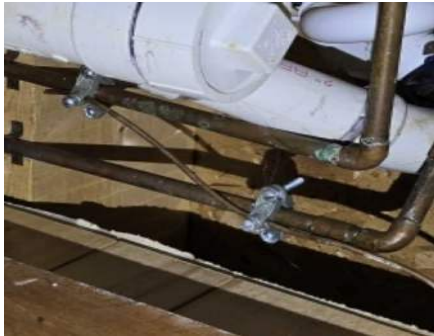
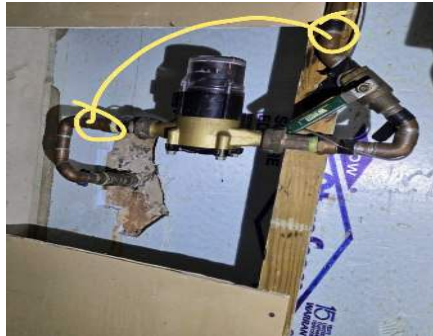
Location: At water meter/ equipment. Ground run to water lines, but missing jumper around meter equipment.

• Ground Electrode Conductor (GEC) Continuous Path Broken

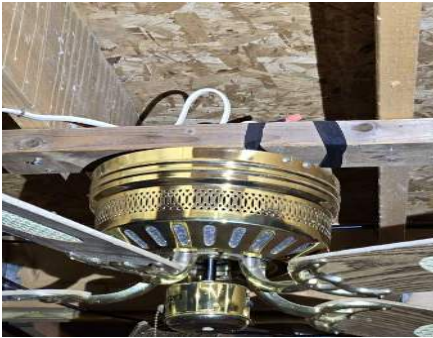
Location: Unfinished basement ceiling fan missing box.

- Exposed Wiring Splices Observed

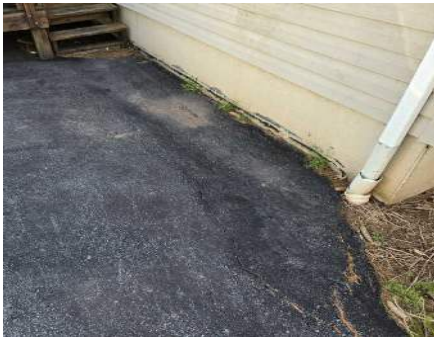
- **Asphalt.** Asphalt is a combination of rocks, sand and black sticky asphalt cement that serves as the glue to bind the pavement. It is durable, long lasting, and easy to maintain.
- **Driveway Abuts The Structure.** It is suggested to seal along the area where the driveway abuts the structure to help reduce water penetration.
- **Common Cracks Observed.** It is suggested any cracks sealed or resealed, monitored and maintained to prevent further deterioration as a part of good maintenance.
- **Surface Settlement Observed.** The soil below the driveway has settled. Resurfacing, leveling or patching may be necessary to correct the deficiency. If significant, it is suggested to have a qualified specialist make corrections as needed.
- **Location:** Against house foundation

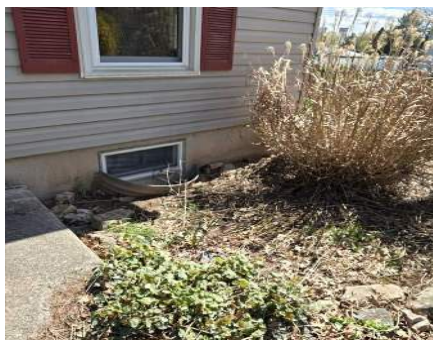
- **Flat Site**
- **Minor Slope**
- **Improper Soil Slope Toward Foundation.** This condition adds to the potential of moisture penetration and/or water entry in basements, crawl spaces, windows and doorways of a structure. It is suggested that proper regrading of the soil adjacent to the foundation at the areas noted in your report be completed. Soils should slope away from the structure at a rate of one inch per foot for at least the first six feet.
- **Location:** Room for improvements on all sides

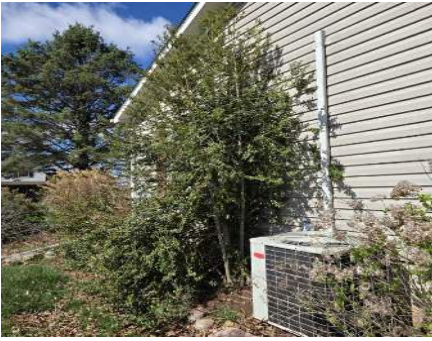
- **Vegetation In Contact With The Structure.** All vegetations should be trimmed away from the structure. It is suggested to have a qualified specialist make corrections as needed.

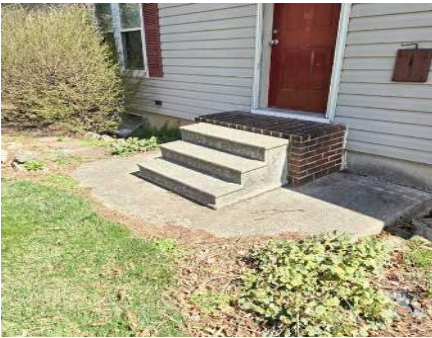
- Front

- **Porch Settlement Observed.** The soil below the porch has settled. Minor settlement may occur over the life of a porch and is not considered a structural defect. Resurfacing, leveling or patching may be necessary to correct the deficiency. If significant, it is suggested to have a qualified specialist further evaluate and make corrections as needed.

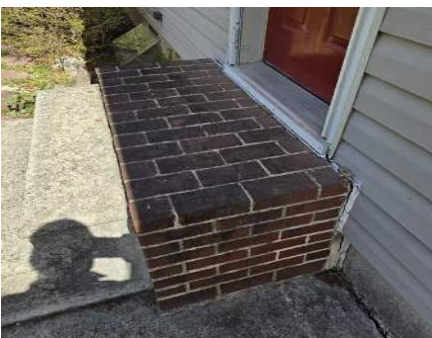
- **Porch Abuts Structure.** It is suggested to seal along the area where the porch abuts the structure to help reduce water penetration.

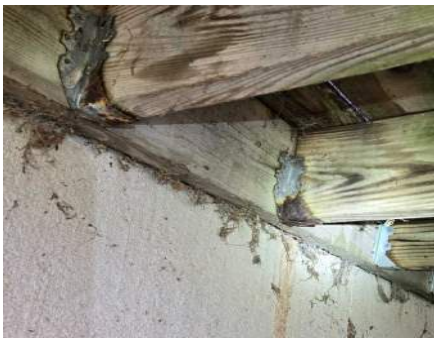
- **Joist Hanger(s) Deterioration Observed.** Joist hangers are used to secure and support joist attachments in deck construction. Every hole in a structural hanger should be filled with an approved structural fastener/screw or nail. It is suggested to have a qualified specialist make corrections as needed.

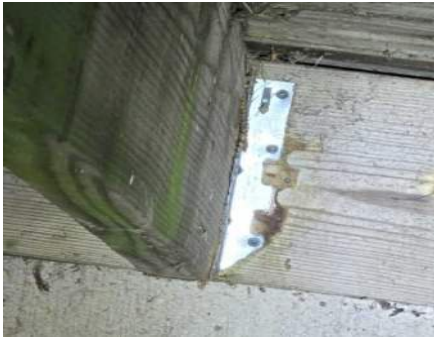
- **Improper Joist Hanger Fasteners Installed.** Current fasteners are not intended for use in hangers. Every hole in a structural hanger should be filled with an approved structural fastener/ screw or nail. It is suggested to have a qualified specialist make corrections as needed.

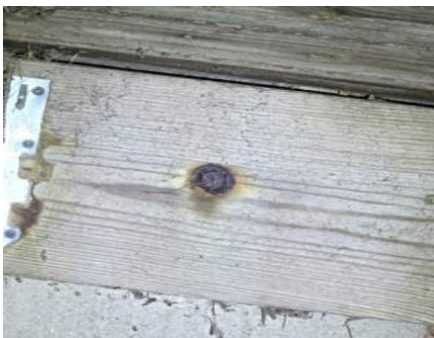
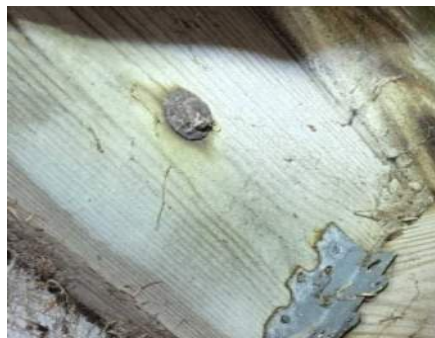
- **Curling, Cupping and/or Cracking To Deck Material Observed.** It is suggested to have qualified specialist make corrections as needed.
- **Structural Components Moisture Damage Observed.** It is suggested to have qualified specialist make corrections as needed.
- **Location: Ledger bolts corroding**

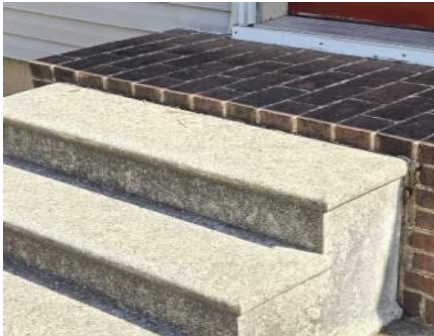
- **Concrete.** Concrete steps will usually crack somewhat depending on climate and installation practices, but if adequately thick, supported on proper gravel base and use of control and expansion joints, it may last for decades. Do not spread salt on concrete surface as it will likely deteriorate the surface.
- **Uneven Riser Height Observed.** The rise is the vertical distance from the top of one tread to the top of the next. The maximum rise is 7.75 inches. An uneven riser height can be a tripping hazard. It is suggested to have a qualified specialist make corrections as needed.
- **Location:** From concrete steps to brick

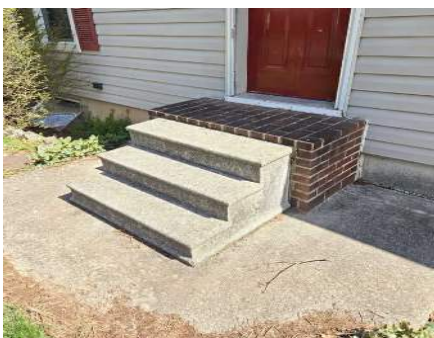
- **Handrail(s) Not Installed.** Handrail(s) should be provided on a stairway with four or more risers or height that exceeds 30 inches above grade. This includes guardrails around stairway openings. However, local building codes or other regulations may require handrails for stairways with fewer risers. It is suggested to have a qualified specialist make corrections as needed.

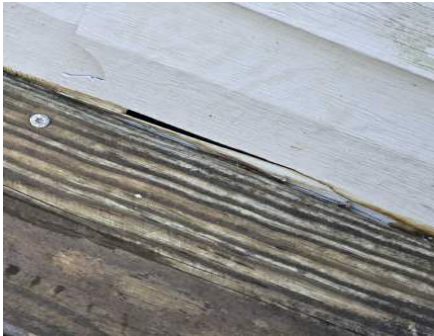
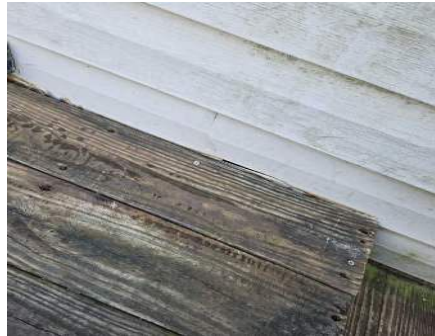
- Satisfactory
- **Damaged Siding Observed.** It is suggested to have a qualified specialist make corrections as needed.
- Location: At left side deck

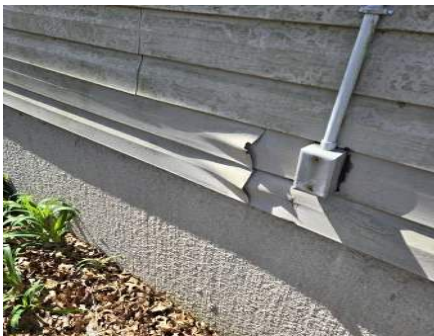
**Wall Coverings Inspector's Remarks**

- Melted siding from having grill too close. Suggest monitoring or preventative corrections

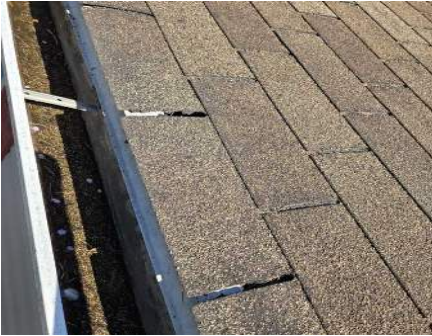
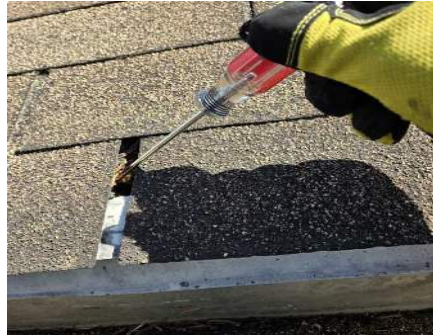
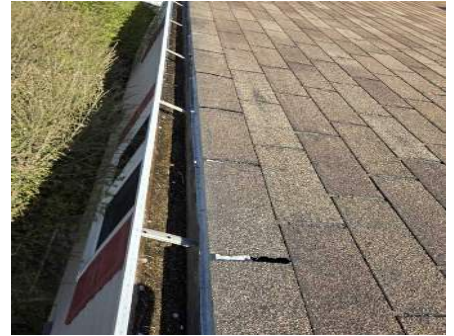
- **Metal Ridge Vent Installed.** Metal ridge vents can be susceptible to leakage with wind, rain, snow and other weather elements. IMPORTANT NOTE: Homechek does not guarantee and/or warrant against wind, rain, snow or other weather related moisture intrusion with regards to metal ridge vents. Continual maintenance will be required in order to prevent moisture intrusion when metal ridge vents have been installed. Yearly inspections by a qualified specialist is suggested.
- **Ridge Vent Fasteners Not Sealed and/or Deteriorated Sealant.** It is suggested to have a qualified specialist make corrections as needed.
- **Underlayment and/or Substrate Damage Observed.** It is suggested to have a qualified specialist further evaluate and make corrections as needed.
- **Location:** Front and rear along gutters over eaves

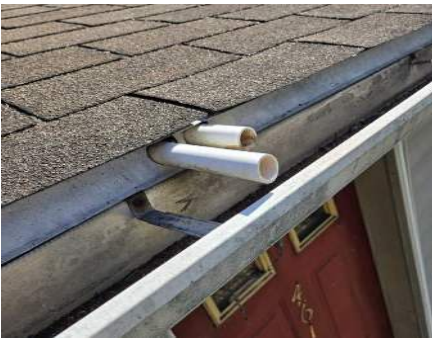
- Air conditioning condensation lines improperly drilled and run through drip edge and fascia, subject to water infiltration, suggest relocation .

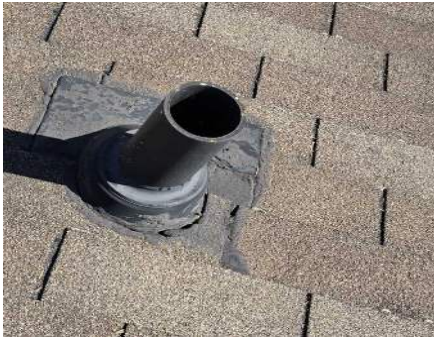
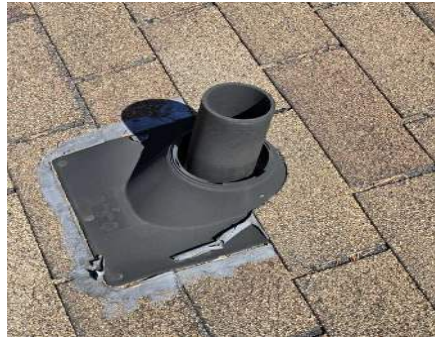
- **Roof Pipe Flashing Damaged.** Pipe flashing, sometimes referred to as a roof boot, is manufactured to seal tightly around small ventilation pipes, plumbing, and other vents and equipment that protrude from the roof of a home or commercial building. The flashing is necessary to prevent leaks. The base is typically a flexible metal so that it is compatible with virtually any roofing material. It is suggested to have a qualified specialist make corrections as needed.

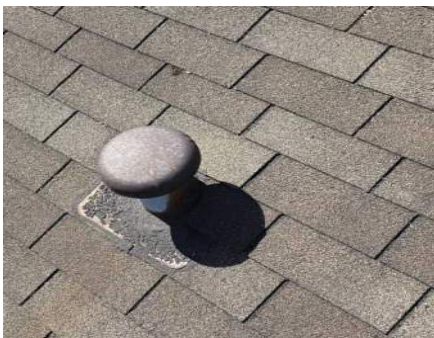
- **Roof Pipe Flashing Rusted.** Pipe flashing, sometimes referred to as a roof boot, is manufactured to seal tightly around small ventilation pipes, plumbing, and other vents and equipment that protrude from the roof of a home or commercial building. The flashing is necessary to prevent leaks. The base is typically a flexible metal so that it is compatible with virtually any roofing material. It is suggested monitor the roof pipe flashing in the future and make corrections as needed.

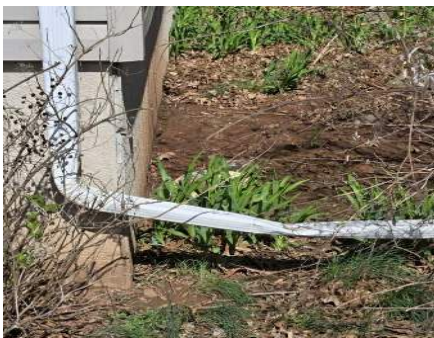
- **Damaged Downspout(s).** It is suggested to have a qualified specialist make corrections as needed.
- Location: Right rear extension

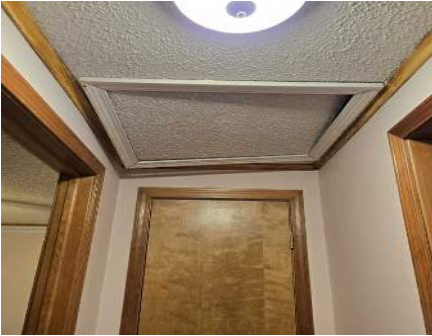
- Attic ceiling hatch trim is loose, suggest corrections to secure.

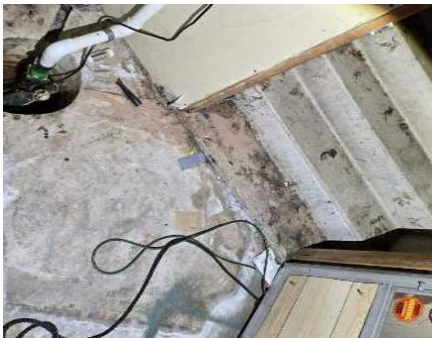
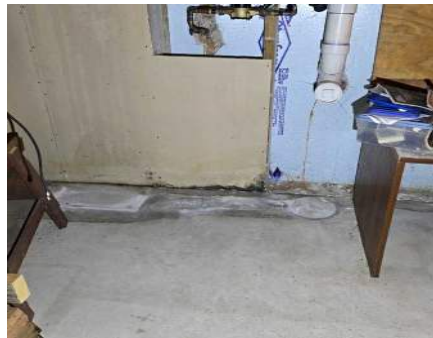
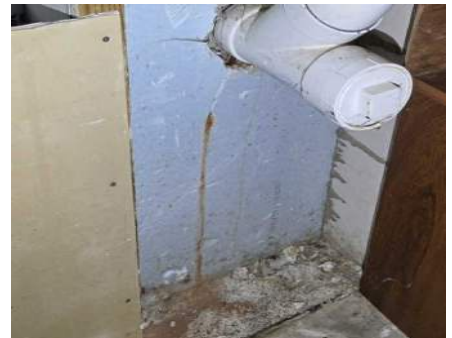
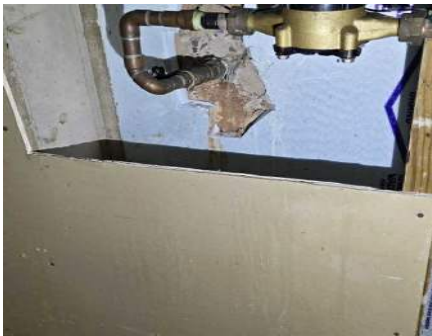
- Location: Rear exterior entry, front water and waste penetrations

- Satisfactory
- Dry Stain(s) Observed On Wall(s). Stains were checked with a highly accurate moisture meter and found to be dry at the time of the inspection. This condition may vary seasonally and/or with precipitation intensity. Grading and drainage improvements are strongly suggested as a first step in controlling water. Ensure gutters are installed where needed, are sized properly, in good working condition and clear of any debris. Ensure Downspouts are draining away from the foundation and that soil slopes away from the foundation. This condition should be monitored to determine if drainage tiles or a sump pump are necessary. In some instances, some gutter hoods or helmets installed to keep debris out of gutters can actually contribute to excess water at the foundation. The hoods or helmets may allow heavy roof runoff to flow out over gutters. If installed, suggest monitoring; if allowing runoff, suggest corrections to prevent excess water at the foundation. It is also suggested to consult with the current occupant(s) of the property to determine any past or present water intrusion.

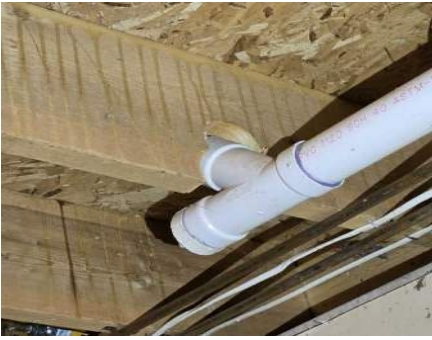
- Location: Left rear basement

- 2x10's
- Satisfactory
- Incorrect Drilling/ Cuts/ Notches in Solid Lumber. Cuts/ Notches in solid lumber joists, rafters or beams shall not exceed 1/6 of the depth of the member. They shall not be longer than 1/3 of the depth of the member. They shall not be located in the middle 1/3 of the member span. Notches at the ends of the member shall not exceed 1/4 the depth of the member. The tension side of members 4 inches or greater in thickness shall not be notched except at the ends of the members. The tension side of a member refers to the side that goes into tension when a load is applied whereas the opposite side goes into compression. The diameter of holes bored or cut into members shall not exceed 1/3 the depth of the member. Holes shall not be closer than 2 inches to the top or bottom of the member or within 2 inches of another

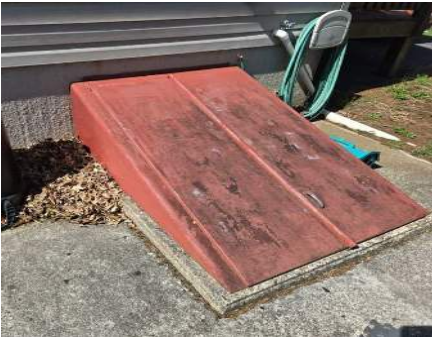
- Satisfactory
- Rust and Corrosion Observed On Bilco Doors. It is suggested to have a qualified specialist make corrections as needed.
- Caulking and/or Sealant Missing Around Bilco Doors. It is suggested to have a qualified specialist make corrections as needed.

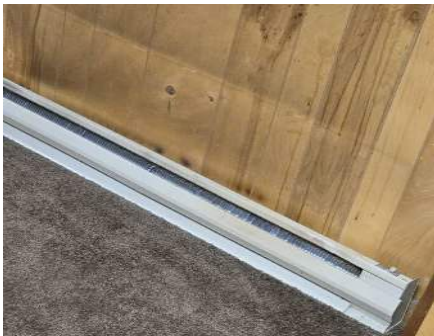
Electric Baseboard Inspector's Remarks

- Basement units all mounted up side down, suggest corrections by qualified specialist .

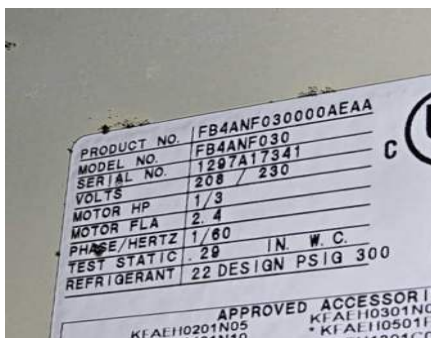
- **Air Temp Below 65 Degrees F. (Unable to Test).** Many manufacturers specify that air conditioning systems should not be operated when temperatures are below 65 degrees. Doing so can cause damage to the compressor and void any manufacturers warranty.

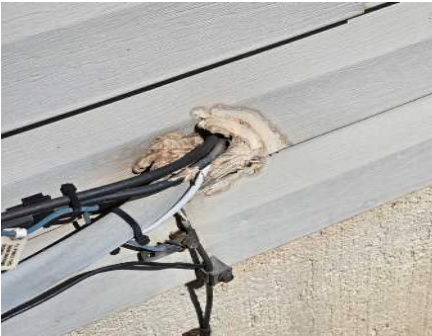
- Satisfactory
- Sealant Missing and/or Deteriorated Where SEC Enters Structure. It is suggested to have a qualified specialist make corrections as needed.

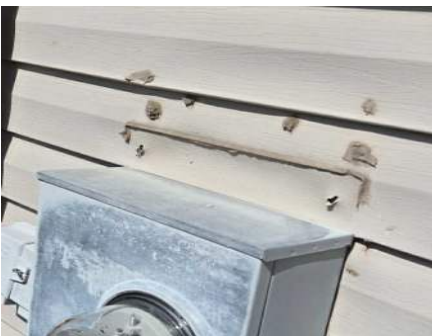
Electrical Service Meter Inspector's Remarks

- Seal holes in siding above current meter, likely from previous meter location.

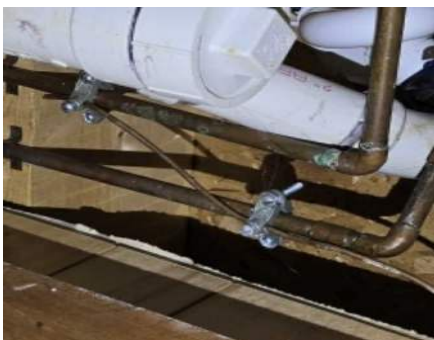
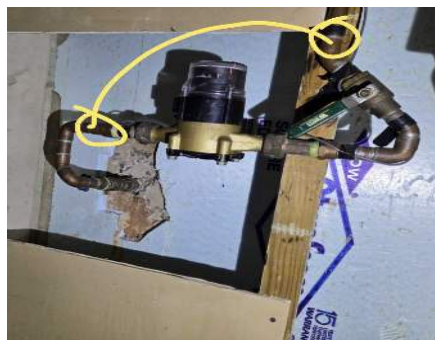
- **Ground Electrode Conductor (GEC) Continuous Path Broken.** To have a continuous ground path, steps must be taken to make sure that nothing breaks (interrupts) that path. Consequently, a connection must be made around (in parallel with) anything that breaks the ground path. For example, a water meter breaks the electrical continuity in the water pipe. Another example is if the ground conductor is attached to the metal water pipe and plastic piping was installed downstream. It is suggested to have a qualified specialist make corrections as needed.
- Location: At water meter/ equipment. Ground run to water lines, but missing jumper around meter equipment.

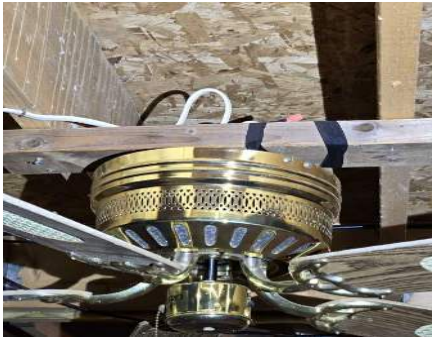
- Satisfactory
- **Exposed Wiring Splices Observed.** Electrical splices can never be left on their own in a wall or ceiling cavity. Instead, all splices must be contained within an approved junction box or fixture electrical box. It is suggested to have a qualified specialist make corrections as needed.
- Location: Unfinished basement ceiling fan missing box.

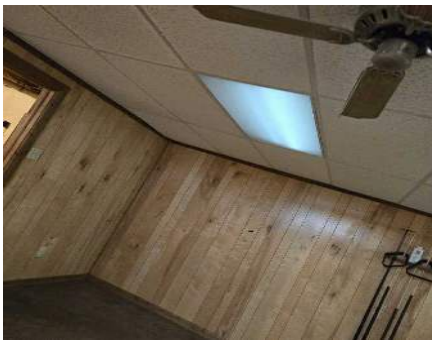
- Location: Finished basement

- **Functional**
- **Non-Working Light Fixtures Observed.** Here are some general reasons why light fixtures may not function: Loose wiring: Loose connections between wires and the light fixture can cause flickering or burning out bulbs. Loose bulb: A bulb that's not screwed in tightly can limit the amount of power it receives, causing flickering or inconsistent lighting. Faulty switch: A faulty switch can prevent electricity from reaching the light, causing it to flicker. Overloaded circuit: If too many appliances are connected to one circuit, there might not be enough current for each light fixture, resulting in dim or no lighting. Tripped circuit breaker: A tripped circuit breaker can cause a faulty switch circuit. Damaged wiring: Damaged wires can prevent lights from working properly. It is suggested to have a qualified specialist further evaluate and make corrections as needed.

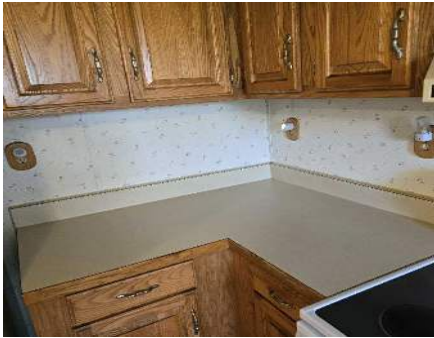
- **Functional**
- **GFCI's Not Installed At Kitchen Countertop(s).** In kitchens, all outlets that serve countertop surfaces should be equipped with GFCI outlet protection. That would include any outlets on walls, behind wet areas (sinks, etc.) that have features such as countertop breakfast bars (open counter surfaces above sinks used to sit at on the opposite side). It is suggested to have a qualified specialist make corrections as needed.
- Location: Left of range, breakfast bar

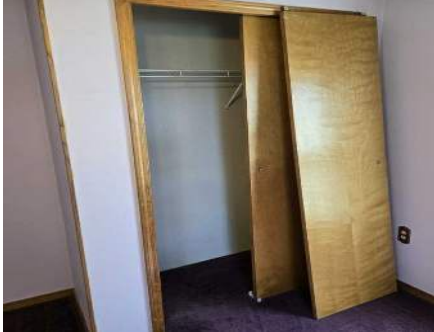
- Closet bypass doors need adjustments throughout, off track, dragging on floor, missing floor guides.

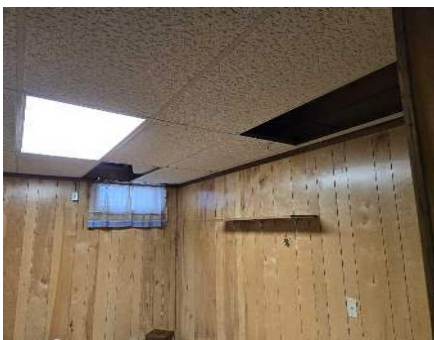
- Some suspended ceiling tiles missing or damaged, suggest corrections

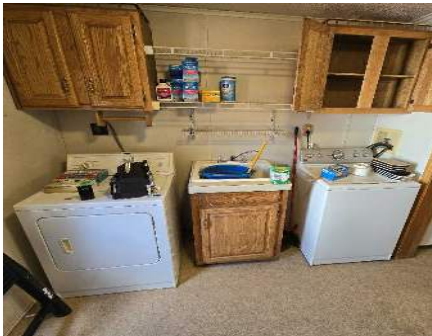
- Suggest upgrading from rubber hoses

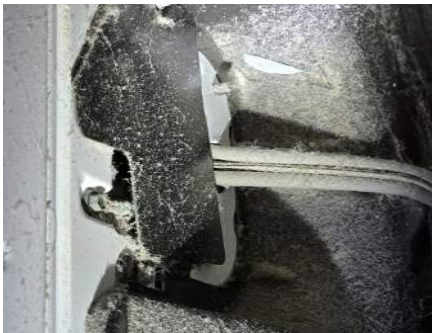
- Missing clamp on chord at back of dryer, suggest install to protect from vibration.

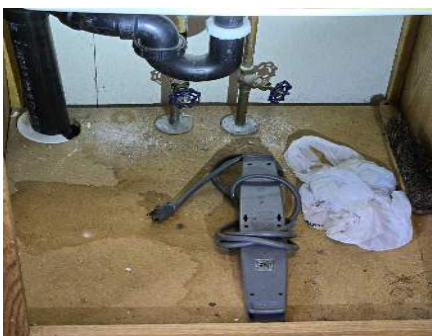
- Dry staining on cabinet under sink

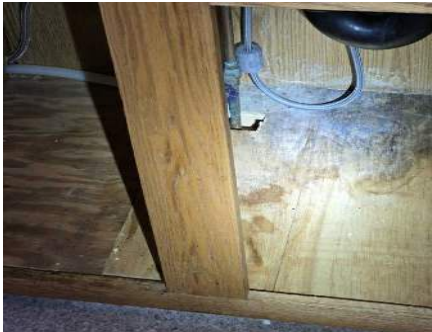
- Satisfactory
- Cabinets Show Signs Of Normal Wear & Tear. Normal wear and tear is the expected decline in the condition of a property due to normal everyday use. It is deterioration that occurs in the course of living in a property. It is not caused by abuse or neglect.
- Moisture Damage Observed Inside Cabinet Below Kitchen Sink. It is suggested to have a qualified specialist further evaluate and make corrections as needed.

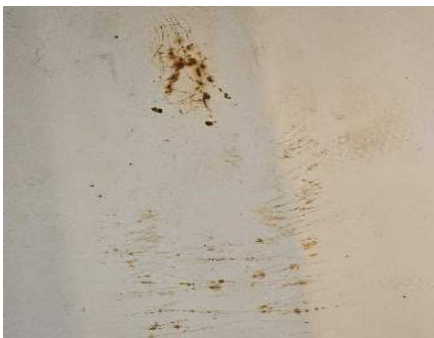
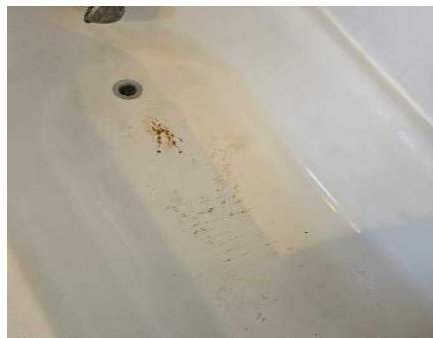
- **Bathtub Damage Observed.** It is suggested to have a qualified specialist make corrections as needed.
- Location: Enamel coating in tub, causing steel to rust
