# **INSPECTION REPORT**

# 85 Vera Cruz Rd Reinholds, PA 17569

09/26/2024

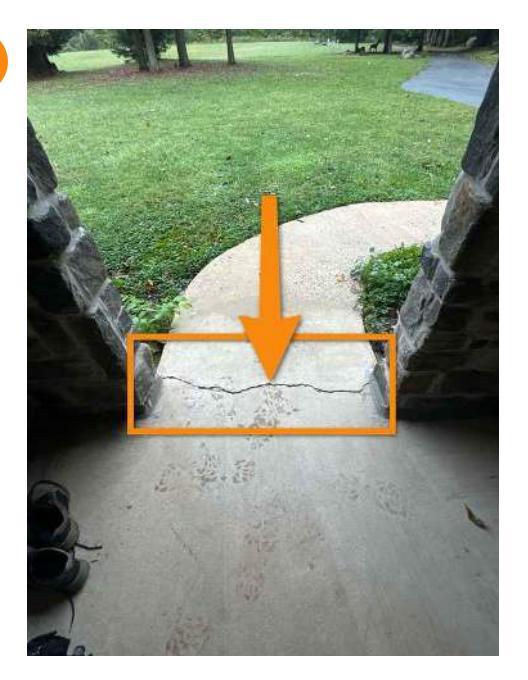
# **CONCRETE CRACKING - MODERATE**

At the time of the inspection the walkway showed signs of moderate cracking. In order to maintain a safe and serviceable surface and to avoid water penetration, walks and steps should be maintained free from cracking. I recommend evaluation and repair of this section of walkway.

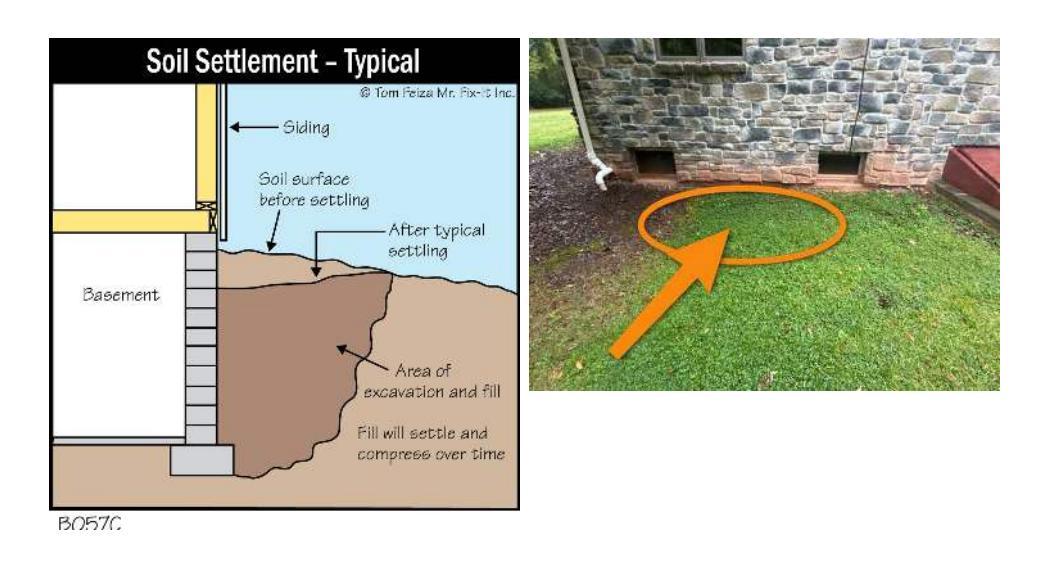
## 3.4.1 Grading and Drainage GRADING - POTENTIAL LOW SPOT

At the time of the inspection there was a potential low spot or area against the foundation that could hold water. This area could allow water to trap and not drain away properly. I recommend this area(s) be evaluated and re-graded to avoid the pooling of water in the yard.

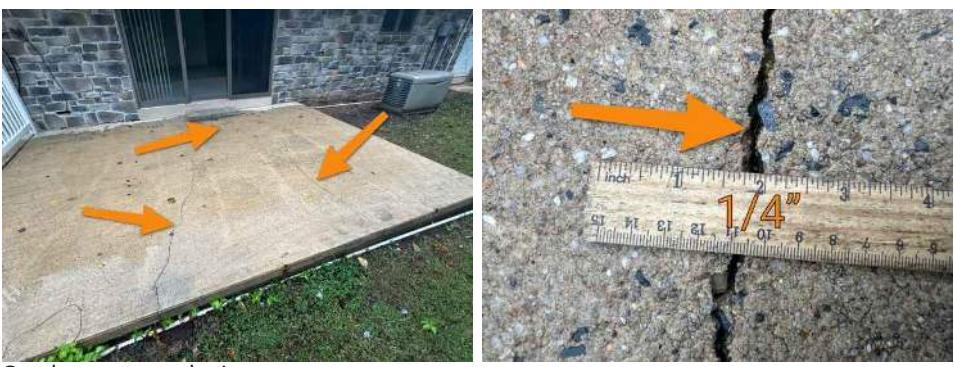
3.8.1 Porches, Balconies, Steps and Railings

At the time of the inspection I observed an area(s) where the concrete surface was cracking. The size of this particular crack is small. There does not appear to be any underlying structural problems, however this area should be evaluated by a professional to determine if the problem will continue to degrade so that repairs can be made.

Settlement cracks in concrete

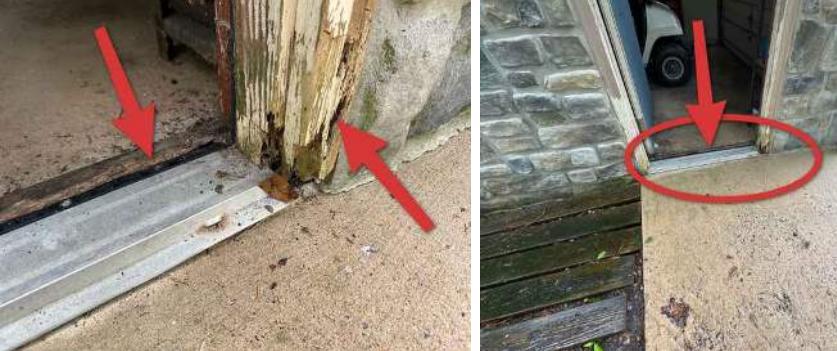
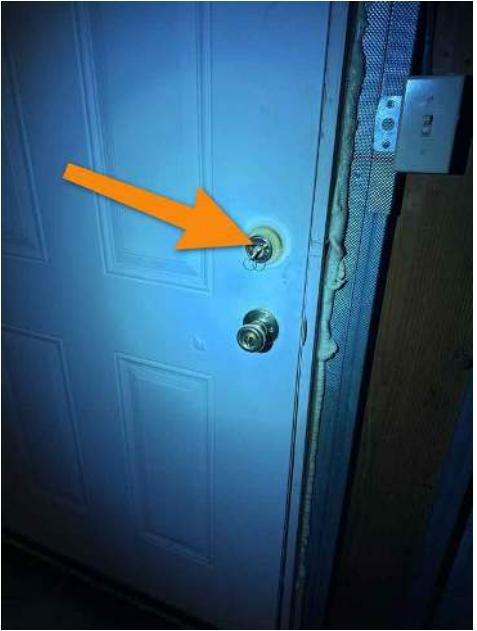
At the time of the inspection I observed a door(s) in which the **door**, **sill**, **jamb or all three** were rotted in one or more locations. See photo descriptions. The apparent cause is moisture. I recommend a qualified professional to evaluate and repair or replace.

Close up

Threshold and trim rot

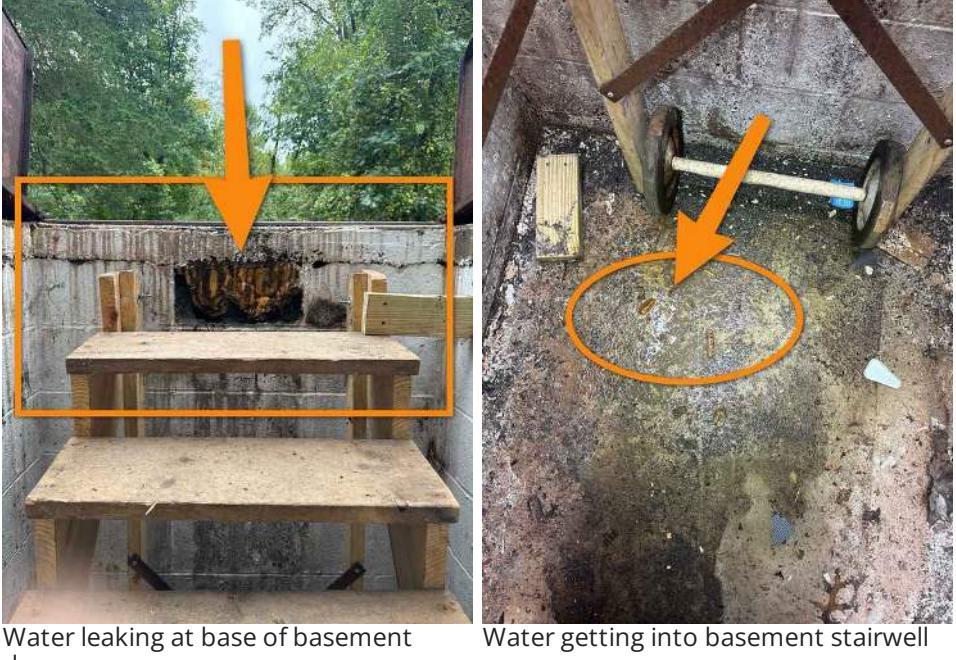
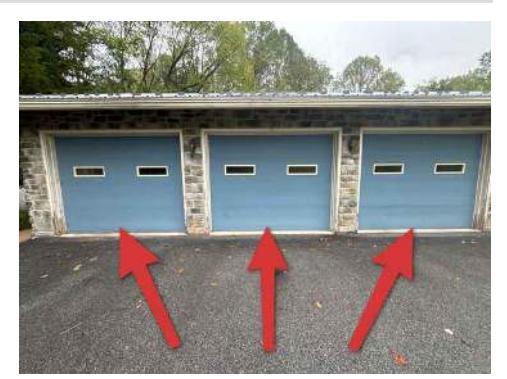
At the time of the inspection the painted exterior surfaces showed signs of peeling/blistering and exposure to weather in numerous locations. I recommend all the exposed surfaces be evaluated and maintained on a regular basis.

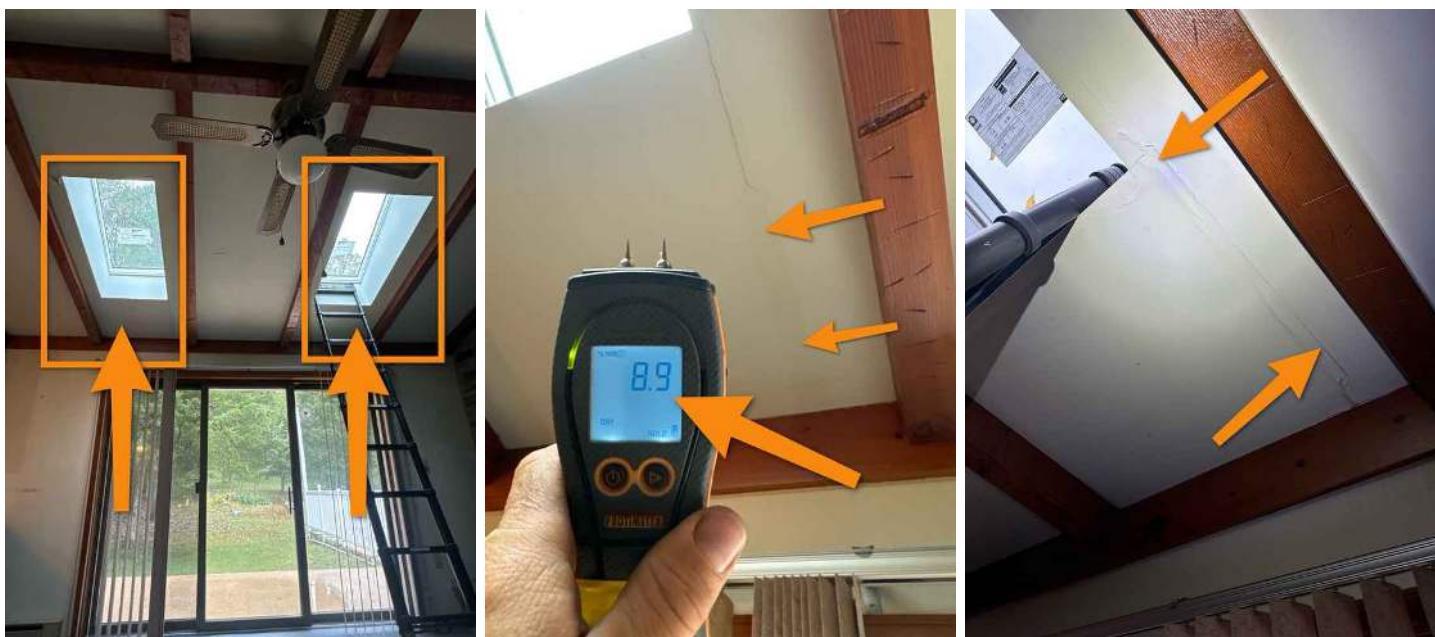
I observed ceiling damage that appears to be the result of a past leak above. There was no moisture evident at the time of the inspection. I recommend the ceiling be repaired.

Minor drywall damage

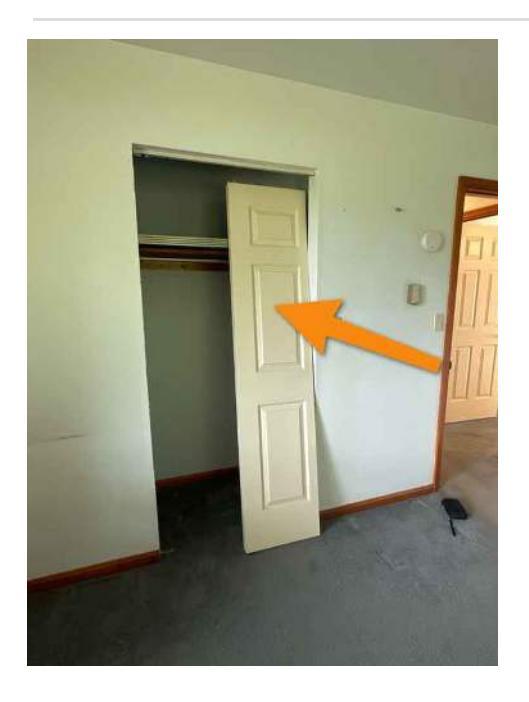
I observed one or more bi-fold doors where the operating hardware was off track or was in need of replacement. I recommend a handyman or DIY repair this so that the door operates properly.

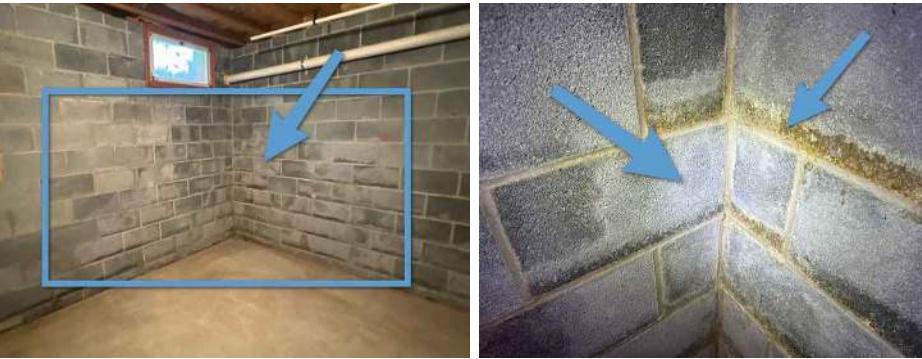
#### Efflorescence

Signs of fluorescent on block wall

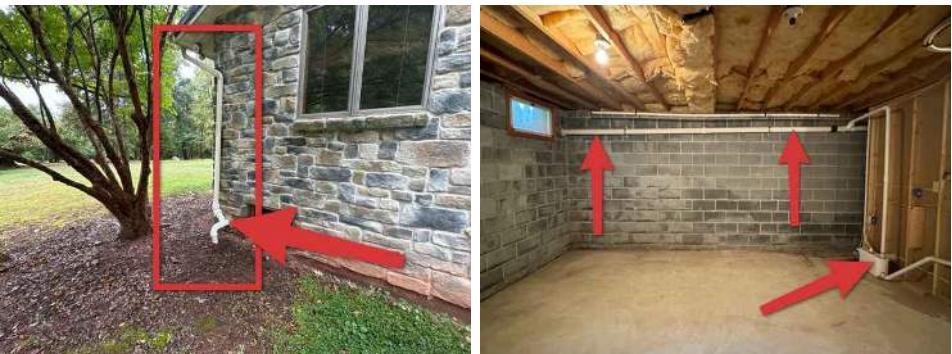
## 10.8.1 Sewage Ejectors SEWER EJECTOR DRAIN DEFECT

**\*\*Health Hazard\*\*** The bathroom sewer ejector appeared to drain into an exterior roof downspout drainage system. This is not a sanitary way to dispose of toilet waste. A qualified professional should evaluate and repair.

Exterior gutter drainage

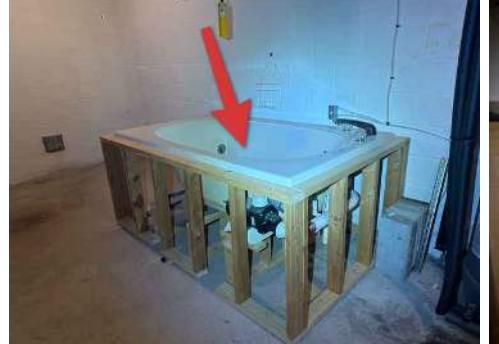
At the time of the inspection I could not inspect the whirlpool because I was unable to fill the tub. The reason is noted in the photo. I recommend a qualified professional to evaluate in or to repair so that the unit can be inspected.

Unable to fill whirlpool

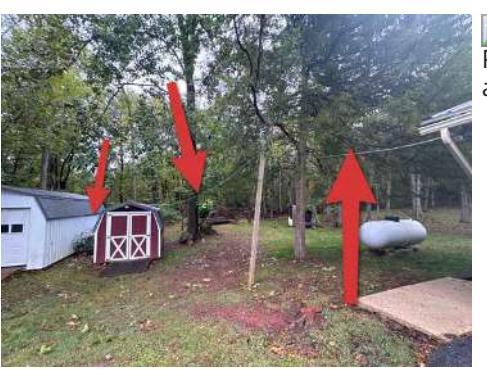
Power to shed should be evaluated by an electrician

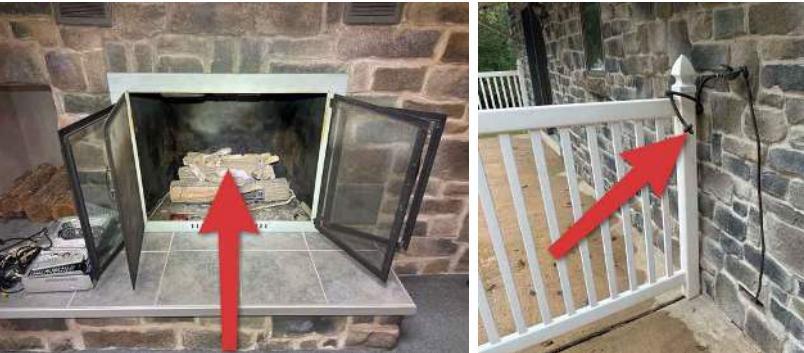
Not able to inspect propane fireplace
